LEHIGH RIVER BASIN,  
POHOPOCO CREEK, PENNSYLVANIA .

BELTZVILLE LAKE.

CONDITION REPORT.  
DAM, OUTLET WORKS & SPILLWAY  
PERIODIC INSPECTION REPORT, NO. 1,

JULY 1970.

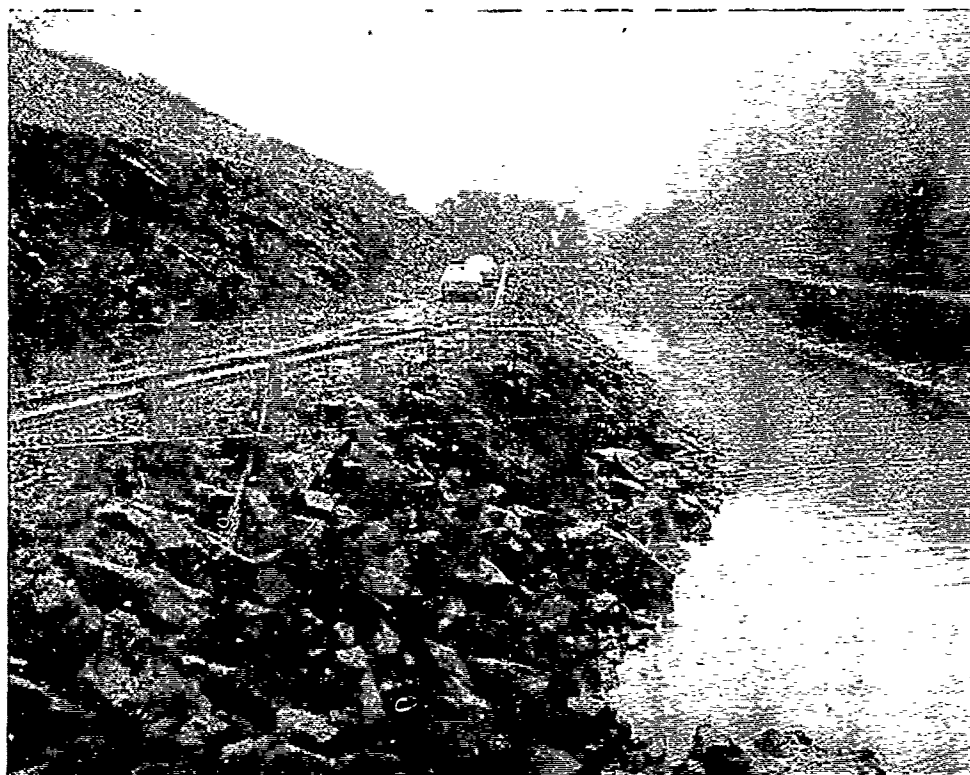
Photo No. 6      Potential undermining of guard  
rail downstream of outlet works.

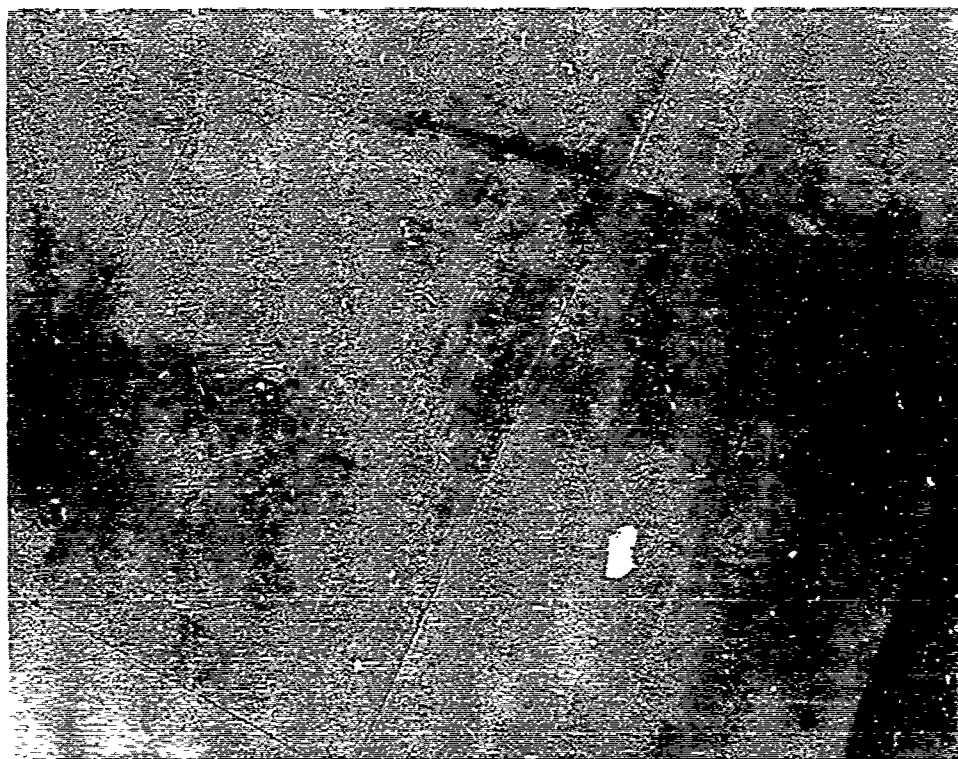
(3) Cracks: Many hairline cracks have appeared in the surface of the spillway slab. The majority, however, are minor in nature. One crack is a working crack and will be sealed. Photographs 12, 13 and 14 show, in general, the surface cracks. Photographs 15 and 16 show the working crack.

Photo No. 13      Cracks in spillway slab.

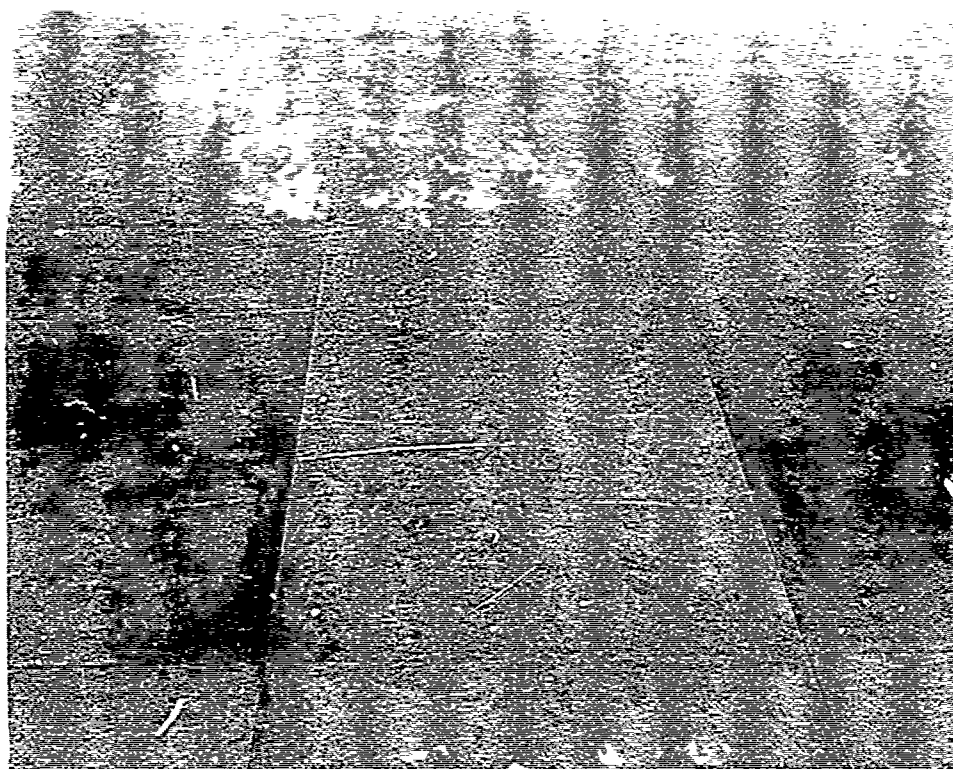
Photo No. 14      Cracks in spillway slab.

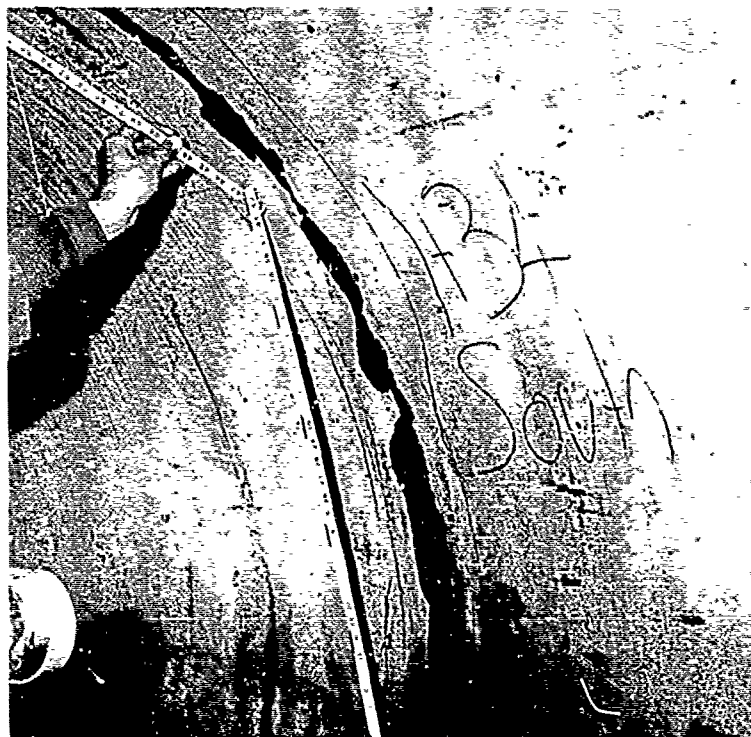
Photo No. A-11 Minor joint spall at  
Sta. 1+34.

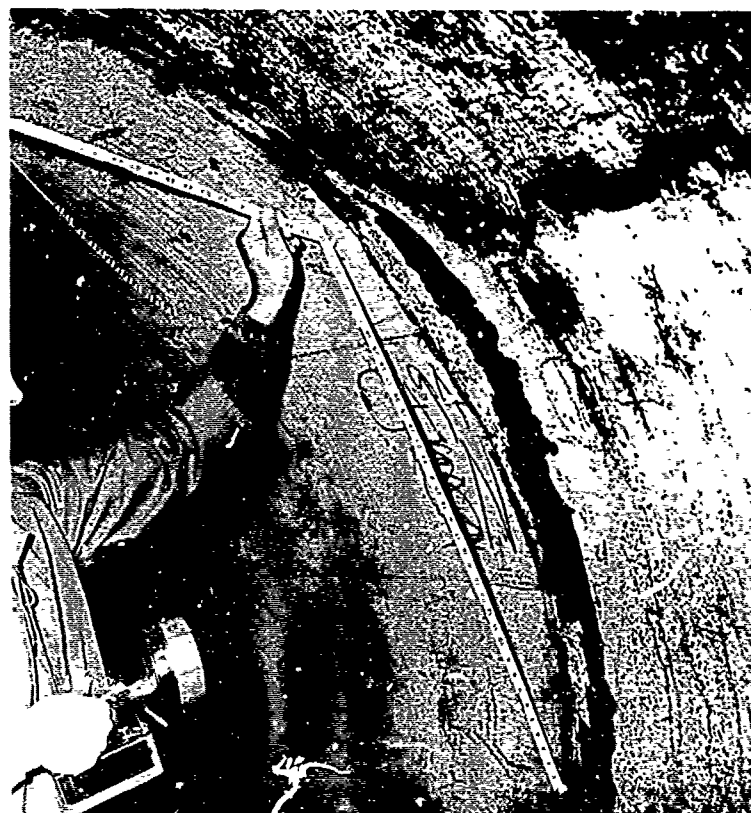
Photo No. A-12 Minor joint spall at  
Sta. 0+94.

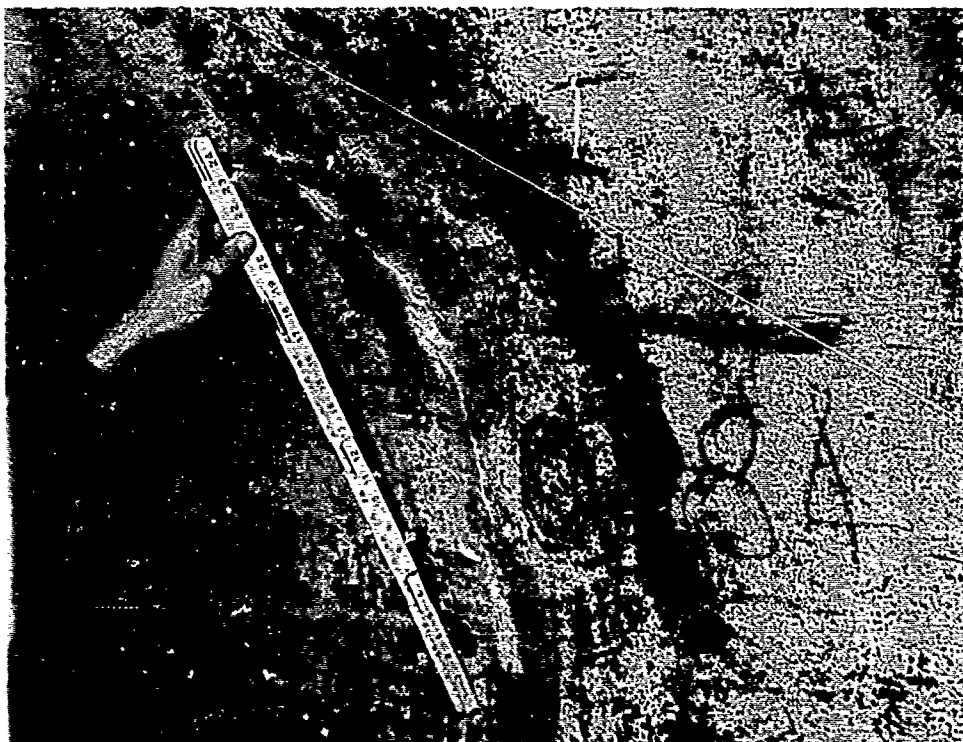
Photo No. A-13     Minor crack sealed by calcium  
deposits at Sta. 0+84.

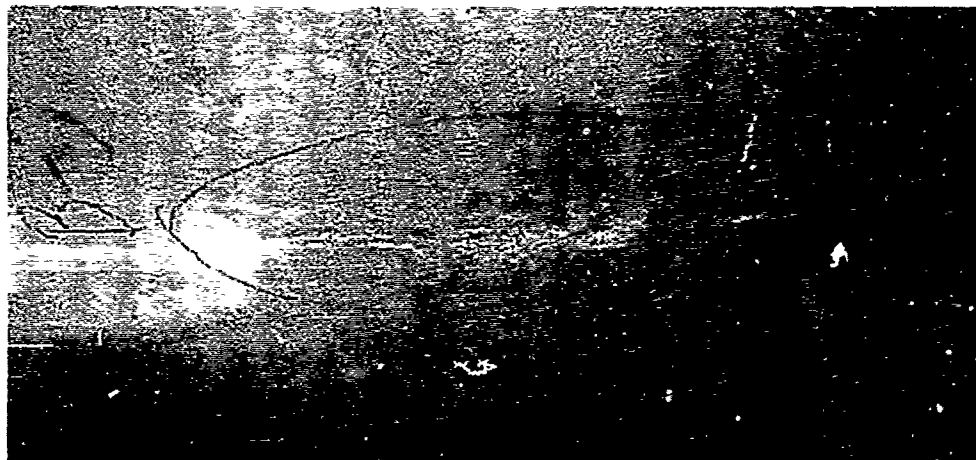
Photo No. B-5      Minor joint spall in wall of  
North Chamber at Sta. 0+43.
