**DEVELOPMENT OF A PAVEMENT MAINTENANCE  
MANAGEMENT SYSTEM  
VOLUME VI: M&R GUIDELINES --  
VALIDATION AND FIELD APPLICATIONS**

**MOHAMED Y. SHAHIN  
CONSTRUCTION ENGINEERING RESEARCH LABORATORY  
CHAMPAIGN, ILLINOIS 61820**

**DECEMBER 1979  
INTERIM REPORT  
SEPTEMBER 1977 - JULY 1979**

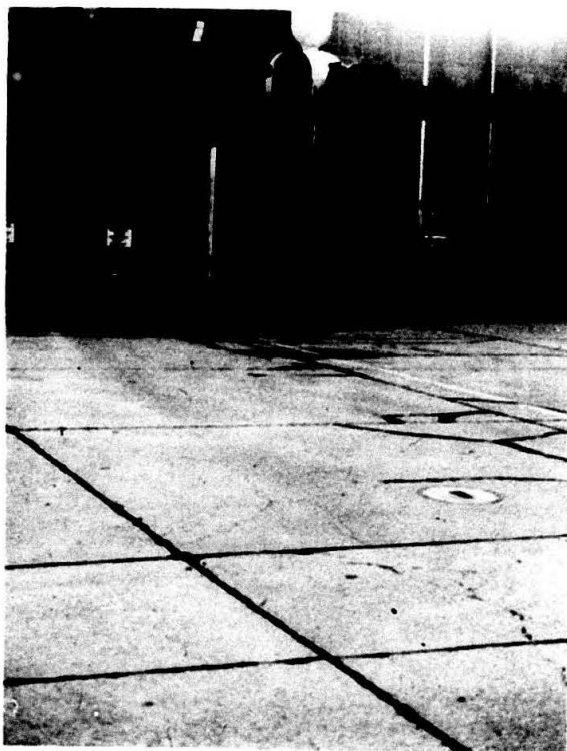
Figure 40. Pavement Damage Along Traffic Lines.

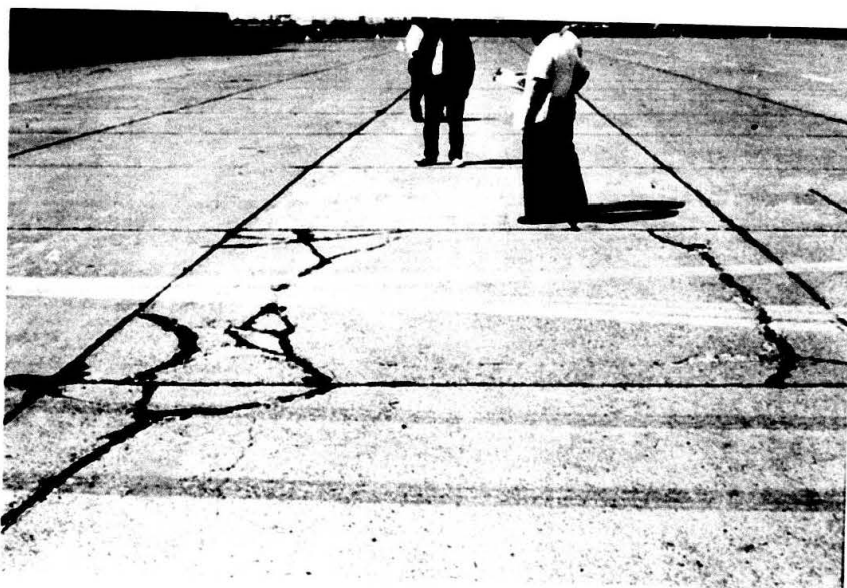
Figure 41. Severely Shattered Slab Located Along Traffic Line.
