DELAWARE RIVER BASIN

SCS PA 477  
BERKS COUNTY, PENNSYLVANIA

NDS I.D. NO. PA 00720  
DER I.D. NO. 6-457

PHASE I INSPECTION REPORT  
NATIONAL DAM INSPECTION PROGRAM

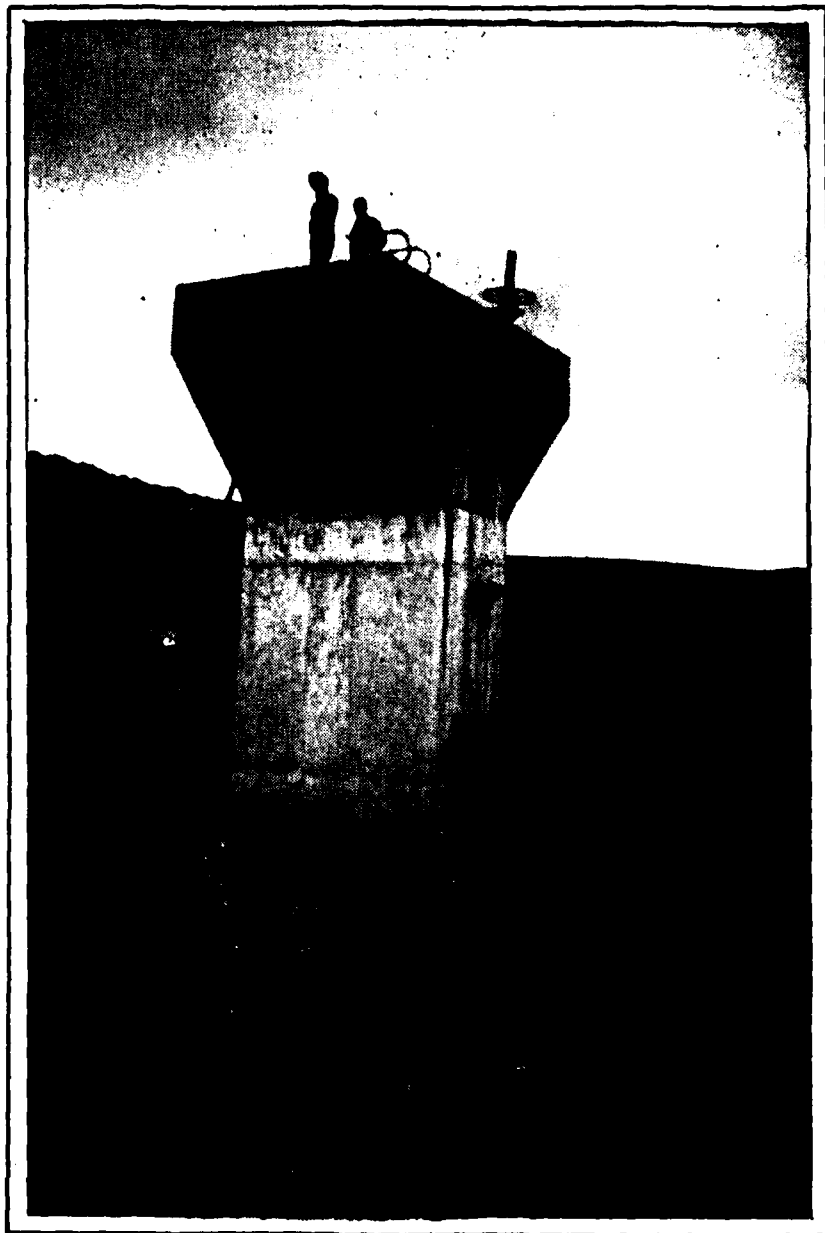
PHOTOGRAPH NO. 1

1. Principal Spillway. As shown on Photograph No. 1, the riser is located within the upstream berm at the shoreline. Exposed portions of the riser were inspected and evaluated to be in good condition with no signs of excessive concrete deterioration, spalling or other structural deficiencies or defects. The interior of the intake riser could not be inspected as one hinge was rusted on the access door and the door could not be opened. The pond drain sluice gate was exercised and found to operate easily.

VIEW OF PRINCIPAL SPILLWAY  
RISER. ALSO NOTE WILLOWS IN  
FOREGROUND AND WOODY VEGETATION  
ON EMBANKMENT BEHIND RISER.

2. The growth of willows should be removed from the embankment shoreline. Cutting is not sufficient to prevent the growth of willows.
3. The access door from the top of the riser should be repaired or replaced, as necessary.

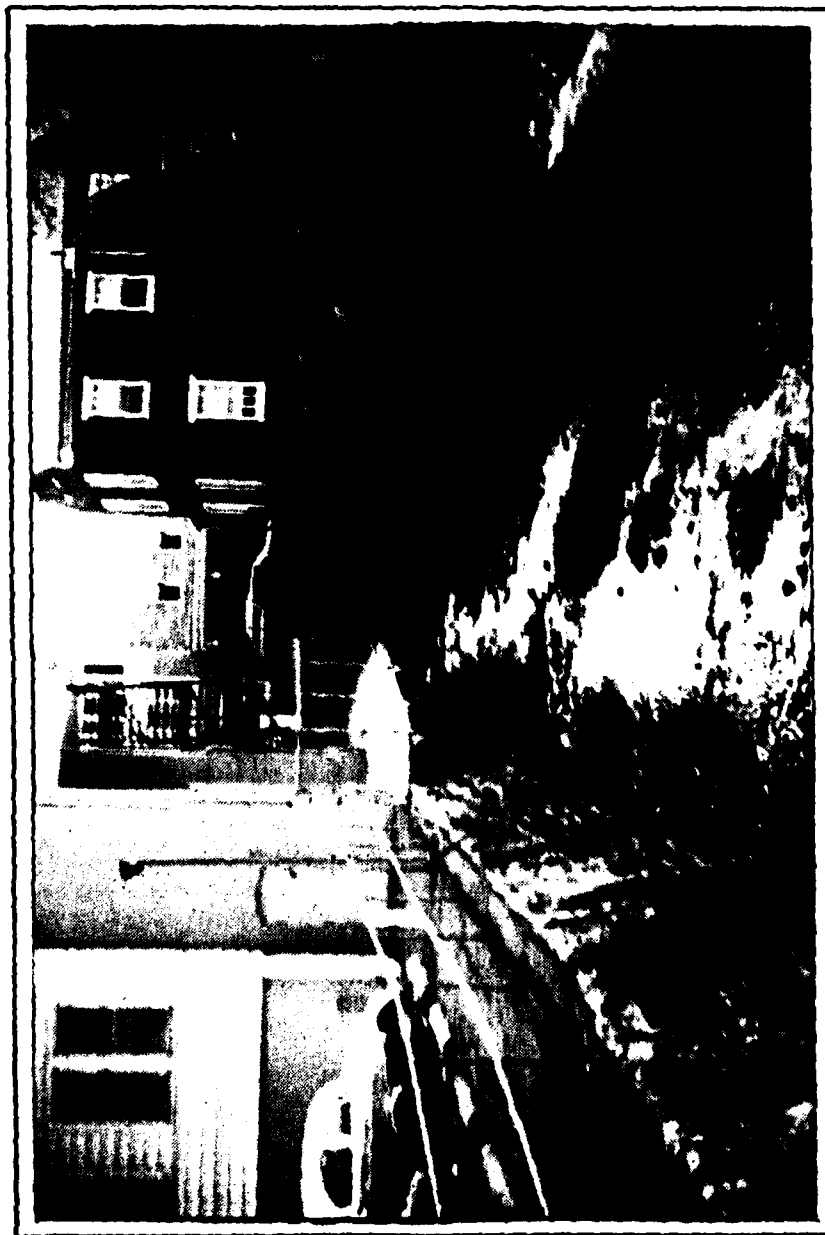
PHOTOGRAPH NO. 12

TYPICAL VIEW OF DOWNSTREAM DAMAGE  
CENTER IN HAMBURG, PENNSYLVANIA.
