(6) National Dam Inspection Program  
RAILROAD CREEK DAM  
~~BUCKS COUNTY, PENNSYLVANIA~~

(NDS I D NO. PA 01062,  
DER I D NO. 9-175,  
SCS NO. PA 615)

Tricounty to West Branch Mechanicsville, PA  
Bucks County, Pennsylvania  
PHASE I INSPECTION REPORT  
NATIONAL DAM INSPECTION PROGRAM

WOODWARD-CLYDE CONSULTANTS  
5120 Butler Pike  
Plymouth Meeting, Pennsylvania 19462

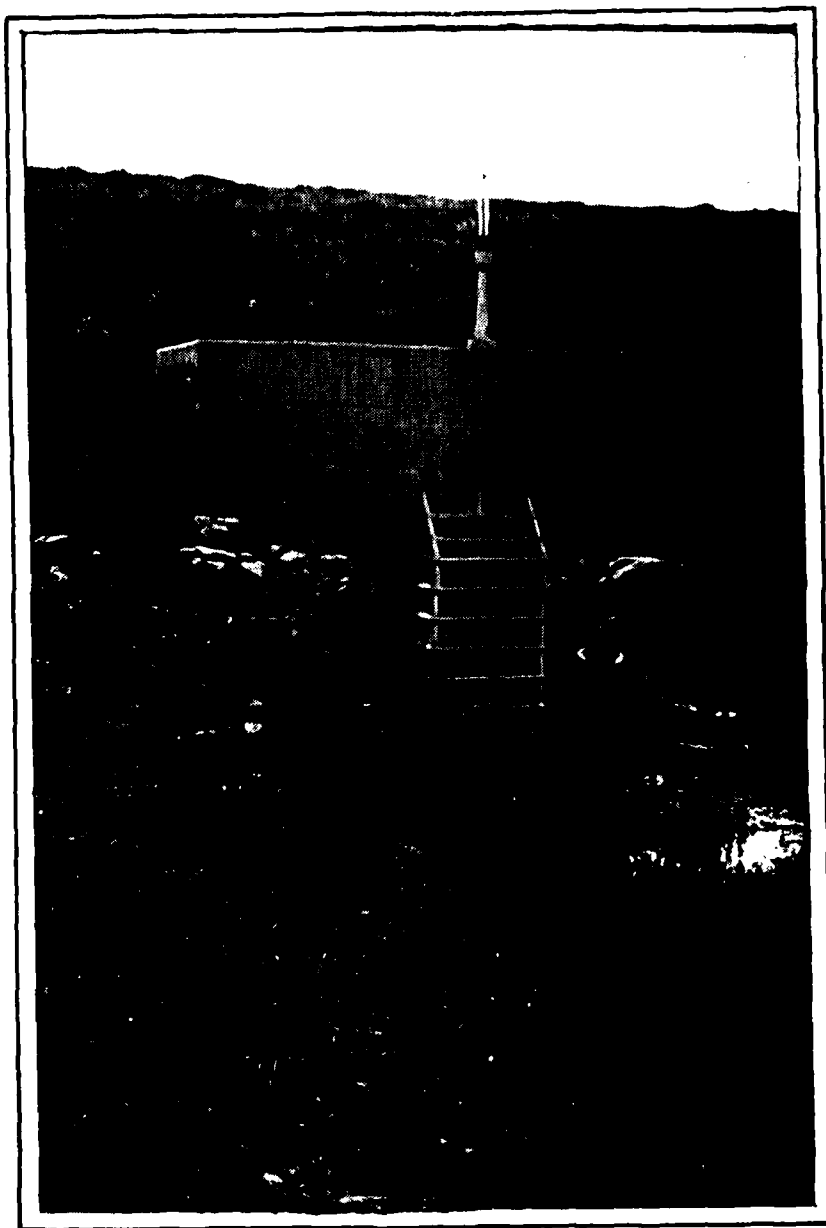
PHOTOGRAPH NO. 1

PRINCIPAL SPILLWAY RISER  
WITH OPEN POND DRAIN GATE.

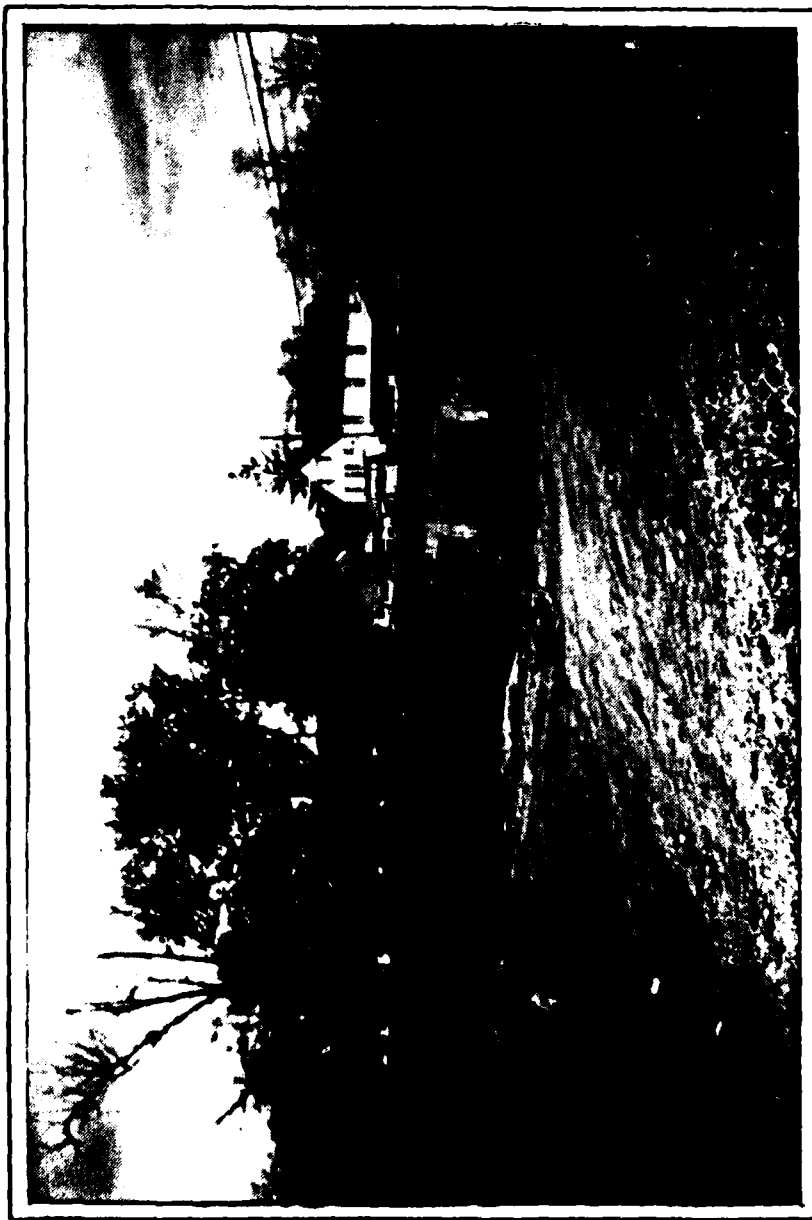
PHOTOGRAPH NO. 11

*About 3,500 feet below the dam, Railroad Creek enters the West Branch of Neshaminy Creek. About 0.75 mile below the confluence, the West Branch flows under U.S. Route 202 and through Chalfont before joining the North Branch. In Chalfont there are at least six homes/businesses subject to damage in the event of dam failure, including one gas station protected by a dike on Route 202.*

SECOND DOWNSTREAM HIGHWAY BRIDGE  
AND DAMAGE CENTER. PICTURE TAKEN  
FROM DIKE PROTECTING GASOLINE  
STATION TO THE RIGHT OF THE PICTURE.
