**WANGAUM FALLS DAM**

Number  
NDI NO. PA-00141  
Number  
DER NO. 64-102

**PHASE I INSPECTION REPORT.**

**NATIONAL DAM INSPECTION PROGRAM.**

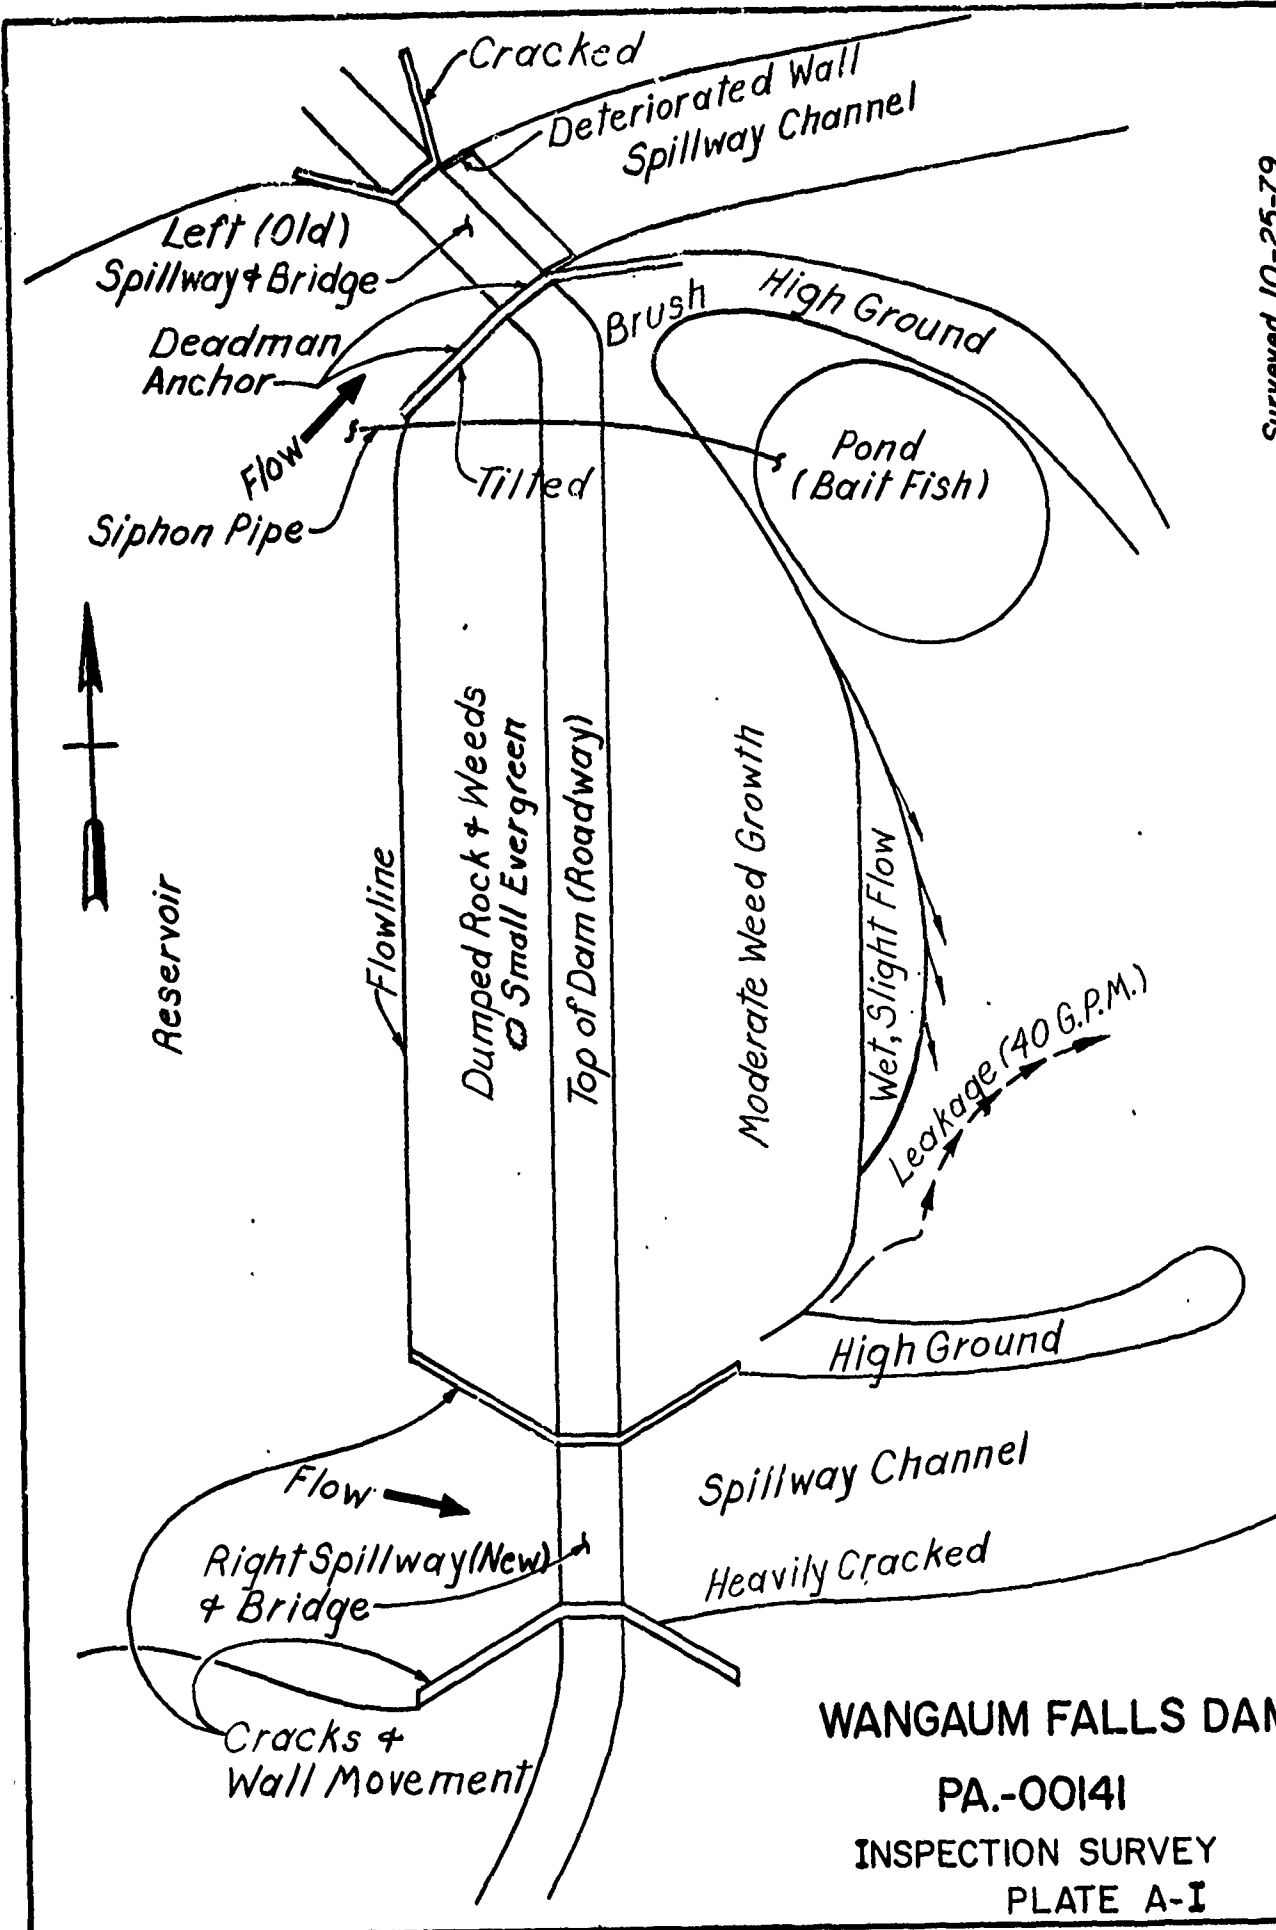
**INSPECTION SURVEY  
PLATE A-I**

The downstream slope has a considerable growth of weeds and heavy brush at several locations (See Plate A-I). Seepage was not detected on the slope, but a wet area was noticed along the toe. Drainage is poor in this area and there is no toe drain. A large flow of water (estimated 40 g.p.m.) was observed at the toe adjacent to a high ridge next to the right spillway. The water was clear and appears to originate from the spillway through the cracked rocks of the spillway. A pond has been constructed about 70 feet beyond the toe. This pond is fed through a siphon from the reservoir and is used to raise bait fish.

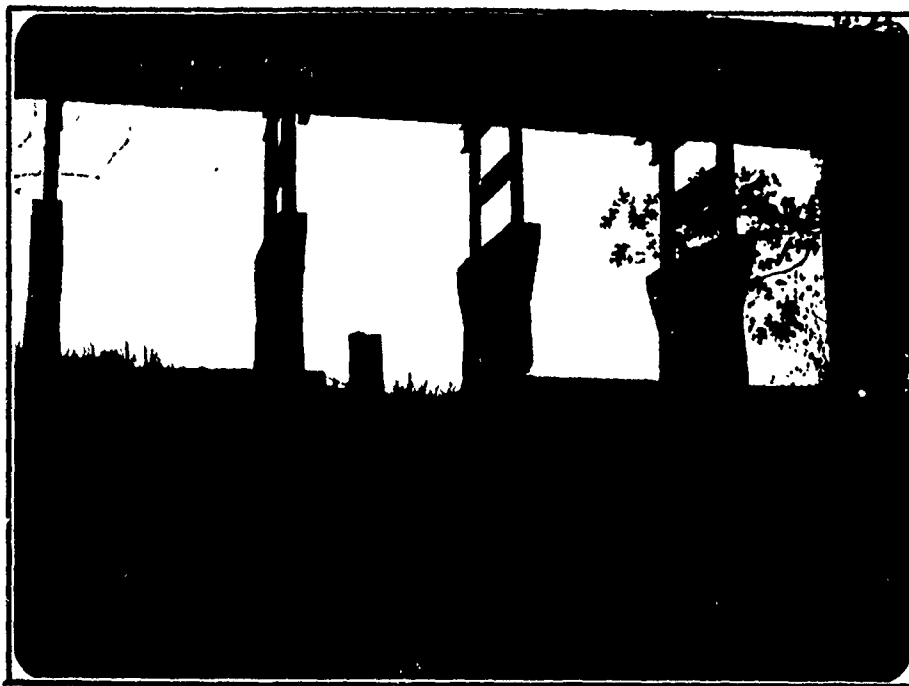
DOWNSTREAM SIDE, LEFT SPILLWAY - NO. 6

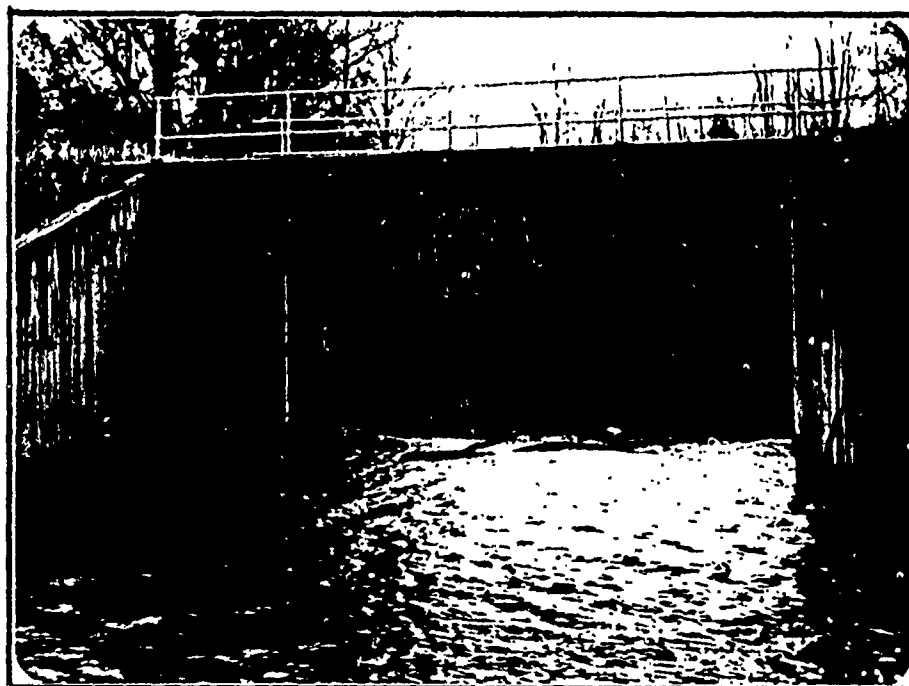
UPSTREAM SIDE, RIGHT SPILLWAY - NO. 7
