SCS DAM PA-445

NDI NO. PA-00099

PHASE I INSPECTION REPORT.
NATIONAL DAM INSPECTION PROGRAM.

Name of Dam: SCS DAM PA-445
State & State No.: PENNSYLVANIA, 64-176
County: WAYNE
Stream: GREEN CREEK
Date of Inspection: November 6, 1979
[Condition in 1979]

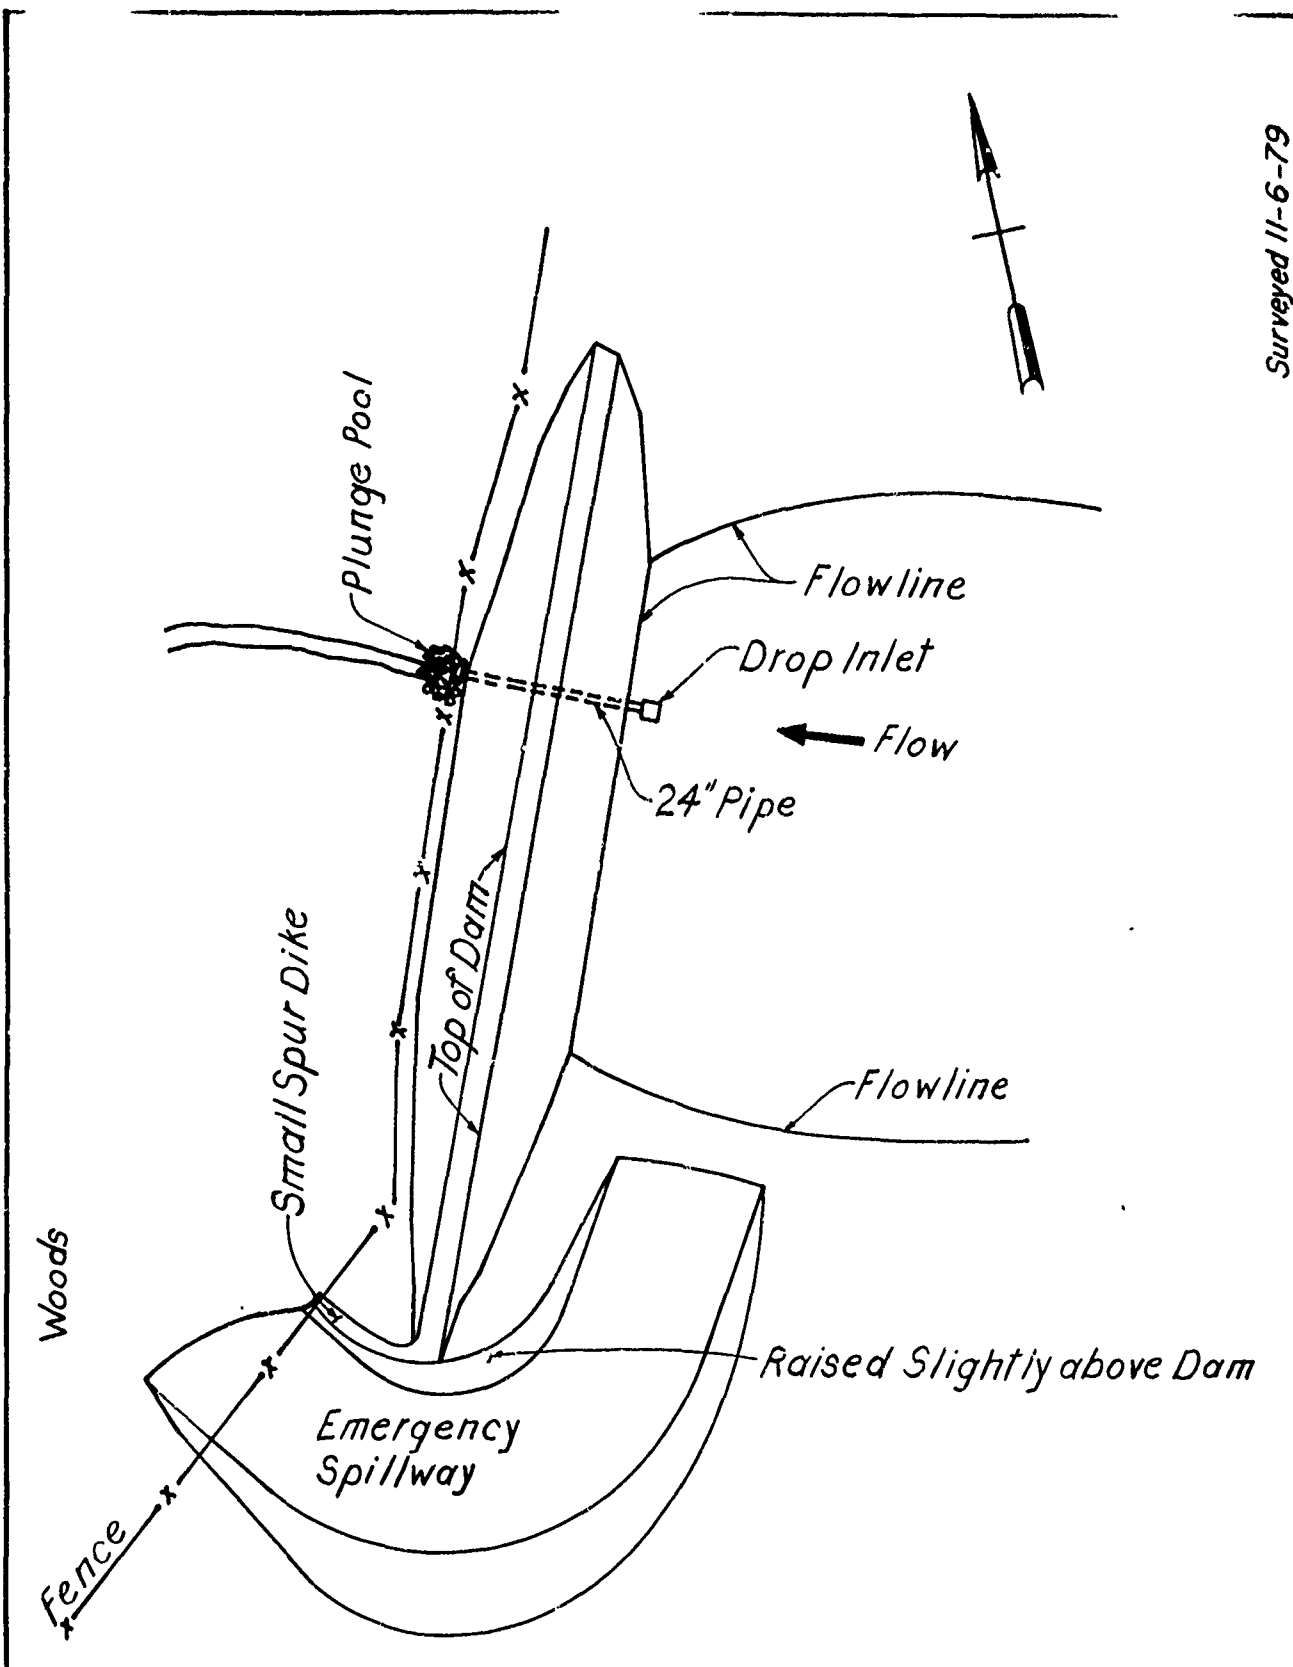
SCS DAM PA.-445
PA.-00099
INSPECTION SURVEY
PLATE A-I

The emergency spillway in the left abutment appeared to be in good condition with a good grass mat for erosion protection. The side slopes are stable and the flow of water is directed away from the toe of the dam by a spur dike. (Appendix A, Plate A-I). The principal spillway appeared to be in good condition.

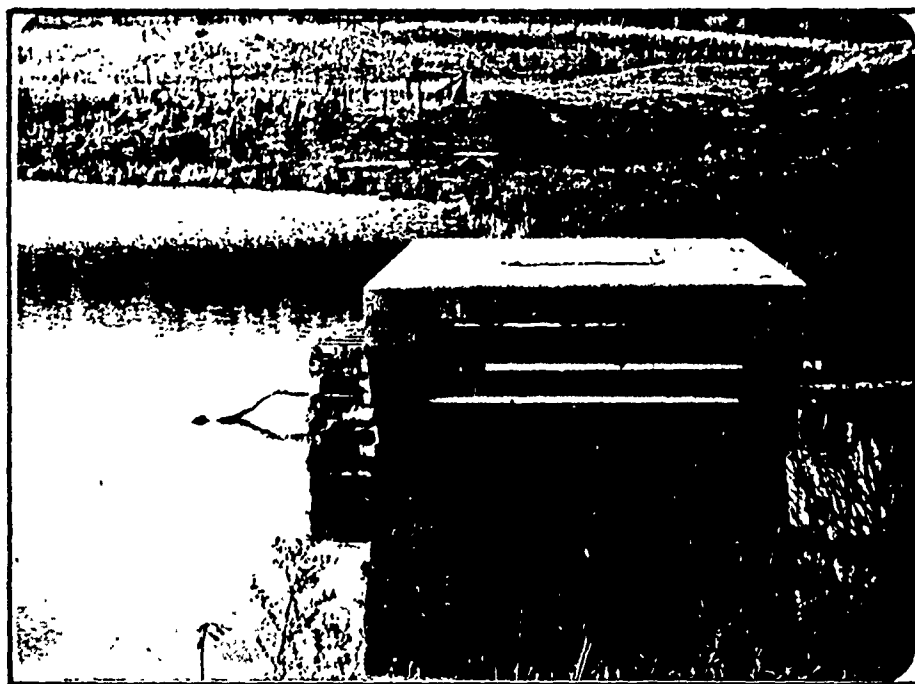
DETAIL PRINCIPAL SPILLWAY - DROP INLET STRUCTURE - NO. 3

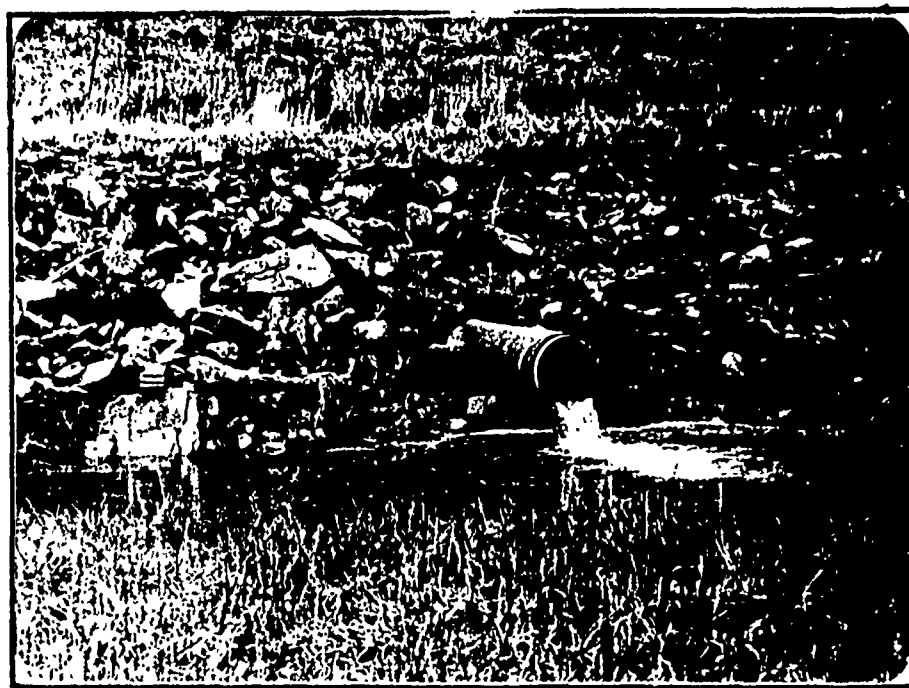
OUTLET PIPE AND PLUNGE POOL - NO. 4

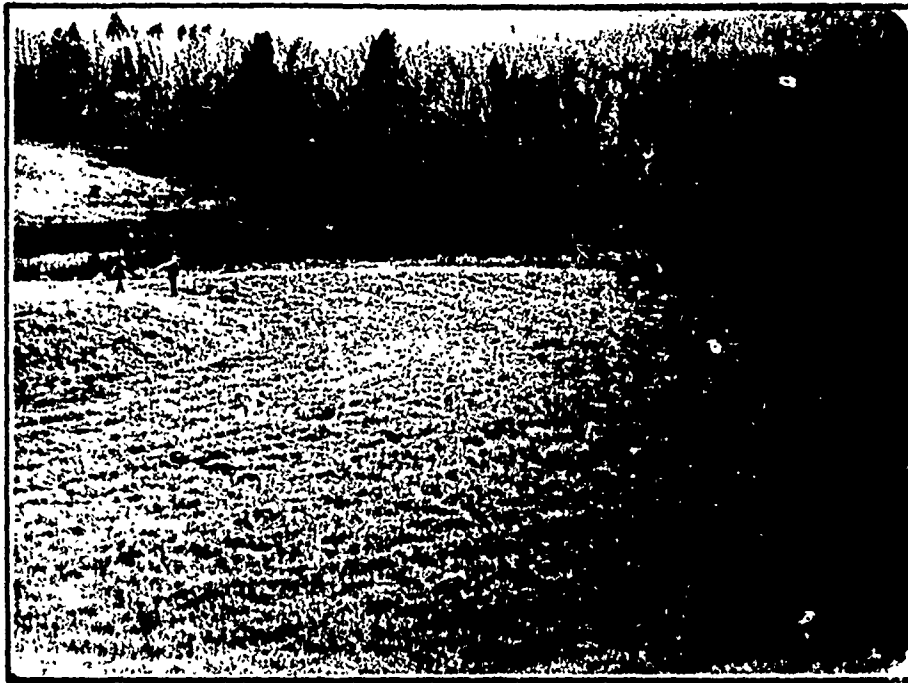
EMERGENCY SPILLWAY LOOKING UPSTREAM - NO. 6

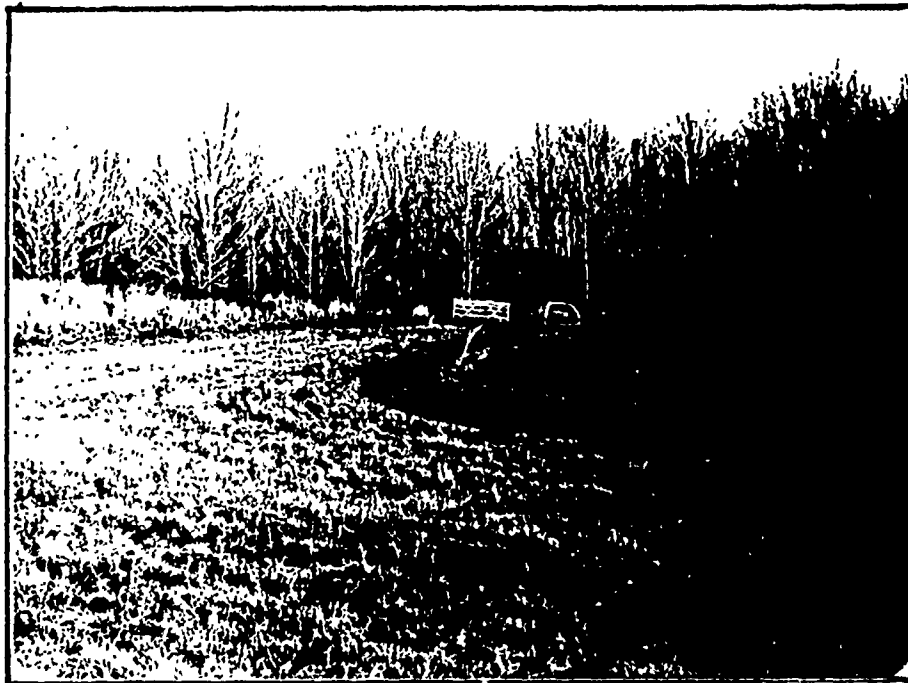
EMERGENCY SPILLWAY LOOKING DOWNSTREAM
DAM AND SPUR DIKE ON RIGHT - NO. 7
