PHASE I REPORT
NATIONAL DAM INSPECTION PROGRAM

Name of Dam: SCS DAM PA-419
State & State No.: PENNSYLVANIA, 64-170
County: WAYNE
Stream: TRIBUTARY TO INDIAN ORCHARD BROOK
Date of Inspection: November 7, 1979

PHASE I INSPECTION REPORT
NATIONAL DAM INSPECTION PROGRAM

SCS DAM PA-419

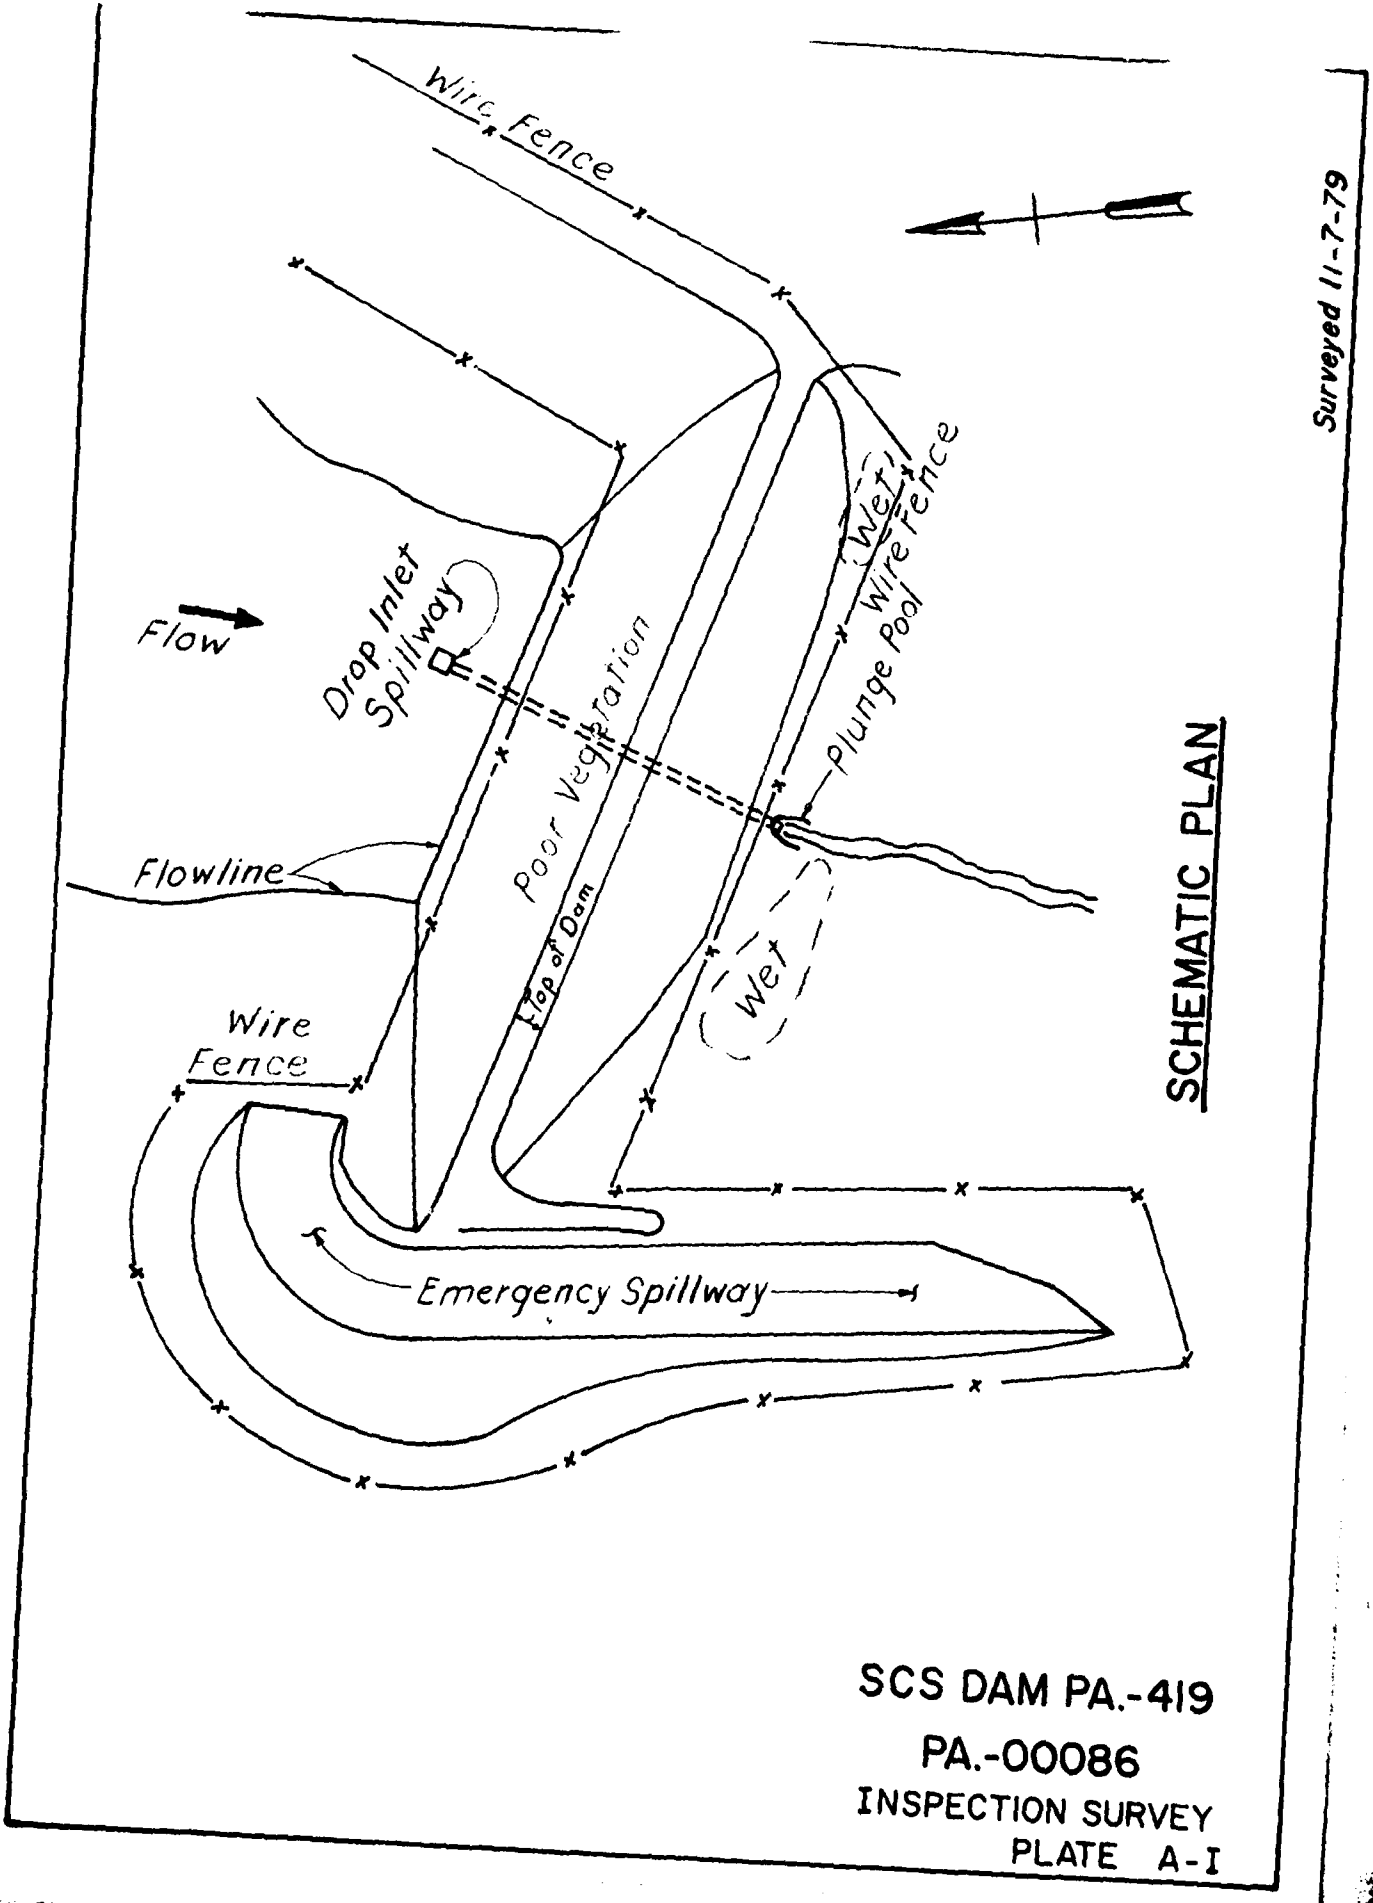
SCS DAM PA.-419
 PA.-00086
 INSPECTION SURVEY
 PLATE A-I

One wet area was observed downstream from the downstream toe of the embankment on the right side. The area is above pool level; hence, this drainage is attributed to the side hill drainage rather than seepage through the embankment.

F. JUNCTION EMBANKMENT & ABUTMENT OR SPILLWAY	Embankment abuts natural ground on left side-good. Right side ends at emergency spillway - no abutment.
G. SEEPAGE	None observed through or under the embankment. Side hill drainage was noted. See sketch (Plate A-I).

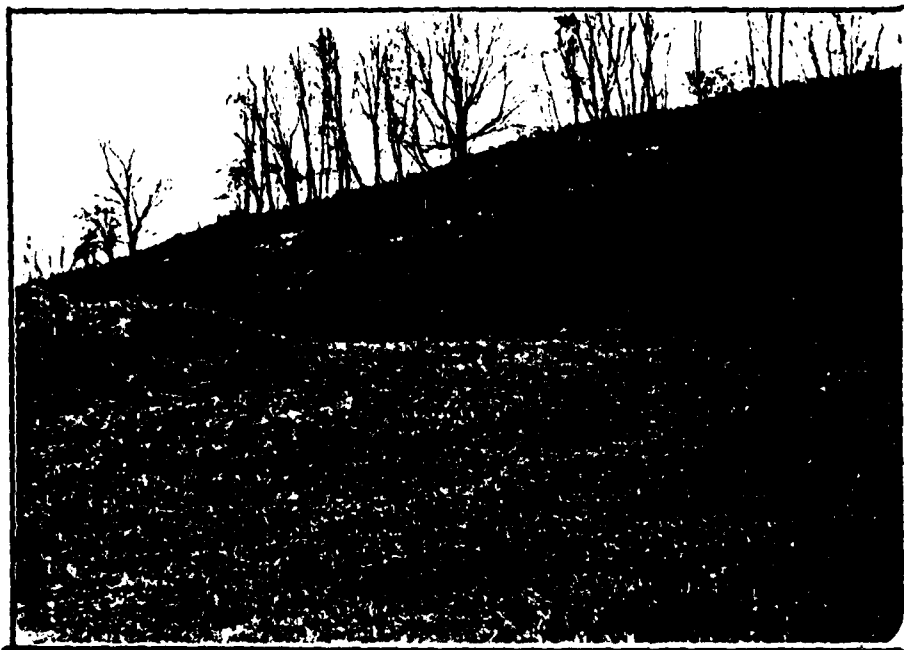
The emergency spillway in the right abutment appeared to be in good condition with a good grassmat for erosion protection. The side slopes are stable and the flow of water is directed away from the toe of dam by a spur dike (Appendix A, Plate A-I).

EMERGENCY SPILLWAY LOOKING DOWNSTREAM - NO. 6

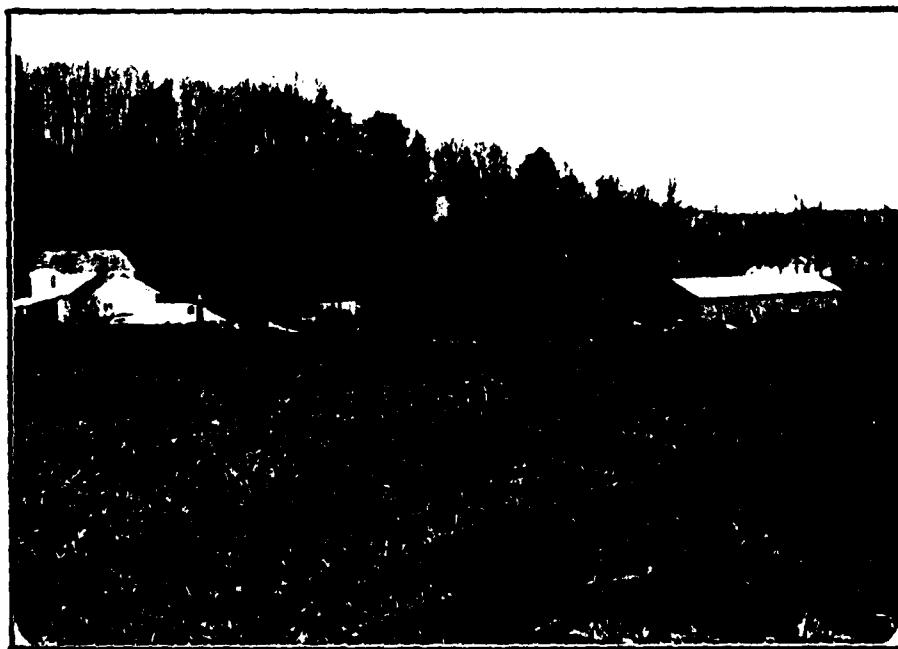
END OF EMERGENCY SPILLWAY - NO. 7
NOTE: FENCE ACROSS SPILLWAY
