SCS DAM PA-452

NDI NO. PA-00100

PHASE I INSPECTION REPORT  
NATIONAL DAM INSPECTION PROGRAM

Name of Dam: SCS DAM PA-452  
State & State No.: PENNSYLVANIA, 64-177  
County: Wayne  
Stream: UNNAMED TRIBUTARY TO WALLENPAUPACK CREEK  
Date of Inspection: November 6, 1979  
[cont'd from p. 1]

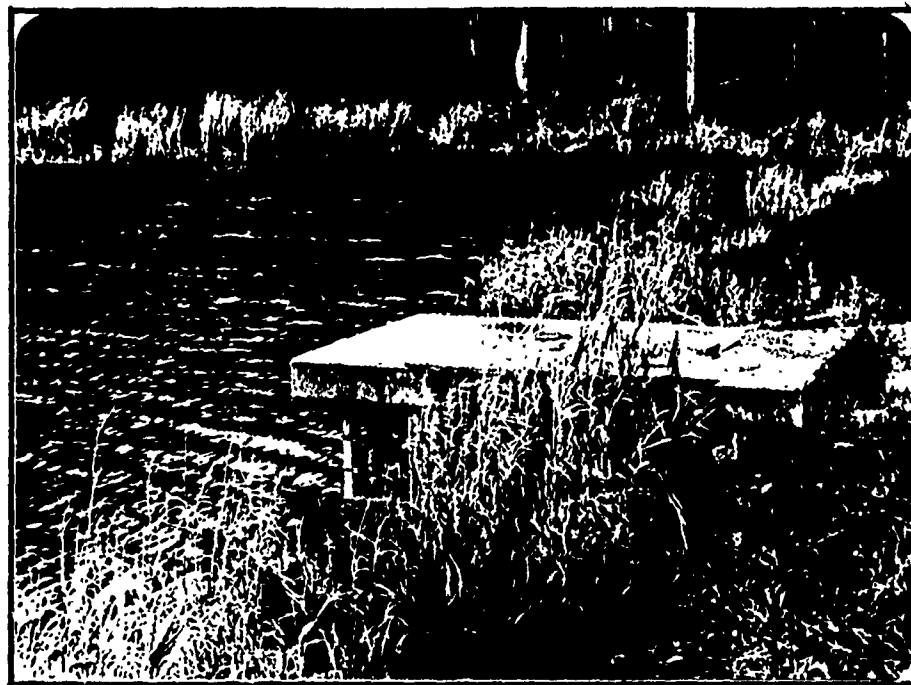
DROP INLET STRUCTURE OR  
PRINCIPAL SPILLWAY - NO. 4

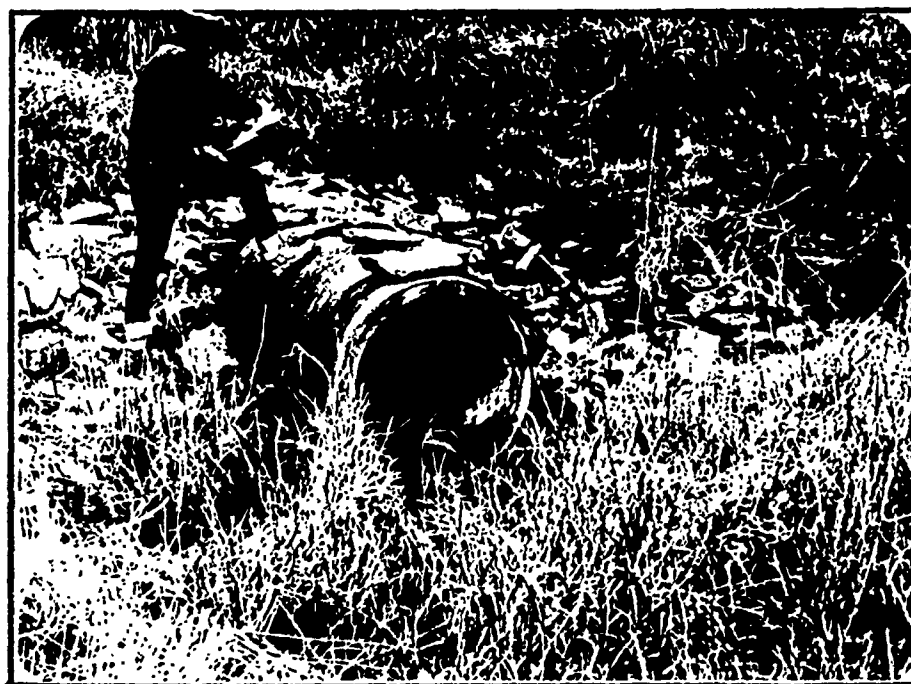
OUTLET PIPE - NO. 5
