PENNSYLVANIA  
NDS ID PA. 00620  
DER ID 46-145

# MARTINS DAM

PHASE I INSPECTION REPORT  
NATIONAL DAM INSPECTION PROGRAM

JANUARY 1980

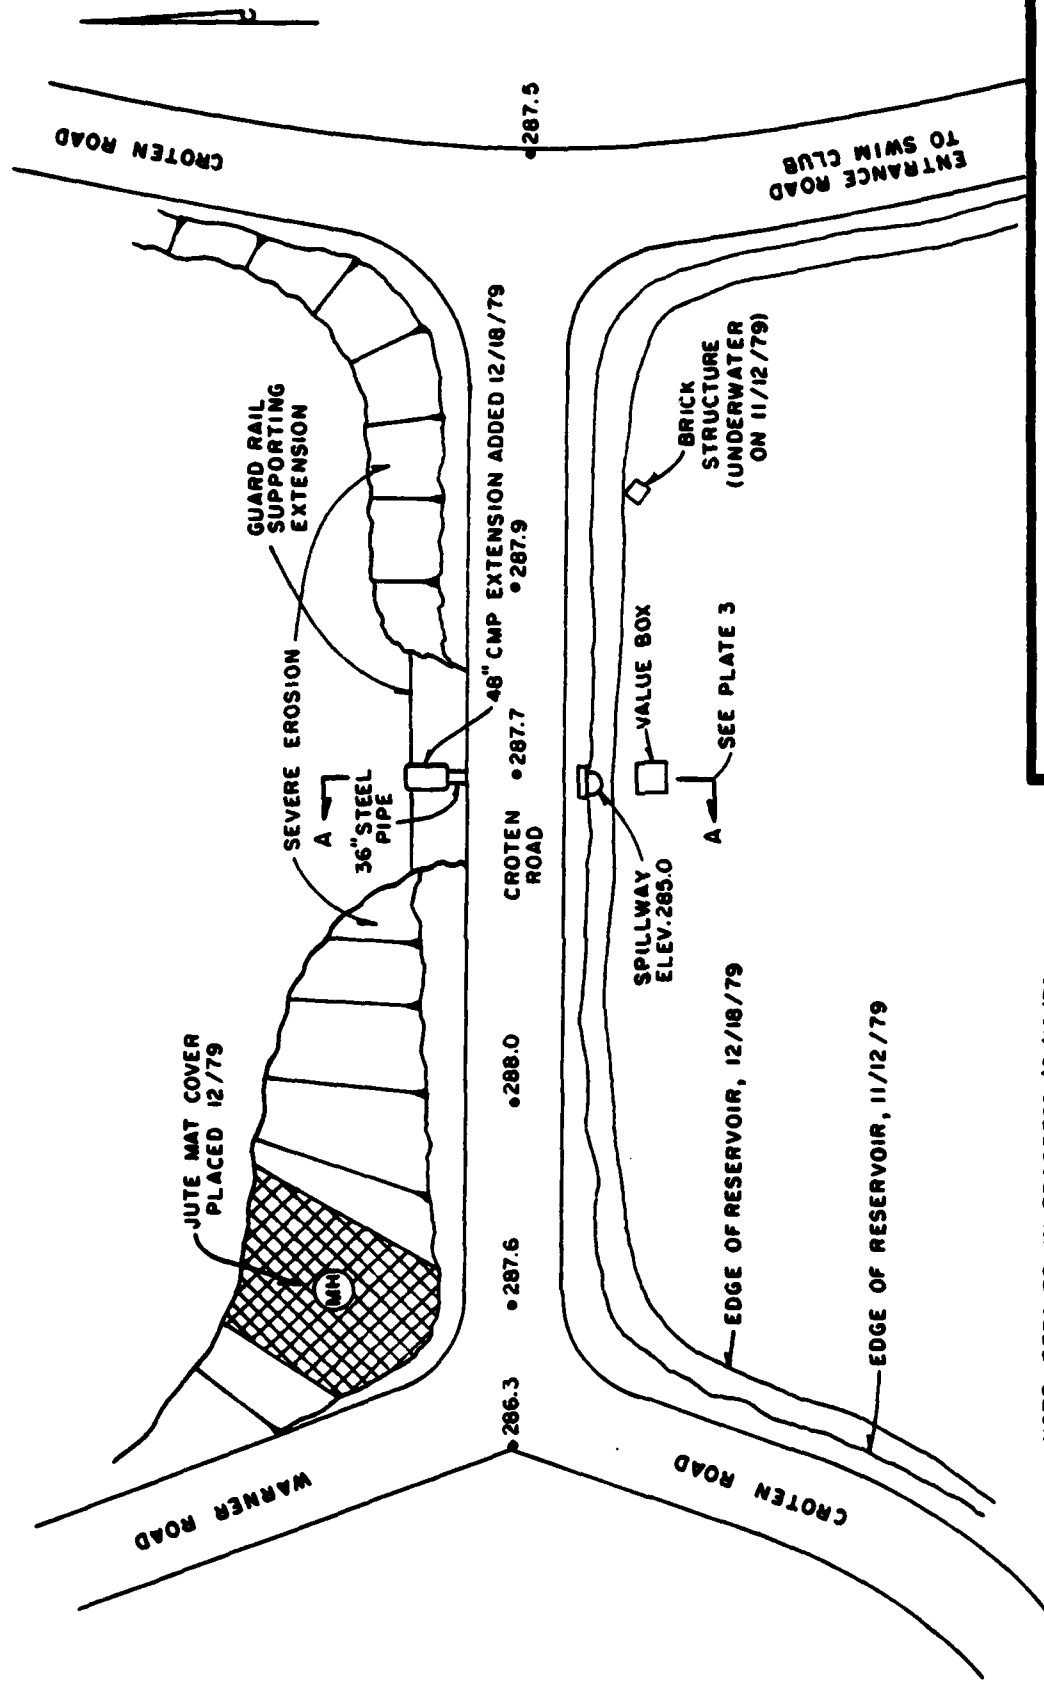
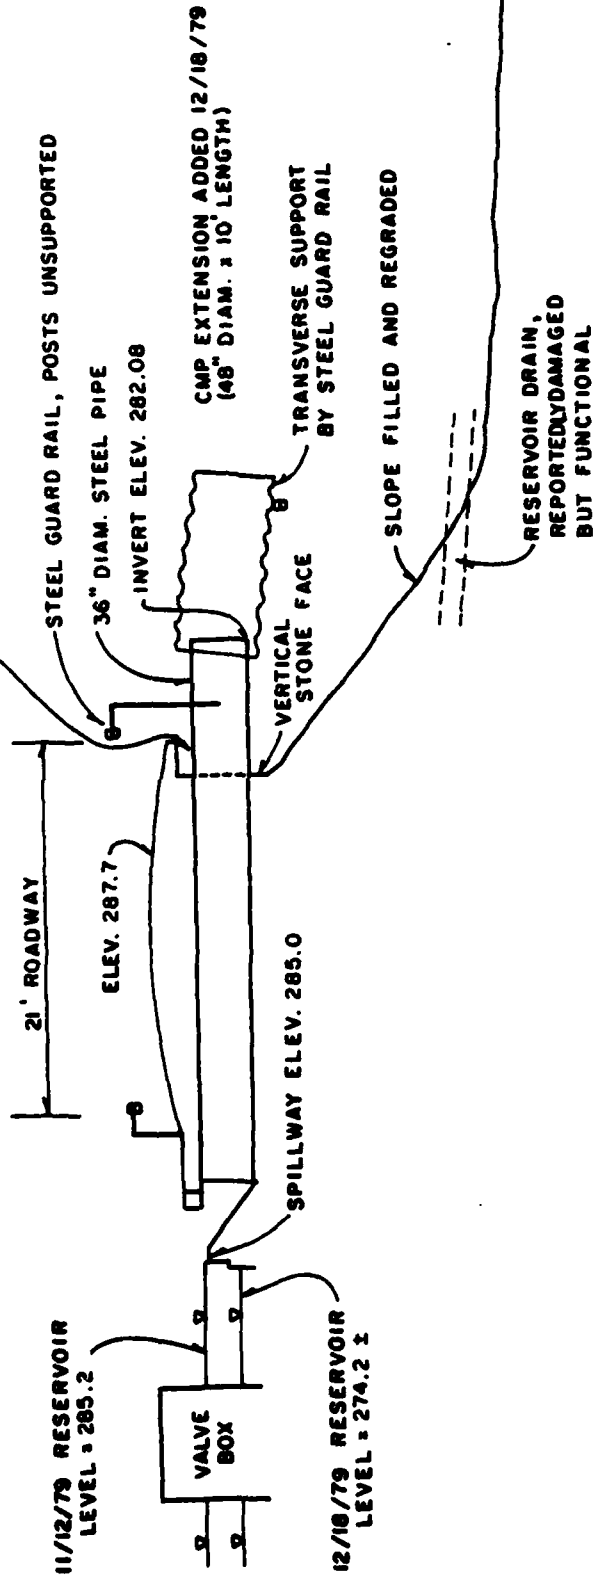
ROADWAY UNDERMINED (REPAIRED BY JANUARY 1980)

NOTE: REPAIRS IN PROGRESS 12/18/79
