USAAVRADCOM-TM-80-D-4

**DEVELOPMENT OF A LOW-COST FIELD FIX FOR THE  
RU-21H AIRCRAFT ANTENNA**

I. E. Figge

February 1980

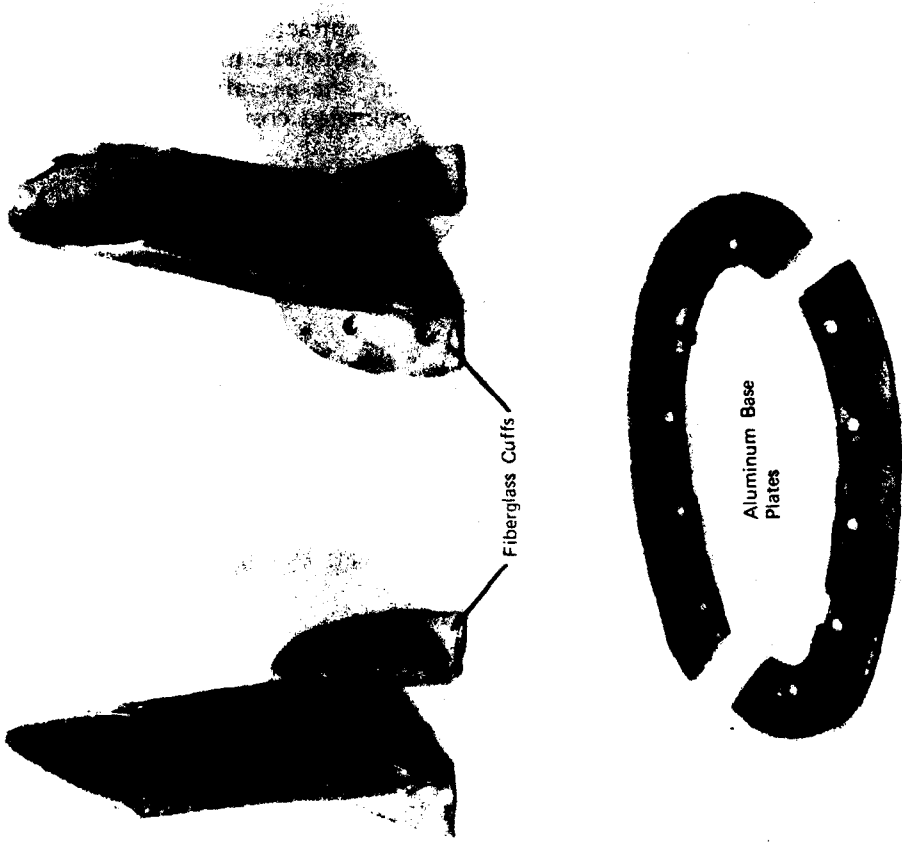
The RU-21H (guardrail) aircraft uses 18 fiberglass antennas in the performance of its mission. It was discovered that after 500 to 1000 hours of field use, a large portion of the antennas were failing as the result of fatigue cracks in the vicinity of the leading- and trailing-edge flange radii. A two-piece (spanwise split at mid-chord) fiberglass cuff repair (Figure 1) was developed, under contract, subjected to limited fatigue testing, and was in the process of being installed on the fleet of RU-21H aircraft. This fix required that the antenna be removed from the aircraft, shipped to the contractor for installation of the cuff repair, shipped to another facility for antenna characteristic measurements, and then returned to the user for installation and calibration on the aircraft. This effort required approximately a five-week aircraft downtime at an estimated cost of about \$1300 per antenna (\$23,400 per aircraft).

Figure 1. Contractor's antenna modification.

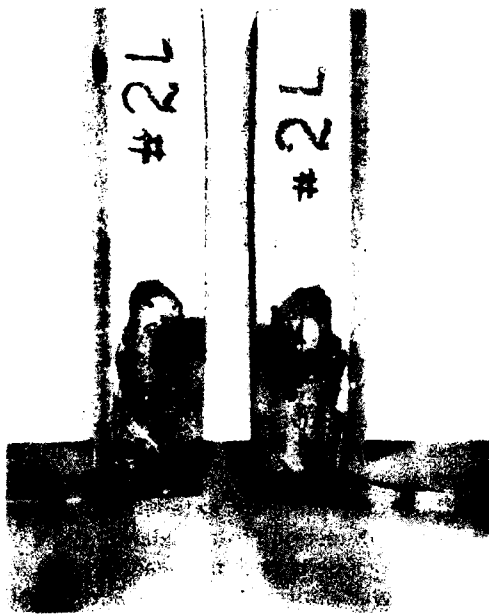
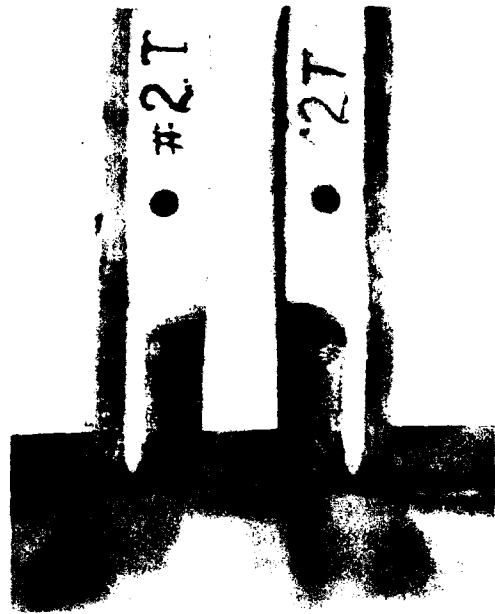
Upon sectioning of antenna 2, it was found that there was gross compaction of the fiberglass cloth in the mast/flange radii (see Figure 3), and that glass-filled resin was used to fair out the compacted area to its design dimensions. Excessive resin starvation in the structural fiberglass material was apparent in the flange radii area. Additional sectioning along the leading and trailing edges of the flange radii revealed a gross folding condition of the material to the extent that it functioned as a "hinge point" rather than a load-carrying structure (Figures 4(a) and 4(b)). This folding was also observed in antenna 5 (Figures 5(a) and 5(b)). Compaction/resin starvation of the material in the flange radii area on the sides of antenna 5 did not appear as excessive as that found in antenna 2.

Figure 4. Antenna 2 - cross sections.

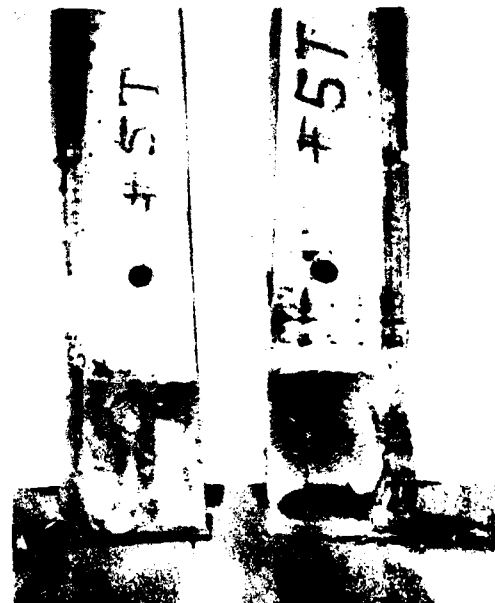
Figure 5. Antenna 5 - cross sections.
