*National Dam Inspection Program  
Shirt's Run Dam*

PHASE I INSPECTION REPORT,  
NATIONAL DAM INSPECTION PROGRAM

NAME OF DAM: Shirf's Run Dam  
STATE LOCATED: Pennsylvania  
COUNTY LOCATED: Cambria  
STREAM: Unnamed Tributary of the North Branch of Black Lick Creek  
SIZE CLASSIFICATION: Small  
HAZARD CLASSIFICATION: High  
OWNER: Spangler Municipal Water Authority  
DATE OF INSPECTION: November 27 and December 28, 1979

SHIRF'S RUN DAM  
NDI I.D. PA-438  
NOVEMBER 27, 1979

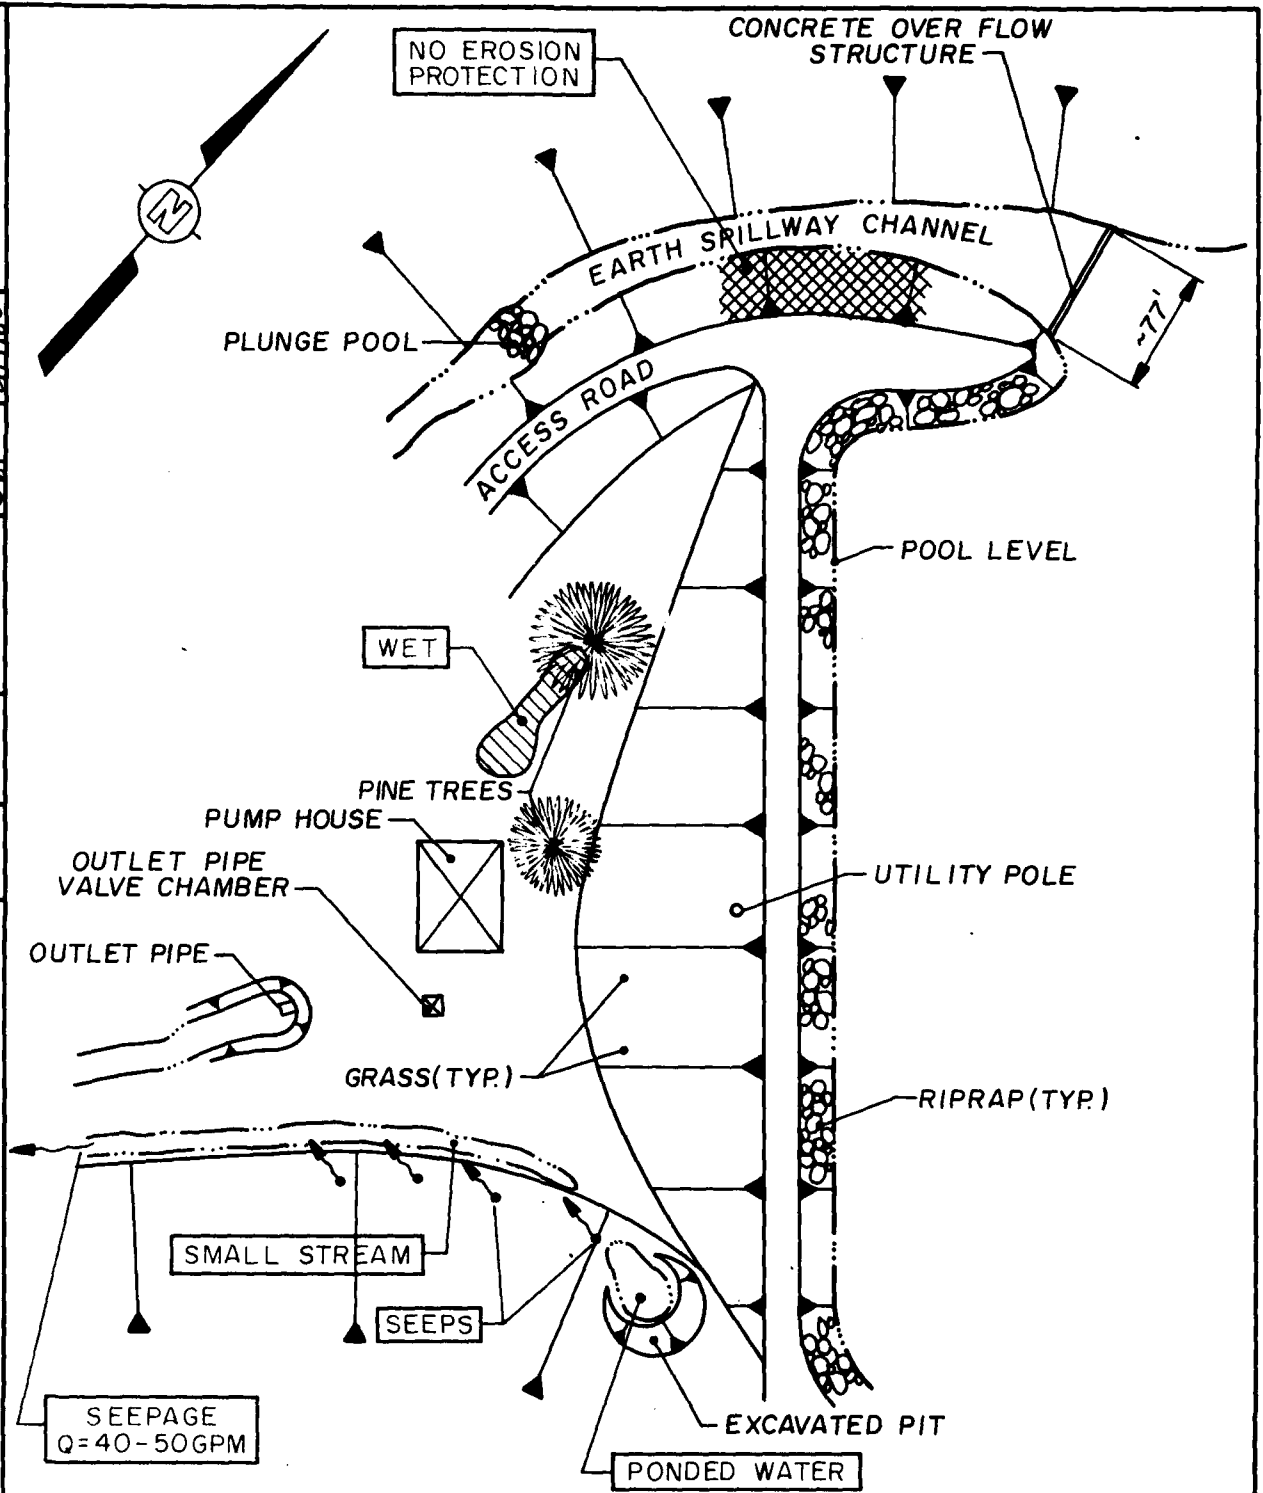
The crest of the dam was surveyed relative to the spillway crest elevation and it was found to be on the order of four to six inches below the design elevation. The dam crest profile is illustrated in Plate 5. Field measurements indicate that the downstream face of the dam is on a 2 horizontal to 1 vertical slope.
