HOWARD NEEDLES TAMMEN AND BERGENOFF NEW YORK  
CHESAPEAKE CITY BRIDGE. BRIDGE INSPECTION REPORT NUMBER 118.(U)  
DEC 79

| REPORT DOCUMENTATION PAGE | | READ INSTRUCTIONS<br>BEFORE COMPLETING FORM |
|---|---|---|
| 4. TITLE (and Subtitle)<br>Bridge inspection report no 11B, Chesapeake City Bridge, Maryland | | 5. TYPE OF REPORT & PERIOD COVERED<br>Bridge Inspection report no. 11B, Contract report 1979 |
| 11. CONTROLLING OFFICE NAME AND ADDRESS<br>U.S. Army Corps of Engineers Philadelphia District<br>2nd & Chestnut Sts.<br>Philadelphia, Pa. 19106 | | 12. REPORT DATE<br>Dec. 1979 |

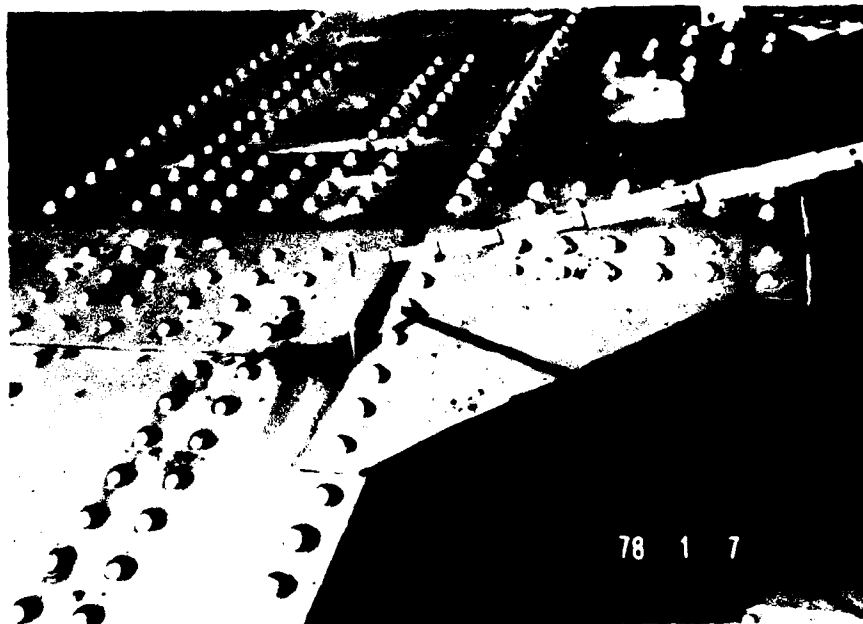
Rust has caused a 1/2 inch separation between the edges of upper splice plate and upper cover plate at Panel Points U2 and U3 of

the east and west arches. (See Photograph 15.) These gaps should be cleaned and sealed.

Photograph 15 - Separation of corner of upper splice plate and upper cover plate on the top chord of the west tied arch due to rust.

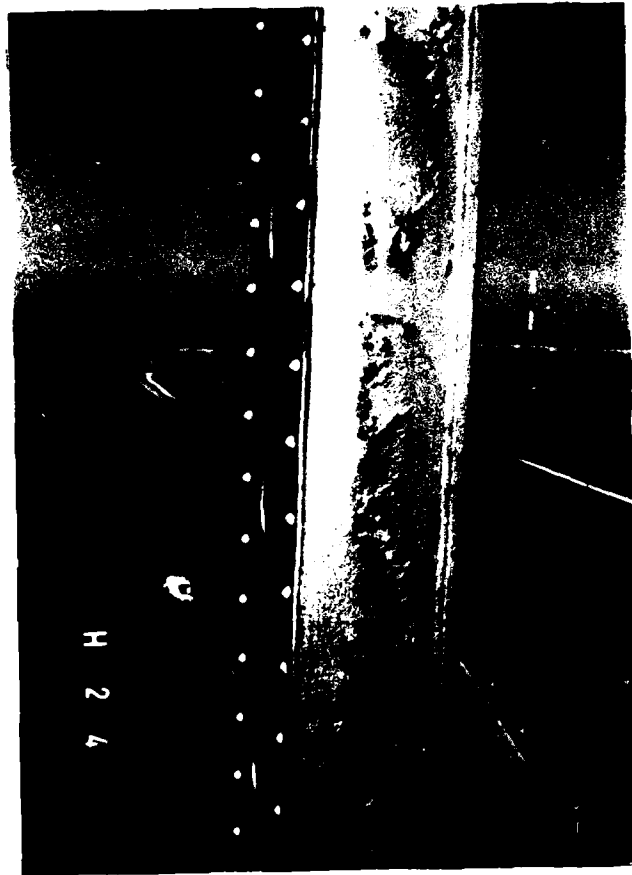
There are isolated areas of blistering of paint and minor section loss on the superstructure of the arch span located above the roadway, including the interior of the hangers and upper chord. The heaviest blistering is on the roadway side of the hangers. (See Photograph 16.)

Photograph 16 - Typical blistering of paint and corrosion on the roadway face of the tied arch hangers.
