ST. GEORGES BRIDGE. BRIDGE INSPECTION REPORT NUMBER 11A.(U)

| REPORT DOCUMENTATION PAGE | | READ INSTRUCTIONS<br>BEFORE COMPLETING FORM |
|---|---|---|
| 4. TITLE (and Subtitle)<br>Bridge inspection report no 11A, St. Georges<br>Bridge, Delaware | | 5. TYPE OF REPORT & PERIOD COVERED<br>Bridge inspection report no.<br>11A, Contract Report, 1979 |

The findings and recommendations of the 1979 inspection of the St. Georges Bridge (Route designation, U.S. Route 13) which crosses the Chesapeake and Delaware Canal was undertaken for the Department of the Army, U.S. Corps of Engineers by Howard Needles Tammen & Bergendoff (HNTB) and are submitted herein. A location map is presented in Drawing 1-0.

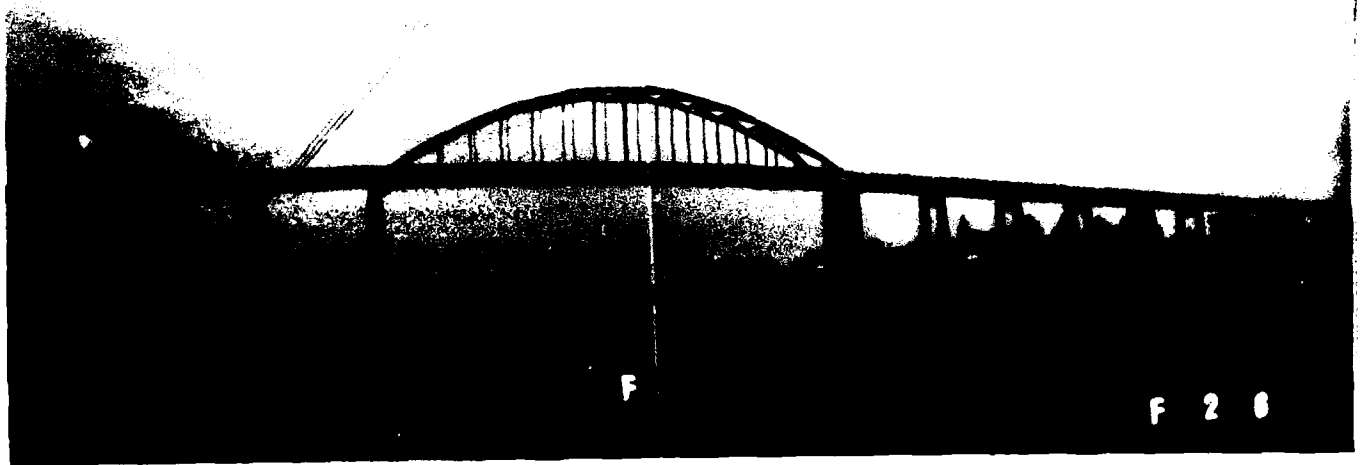
Photograph 1 - St. Georges Bridge - Elevation of tied arch span and portions of the north and south approaches looking west.

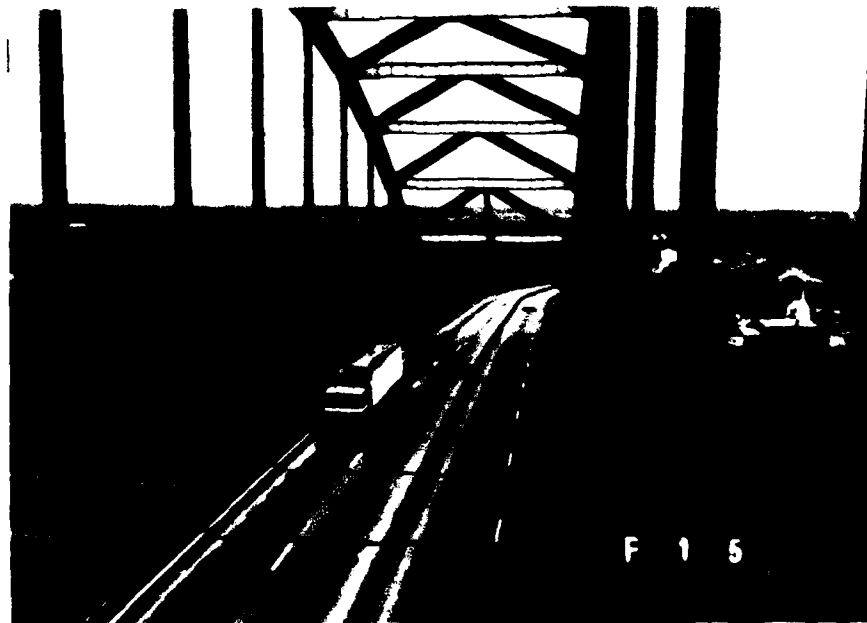
Photograph 2 - Roadway view, looking north through arch span.

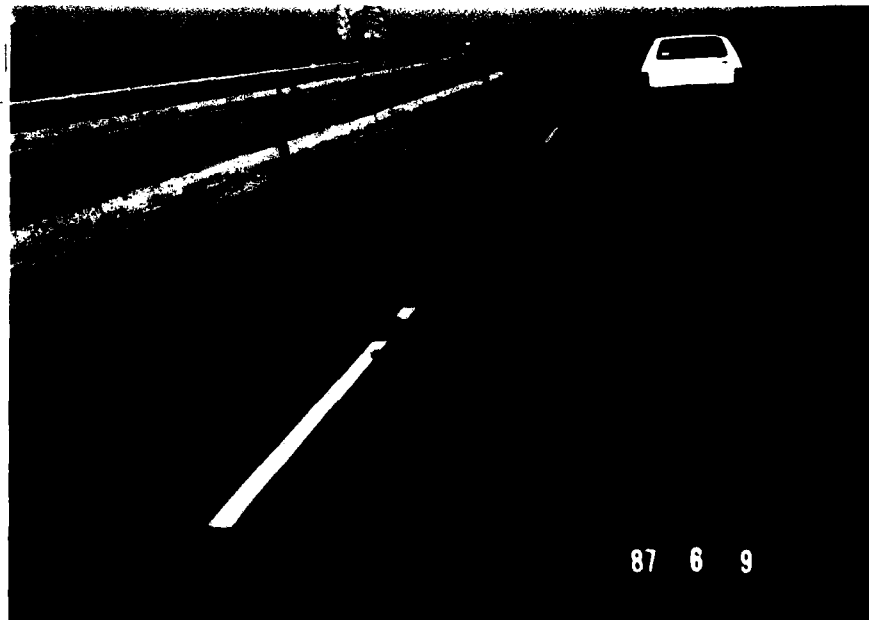
Photograph 24 - Spalled pavement with exposed reinforcing steel in the northbound lanes between Piers 17S and 18S.
