ULTRASONIC VELOCITY MEASUREMENTS IN
CONCRETE, LOCK AND DAM NO. 24
MISSISSIPPI RIVER

Henry T. Thornton, Jr., Dale Glass

April 1980
Final Report

Report for U. S. Army Engineer District, St. Louis
St. Louis, Missouri 63101

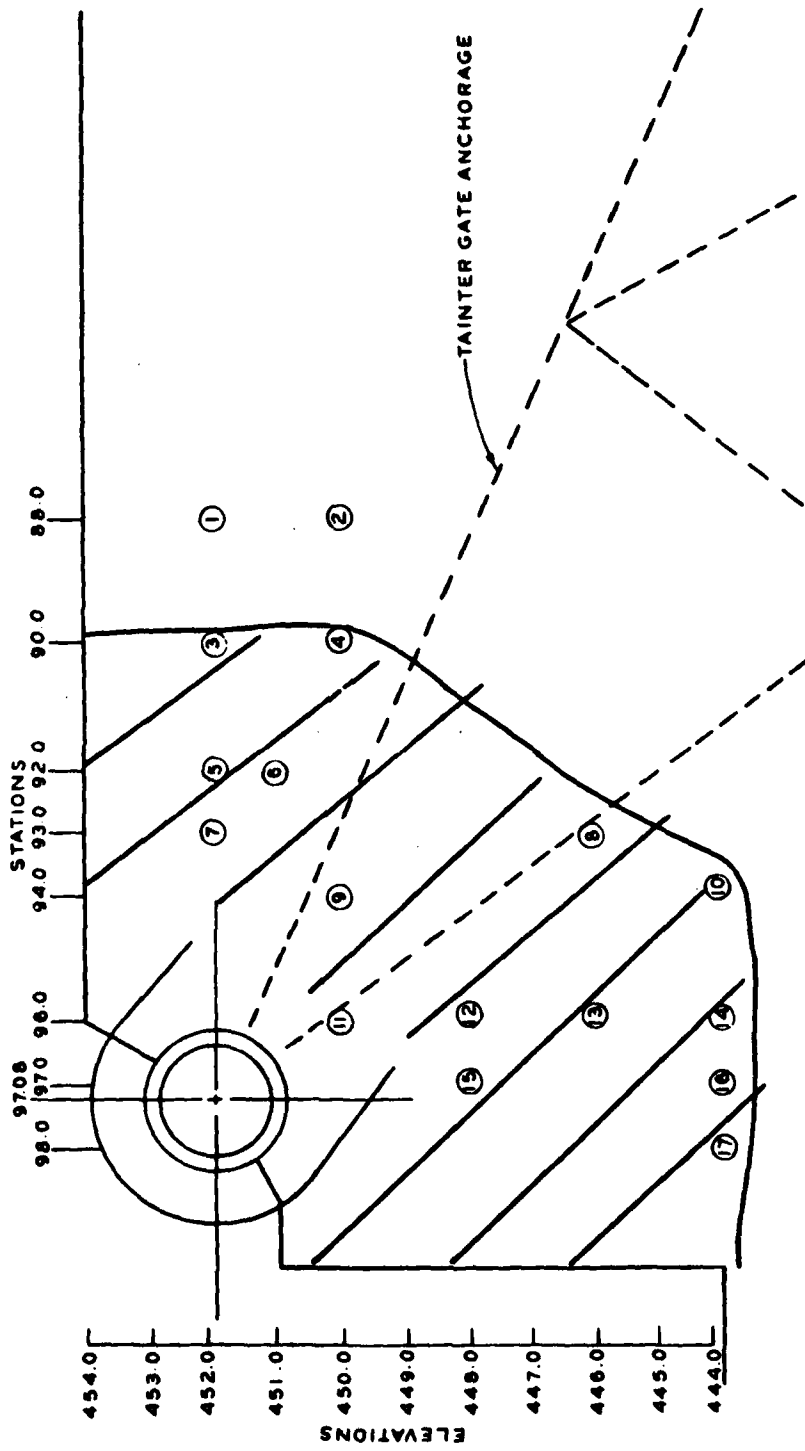
3. The test equipment used in this investigation is described in test Method CRD-C 51-72* (ASTM Designation C 597-71). Velocity measurements were made through piers No. 2 through 15 which constitute part of the dam structure. Access to both sides of a pier was gained by having the transducer holders move along the tainter gate arms located on each side of the pier. Also, a platform built by Lock and Dam No. 24 Government employees was lowered in place using the gantry crane in order to obtain access and make velocity measurements under the trunnion and near the waterline on each pier (Photo 2). The station numbers, elevations, path lengths, and velocities are given in Table 1. Figures 1 through 14 show the side elevations of each pier with the velocities obtained at each data point inscribed on the drawing. This was done in an attempt to delineate and compare areas characterized by low velocities (below 15,000 fps). Figure 15 outlines the area where anomalous velocities

were obtained. This area is bounded by the line of extreme cases, i.e., piers No. 4, 6, 9, and 13. The extremity of low or no velocity readings varies slightly with station number and elevation from pier to pier, but Figure 15 is generally representative of piers No. 2 through 15.

Figure 15. General area of indicated deterioration, Piers No. 2-15

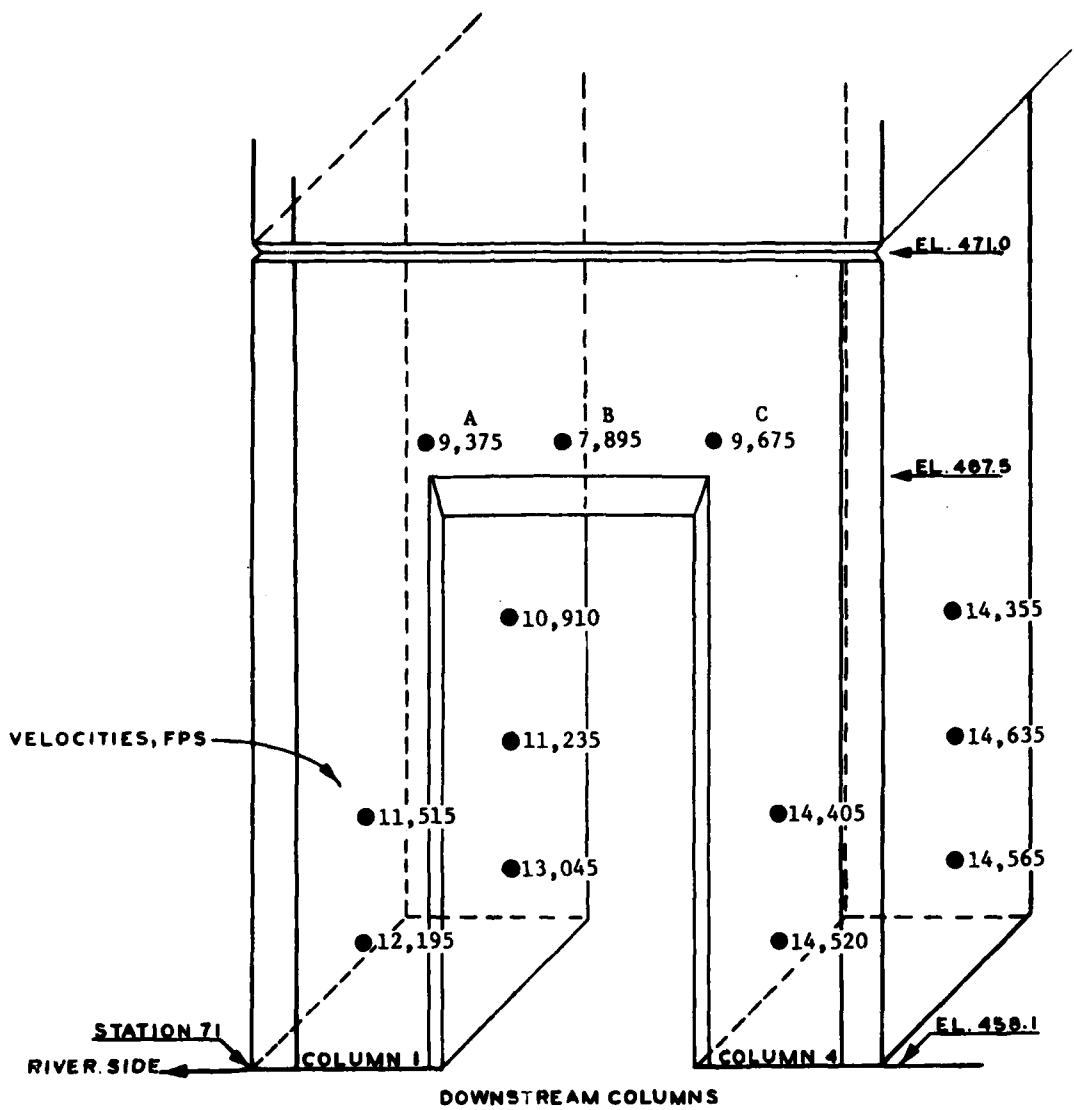
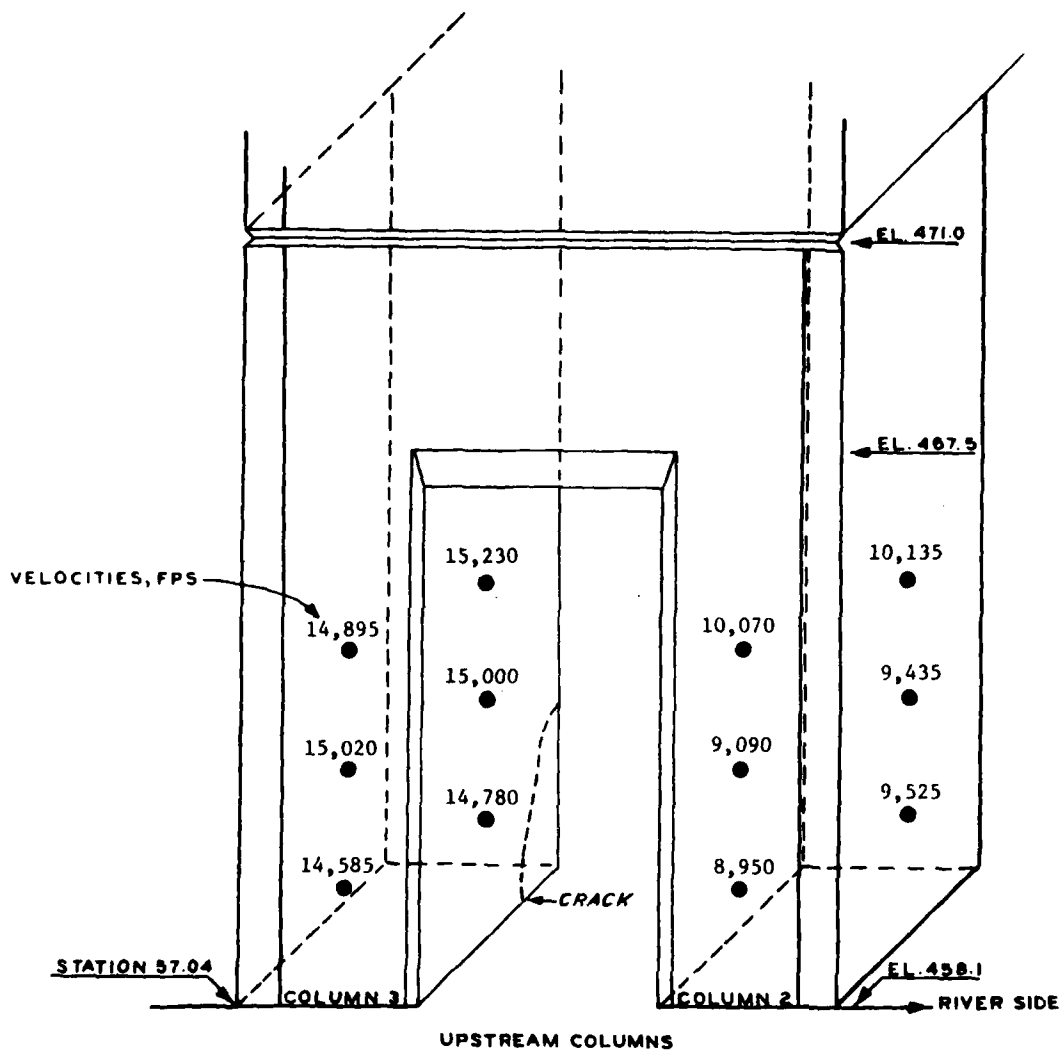
made through the lower elevations of the columns on pier No. 16. These measurements produced velocities in the 14,000- to 15,000-fps range, but there were also numerous velocities obtained in the range of 9,000 to 12,000 fps. These low velocities indicate the presence of cracks, some of which were visible, in the lower elevations of these columns.

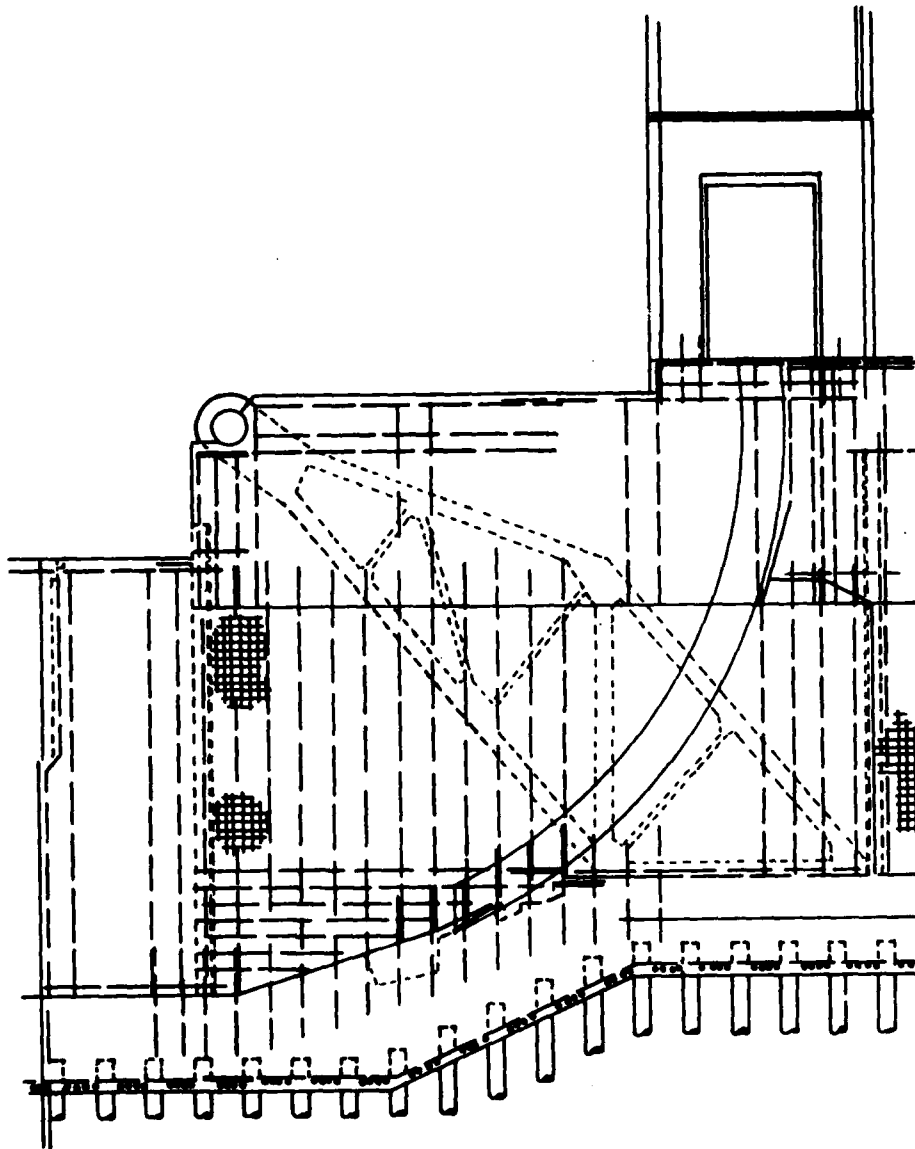
Figure 21. Typical pier elevation showing location of tainter gate tension anchorage

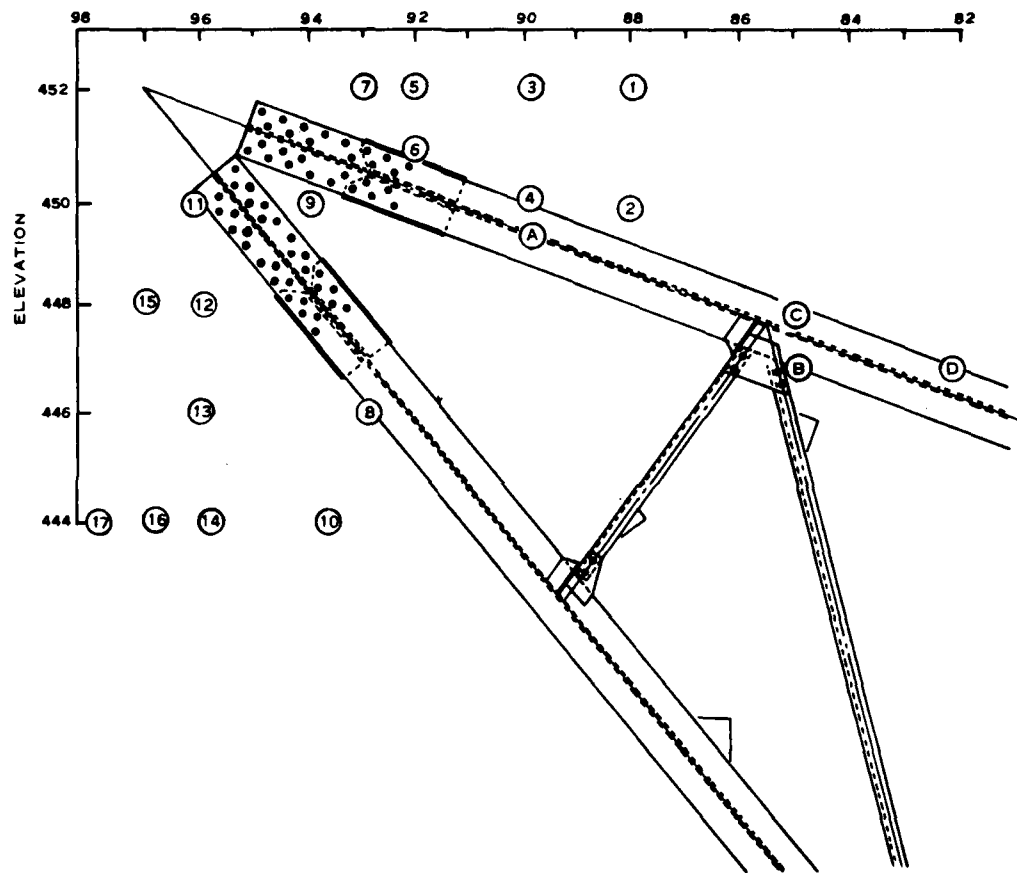
5. Figure 21 is a typical side elevation of piers No. 2 through 15, and shows the location of the embedded tainter gate tension anchorage. Figure 22 shows in more detail the upper portion of the anchorage and locates the velocity data points with respect to the anchorage beams. Data points 1 through 17 are of the current investigation. Data points A through D are of the 1973 investigation (mentioned in paragraph 3) that are thought to be pertinent here. Physical access to the downstream portions of the piers in the areas from which data were desired was restricted by the gate arms and the water level (Photos 1 and 2). The gates in each bay were manipulated to the allowable extent in order to maximize coverage of the extreme downstream area. In 1973 the gates were manipulated to expose maximum area between stations 79B and 90B at elevations 447 to 452. Although most of the data points used in the 1973 investigations were upstream from the data points used in the current study, four of them are pertinent to this study. Point A (1973) corresponds to point 4 (current); and points B, C, D (1973), although they do not correspond to current data points, have signal transmission paths that would pass through or near the steel anchorage beams. These four points, A, B, C, and D, are the only points of the 19 points used in 1973 that show decreased velocity; point B on pier No. 5 showed a decreased velocity; point C on piers No. 5 and 7 showed decreased velocities, and on pier No. 12 no signal passed through; at point D on pier No. 12 no signal would pass through. These data points located at or near elevations where the signal transmission path passed through or near the steel anchorage beam indicated the presence of some form of distress in 1973. The velocity data obtained in this current investigation tell the same story. There is some form of distress at or near the anchorage beams in the areas that were tested. A 12-in. steel beam normal to the transmission path in the center of a 10-ft section of concrete, if it were bonded, would not appreciably affect the ultrasonic velocity. Even an unbonded condition should not cause a drastic reduction in velocity. The data indicate that a general condition of cracking

and deterioration existed around and near the trunnion, head plates, and anchorage beam connections in each of the piers tested, and that some cracking has probably occurred around the top anchorage beam as far down as 15 ft from the trunnion and around the lower beam as far as 6 ft from the trunnion in some piers.

Figure 22. Location of velocity data points with respect to embedded tension anchorage beams

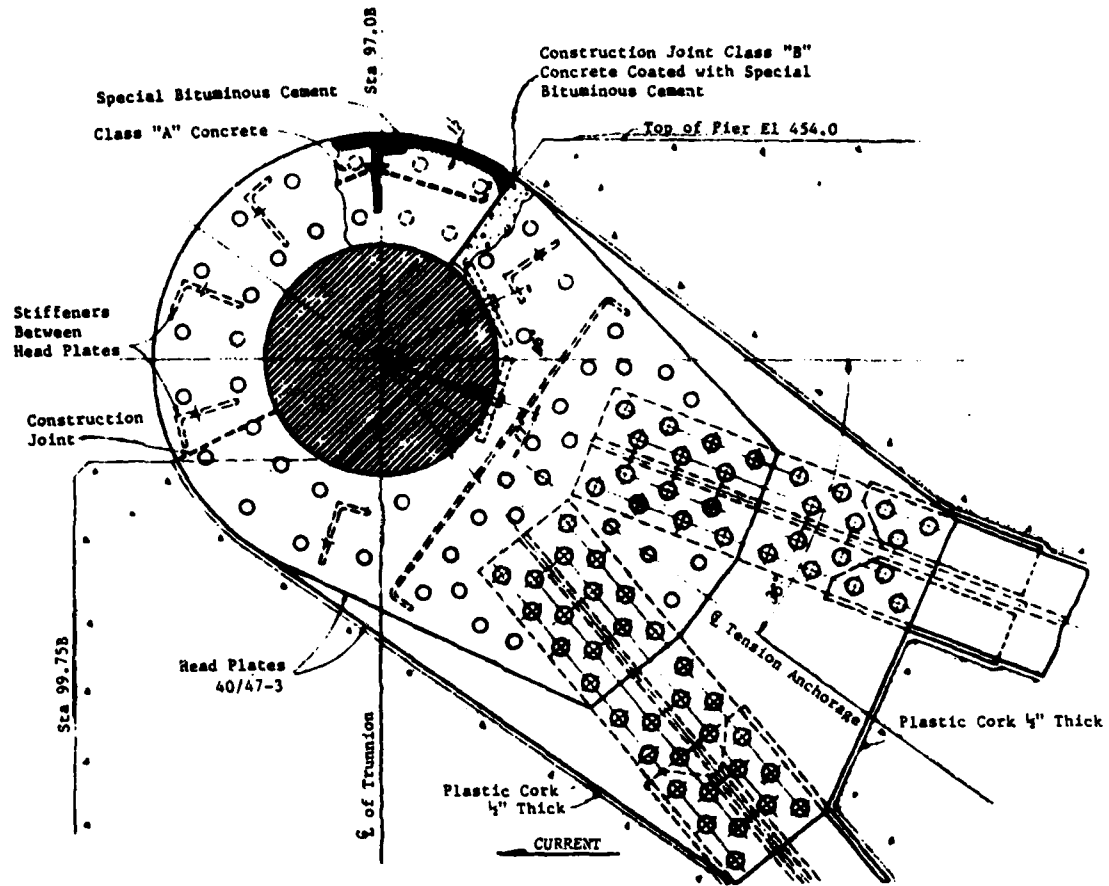
6. Figure 23 is a typical detail drawing of the trunnion, head plates, and anchorage beam connections. This drawing shows a 1/2-in.-thick plastic cork covering most of the head plates and extending down the anchorage beams for some distance. Also shown is a bituminous cement in the construction joint. The deterioration over the years of this cement or cork, or both, could provide a path for water to enter between the concrete and steel anchorage beams. The V-shaped depression at the junction of the concrete and trunnion head plate provides a reservoir where water could be stored for short durations. Stress concentrations at and near the trunnion and anchorage beam connections caused by vibrations of the gates could have provided the mechanism by which small cracks were formed and also could have added to the water intake. Periodic gate vibrations of a severe nature have been described by lock personnel and confirmed by members of the District office. Progressive cracking due to stresses from vibration, and the possible contribution of freezing and thawing of the water, and alkali-aggregate reaction could have resulted in the present condition of the piers. A similar combination of mechanisms probably caused the similar condition of the upper portion of the columns, i.e., cracks caused by stresses from vibration or structural movement and water entrance, with the floor slab at elevation 471.0 serving as a pooling area. Some of the larger cracks in the columns appear to have been caused by static stresses. Although it is beyond the intended scope of this investigation and report to address this issue, one or two observations will be offered here. The movement of a pier, of sufficient magnitude, could place any or all columns on that pier in a condition of inordinate static loading. It has been shown in the laboratory that the resistance to lateral movement (sliding) of a massive structure is greatly reduced while in a state of dynamic excitation, i.e., vibrating motion. The lateral force required to move a 3-

Figure 23. Detail of trunnion, head plates, and anchorage beam connections
