Special Report 80-13

## EXTENDING THE USEFUL LIFE OF DYE-2 TO 1986

PART II: 1979 FINDINGS AND FINAL RECOMMENDATIONS

Wayne Tobiasson and Philip Tilton

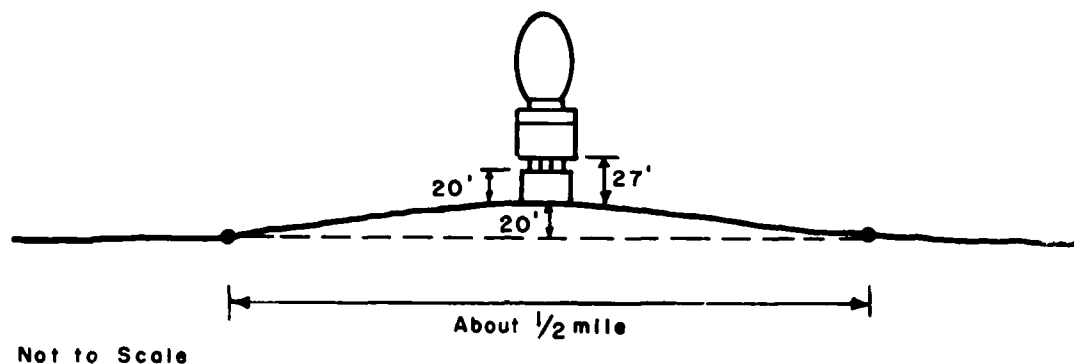
The footings were 32 ft below the snow surface when DYE-2 was built in 1959. In 1979 they were about 102 ft below the snow surface in the immediate vicinity of the building, a change of 70 ft in 20 years or 3.5 ft/yr. Between 1973 and 1979 the footing depth increased from 78 ft to 102 ft, indicating an increase in the net build-up rate to 4 ft/yr. The reason for the increase to 4 ft/yr in recent years is that backfilling under the building has been progressing at a faster rate than the snow build-up in the vicinity. As a result, the building is located on a mound that is about 20 ft higher than the "natural" snow surface in the area (see Fig. 2).

Figure 2. 1979 snow profile of mound at DYE-2.

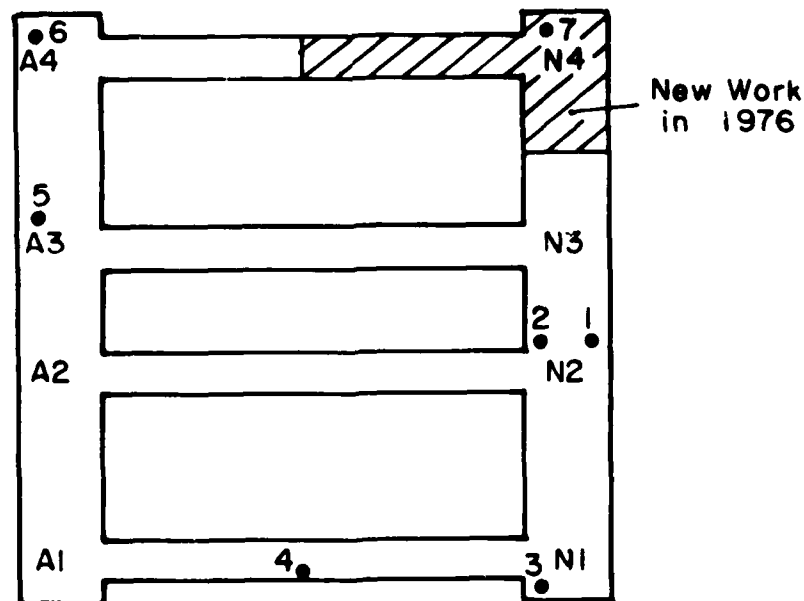
As part of the 1979 truss enclosure inspection, seven dial extensometers were installed between the columns and the truss enclosure to measure the rate of downward movement of the truss enclosure. Figure 11 shows the location of each extensometer; Figure 12 shows a typical installation. A set of readings we took in late July and another set taken by station personnel on 1 September were used to establish the rates of downward movement presented in Table 5.

Figure 11. Location of dial extensometers.

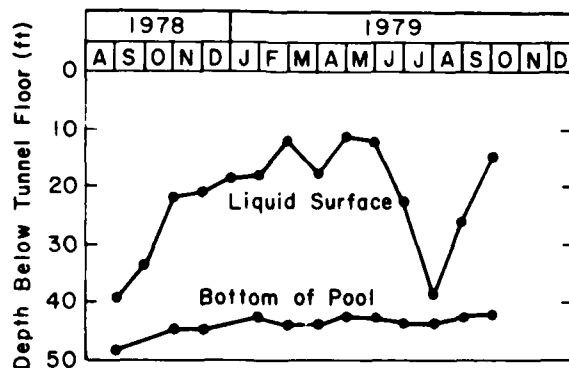
Because large discontinuous ice lenses and layers of very permeable granular depth hoar occur naturally in the snow at DYE-2, the DYE-2 wastewater disposal sumps behave more irregularly than do those at DYE-3. The wastewater disposal sump in use during our site visit had been used since August 1978. In May 1979 the liquid had risen until only 12 ft of freeboard existed below the sewer tunnel floor. In the past when such a limited amount of freeboard existed, wastewater was diverted to another disposal point. However, measurements taken in July and August 1979 indicated that the water level in the sump had dropped significantly. In August, 39 ft of freeboard was present. Since August, the water level has risen rapidly; in October, only 15 ft of freeboard was present. Figure 14 shows the irregular growth of this sump.

Figure 14. Growth of wastewater disposal sump B-2.

Station personnel were advised that a new wastewater disposal point should be readied at the junction of the main and branch tunnels but sewage should be discharged at the existing sump until the freeboard decreases to 10 ft.
