Name Of Dam: LEE HALL RESERVOIR  
Location: CITY OF NEWPORT NEWS  
Inventory Number: VA. 70001

# PHASE I INSPECTION REPORT NATIONAL DAM SAFETY PROGRAM

Name of Dam: Lee Hall Reservoir  
State: Virginia  
Location: City of Newport News  
USGS Quad Sheet: Yorktown  
Stream: Headwaters of Warwick River  
Date of Inspection: 28 November 1979

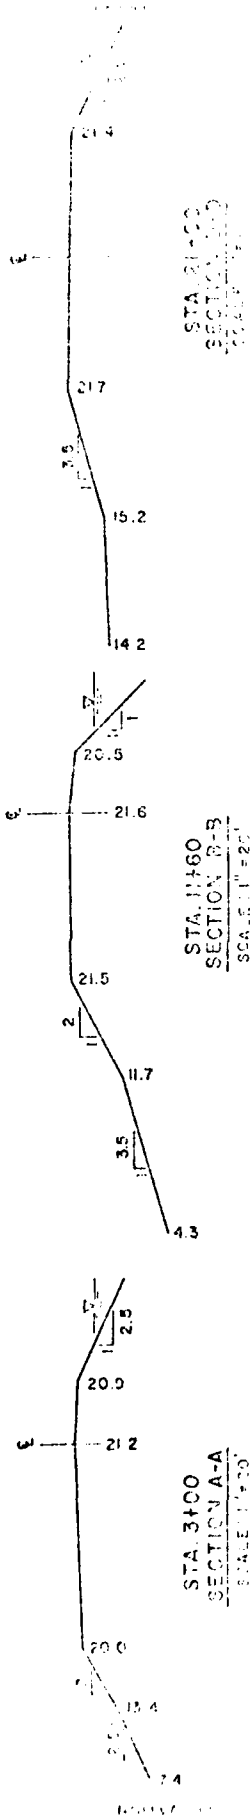
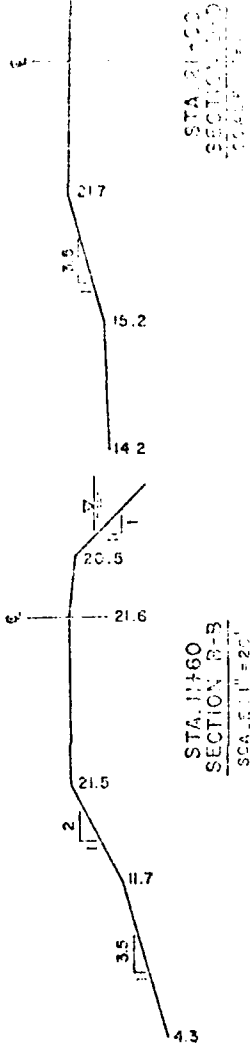
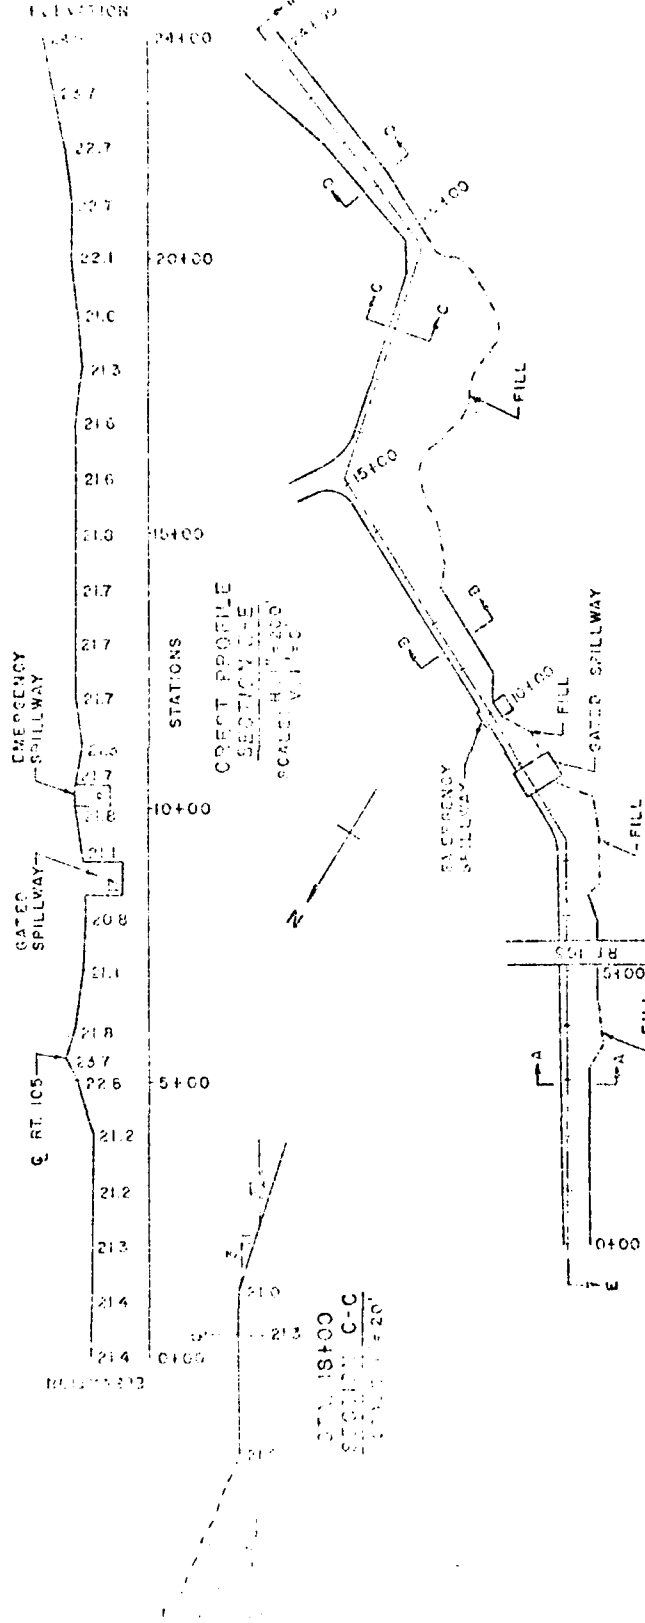
PLAN VIEW - DAM CREST  
SCALE 1" = 200'

There are no signs of surface cracks, unusual movement, sloughing, misalignment, riprap failures, or seepage. However, parts of the downstream embankment are built up with random fill as shown on Plate VIII. Also, portions of the dam are heavily vegetated as shown in Appendix II, Photo 2, and there are a few areas of erosion.

There are several gullies caused by surface runoff located on the downstream slope of the massive fill between STA 12+50 and 19+60. Also, there is a gully at the junction of the fill and original embankment at approximately STA 12+50.

a. The trees located on the crest, on the downstream slope between Stations 0+00 and 12+50 noted on Plate VIII of Appendix I, and the tree located adjacent to the gate spillway approach channel should be cut down and have the root structures removed. The subsequent holes should be regraded, dressed with compacted fill, and seeded. The trees located in the discharge channels of both the gates and emergency spillways should be cut to the trunk. The removal of trees from the embankment and spillways is necessary to prevent further growth and reduce chances of piping.

b. The gully noted at STA 12+50 should be regraded, dressed with compacted fill, and seeded.

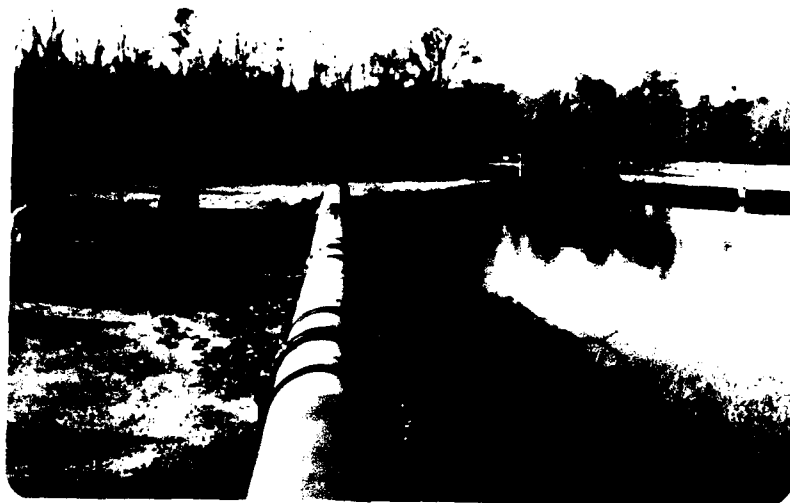
3.1.3 Gated Spillway: The spillway is fitted with a Bascule gate and is in good physical condition. The gate seals abutting the concrete wing wall have deteriorated. There is minor leakage. Also, the city is not satisfied with the past performance of the gate. The City can open the gate, but they are not sure the gate can be closed. Allis-Chalmers, the gate manufacturer, recently checked the gate, but the City is still dissatisfied with the performance of the gate. The approach channel is concrete lined, free from debris, and in good condition, except for a tree growing adjacent to the upstream right wingwall of the channel near the gate. The discharge channel is concrete lined, shallow, free from debris, and in good condition except for trees growing in downstream riprap. Photographs of the spillway are provided in Appendix II, Photos 1, 3, and 4.

PHOTO #1: PARTIAL VIEW OF DAM  
AND PRINCIPAL SPILLWAY

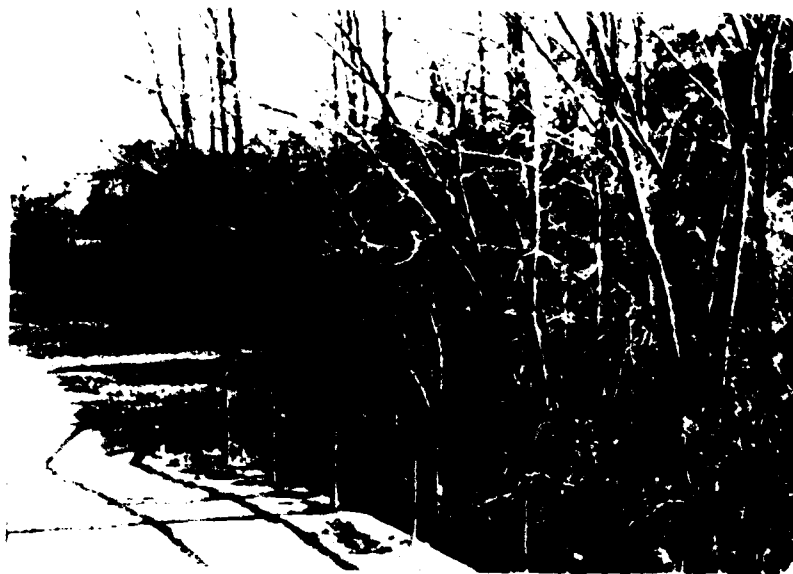
PHOTO #2: TYPICAL OF GROWTH ON  
DOWNSTREAM EMBANKMENT
