MIDDLE FORK SLURRY IMPOUNDMENT

RUSSELL COUNTY, VIRGINIA

VA. NO. 16708

# PHASE I INSPECTION REPORT NATIONAL DAM SAFETY PROGRAM

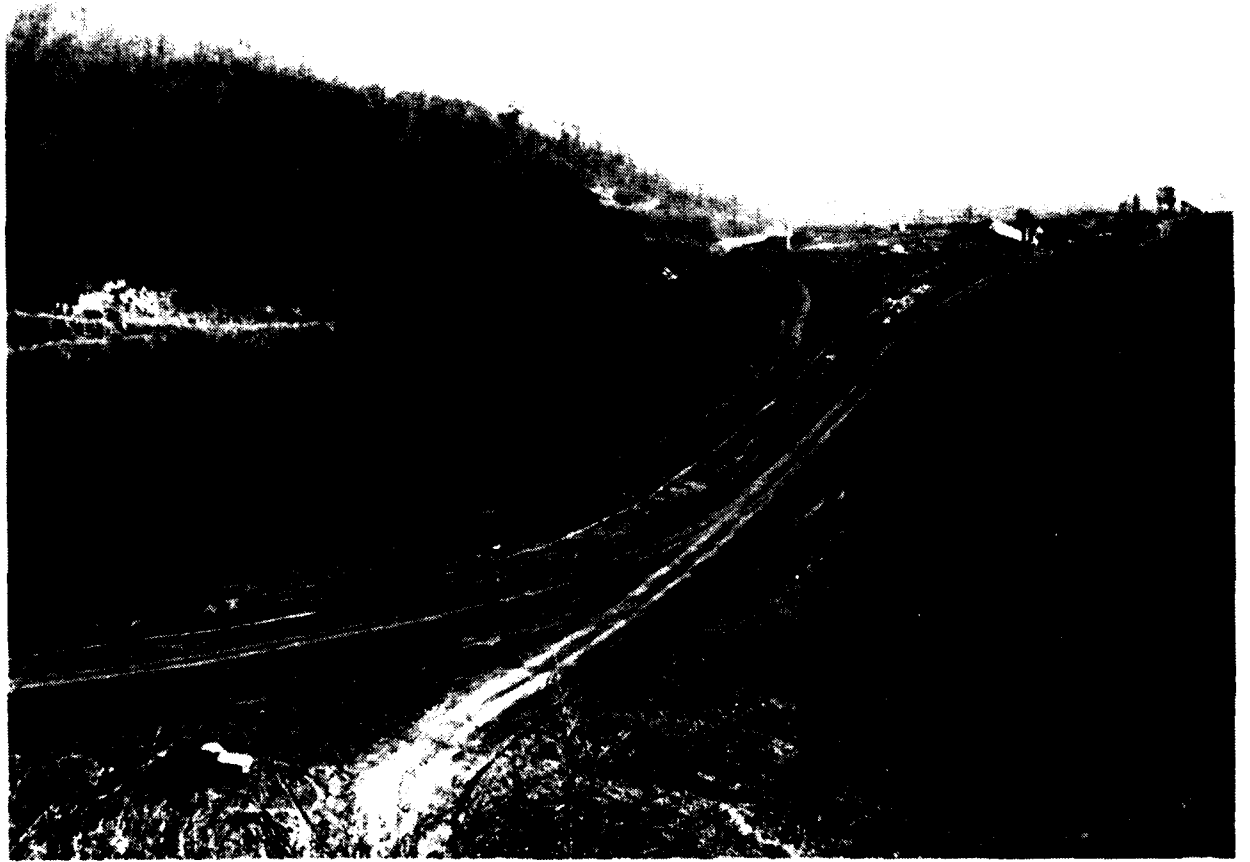
Overview Photo  
Upstream is to the left  
Fall 1970

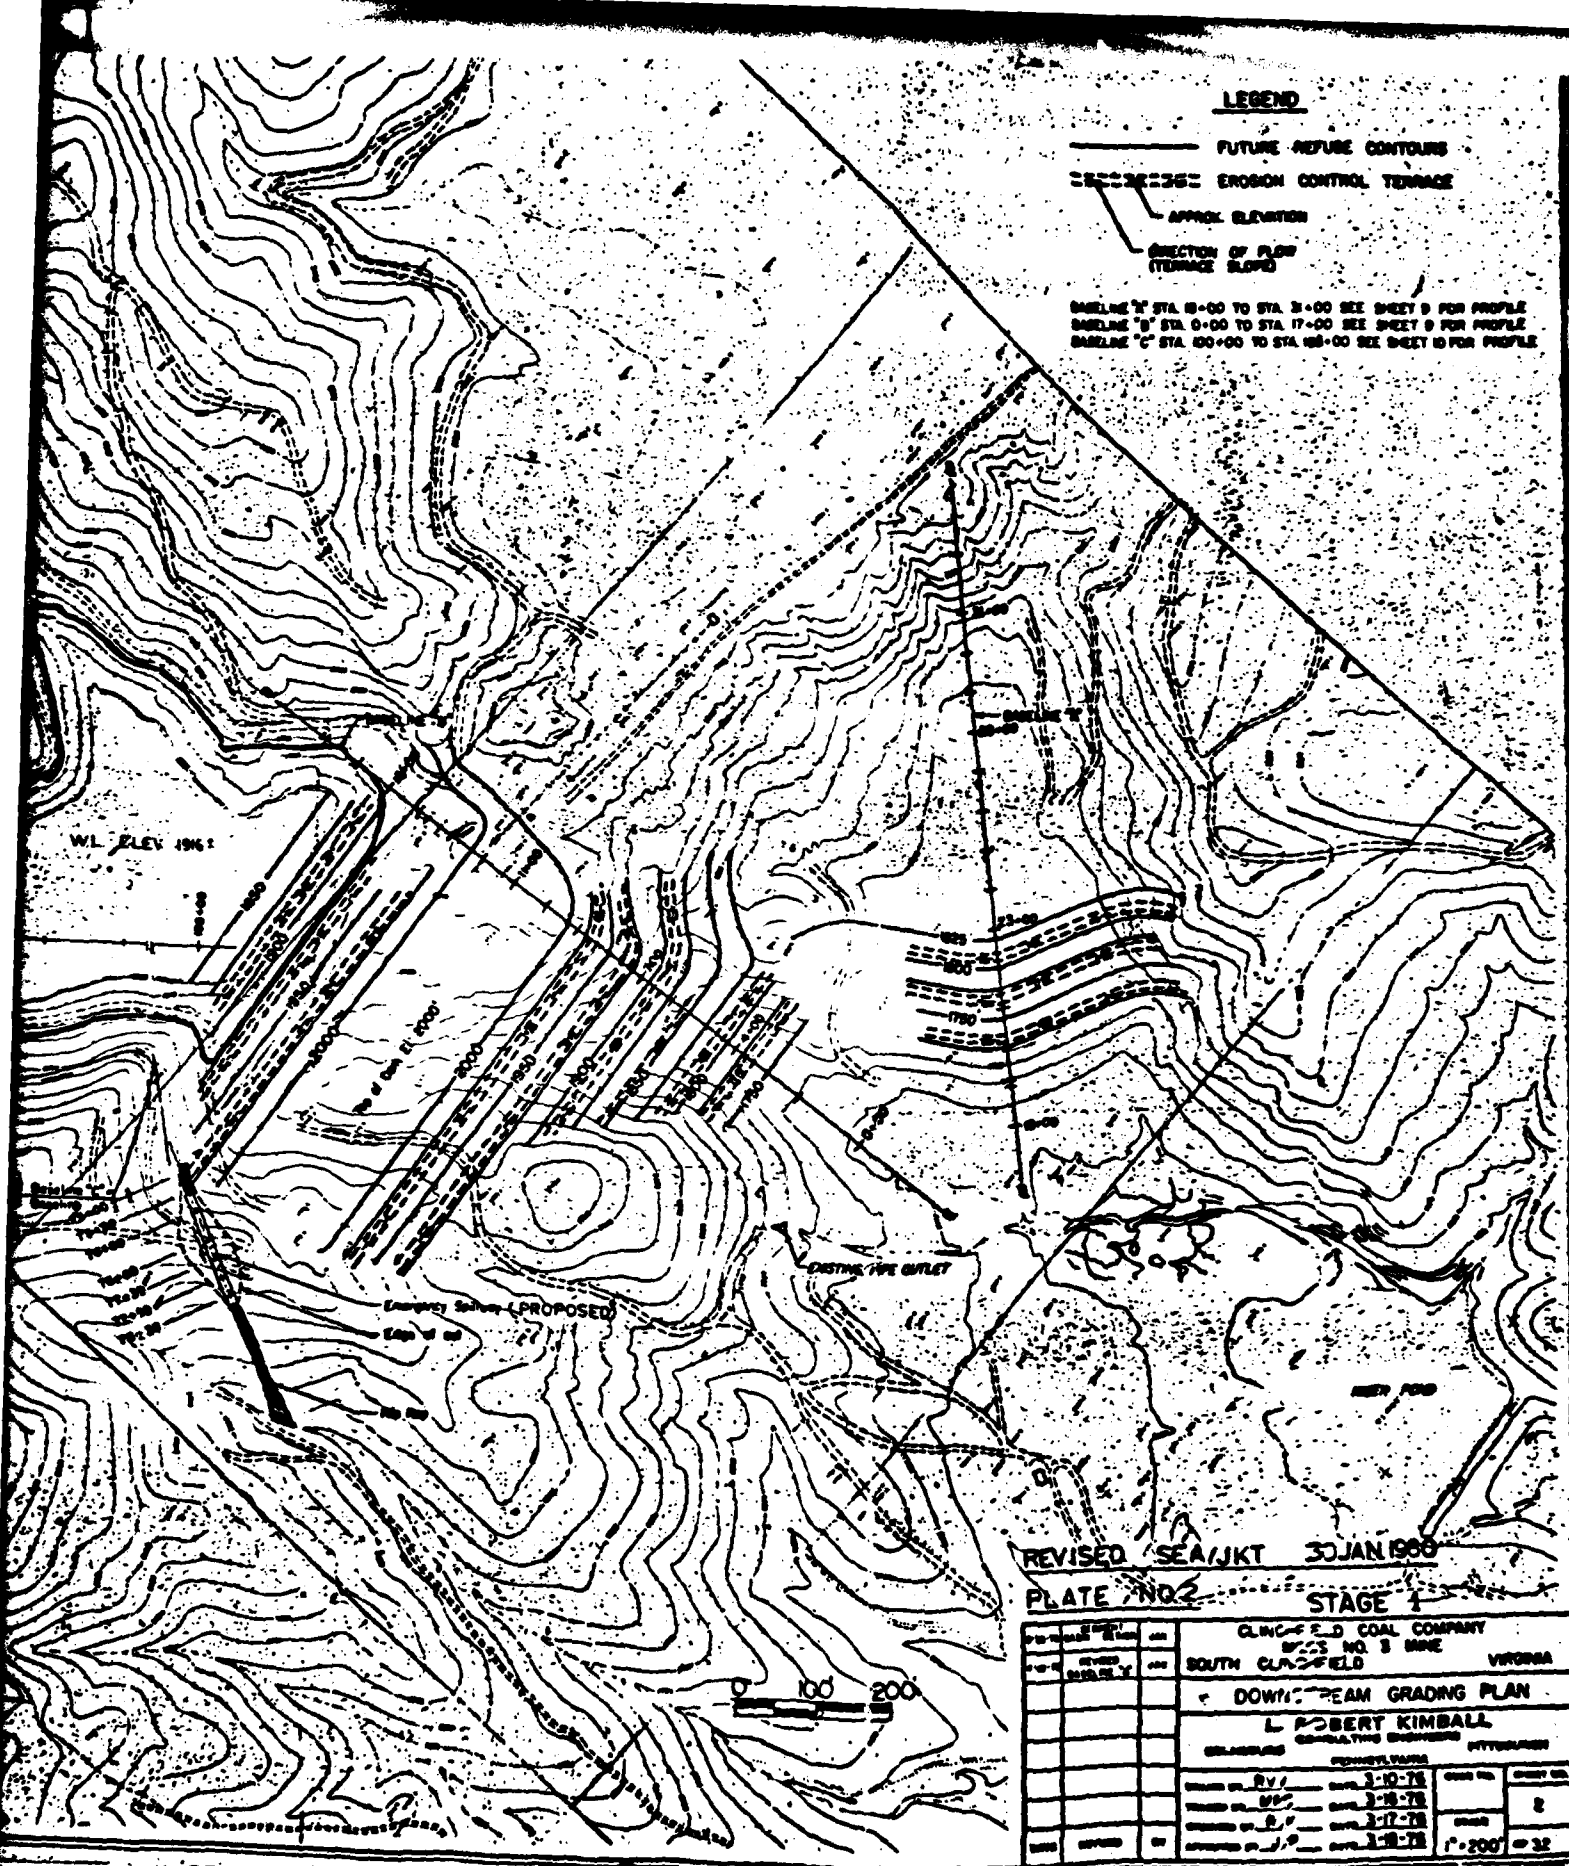
PLATE NO. 2 STAGE 1

Within the impoundment, two additional embankments exist (See Plate No. 2, Appendix I). The middle embankment was previously used for slurry containment upstream, but has been abandoned and replaced with embankment "D" located an additional 1500 ft upstream.

The actual embankment structure is presently being graded to conform to the most recent abandonment drawings (See Plate No. 2, Appendix I). The stability analysis performed for the steady seepage case for the existing embankment indicates a factor of safety of 1.22 which is less than the 1.5 requirement of Reference 1, Appendix VIII. Modifications presently in progress will increase the factor of safety of the embankment and no further studies are recommended.

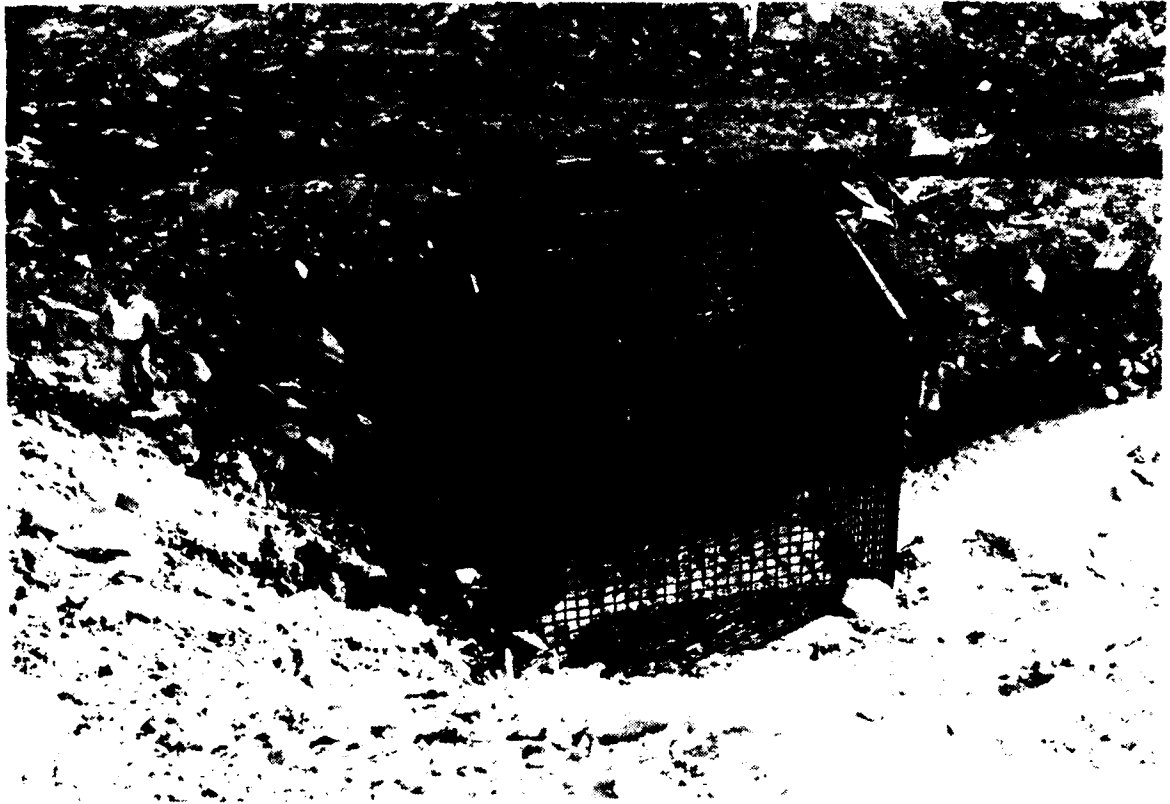
PHOTOGRAPH NO. 2

VIEW OF DEBRIS TRAP AT THE PRINCIPAL SPILLWAY OUTLET PIPE  
(SUMMER 1979) (PRINCIPAL SPILLWAY OUTLET PIPE IS 60"  
IN DIAMETER)

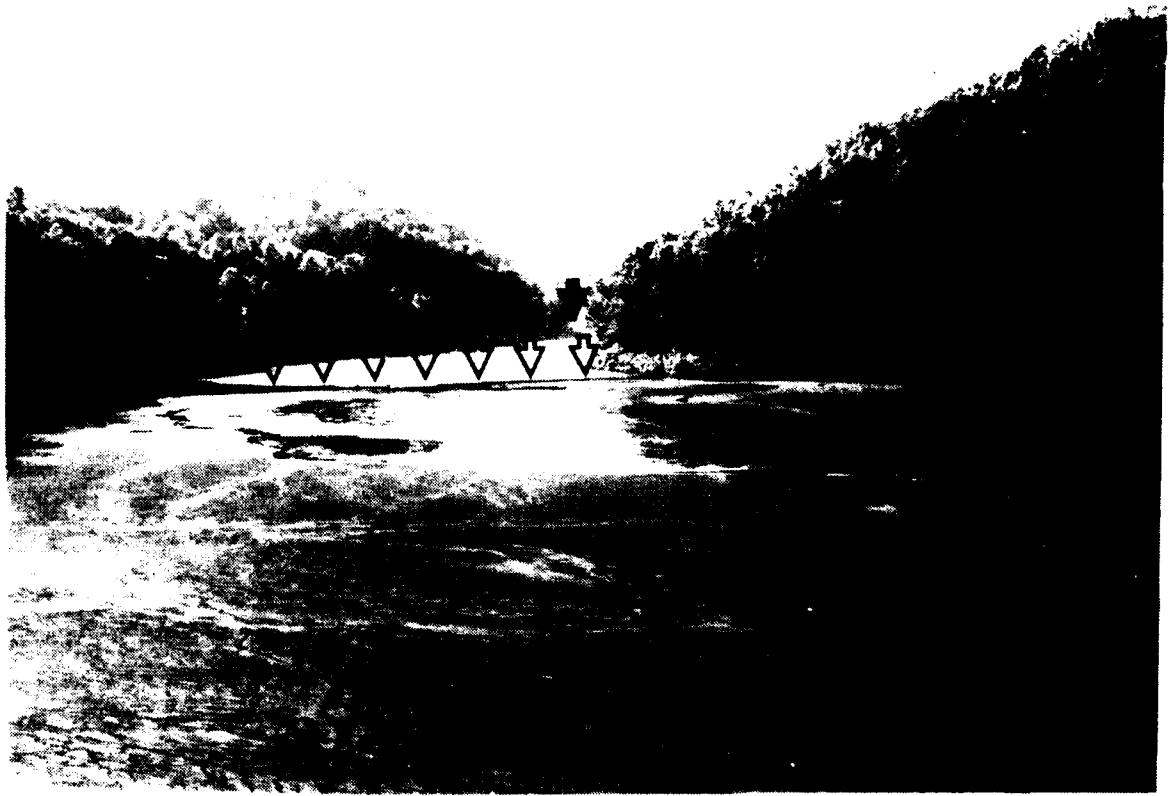
PHOTOGRAPH NO. 4

VIIW OF IMPOUNDED SLURRY POND LOOKING UPSTREAM. (NOTE, HOLLOW ARROWS DENOTE ORIGINAL BEPM) (NOTE, SOLID ARROW SHOWS APPROXIMATE LOCATION OF PRINCIPAL SPILLWAY AND DEBRIS RACK AND SECOND RETAINING BERM). (SUMMER 1979)
