SCHNABEL ENGINEERING ASSOCIATES RICHMOND VA F/6 13/13  
NATIONAL DAM SAFETY PROGRAM, BEAR CREEK RESERVOIR DAM (ID NUMBE--ETC(U)  
MAR 80 R E MARTIN DACW65-79-D-0004  
NL

| REPORT DOCUMENTATION PAGE | | READ INSTRUCTIONS<br>BEFORE COMPLETING FORM |
|---|---|---|
| 4. TITLE (and Subtitle)<br>Phase I Inspection Report<br>National Dam Safety Program<br>BEAR CREEK RESERVOIR DAM<br>WISE COUNTY, VA | | 5. TYPE OF REPORT & PERIOD COVERED<br>9 Final Rpts |

PHASE I INSPECTION REPORT  
NATIONAL DAM SAFETY PROGRAM  
BEAR CREEK RESERVOIR DAM  
VA. NO. 19511

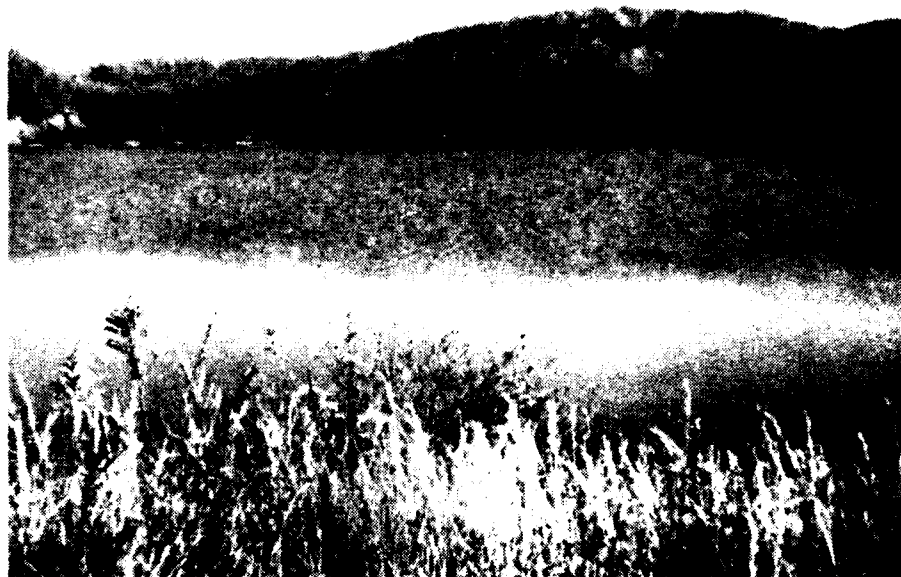
Photograph No. 1  
Reservoir

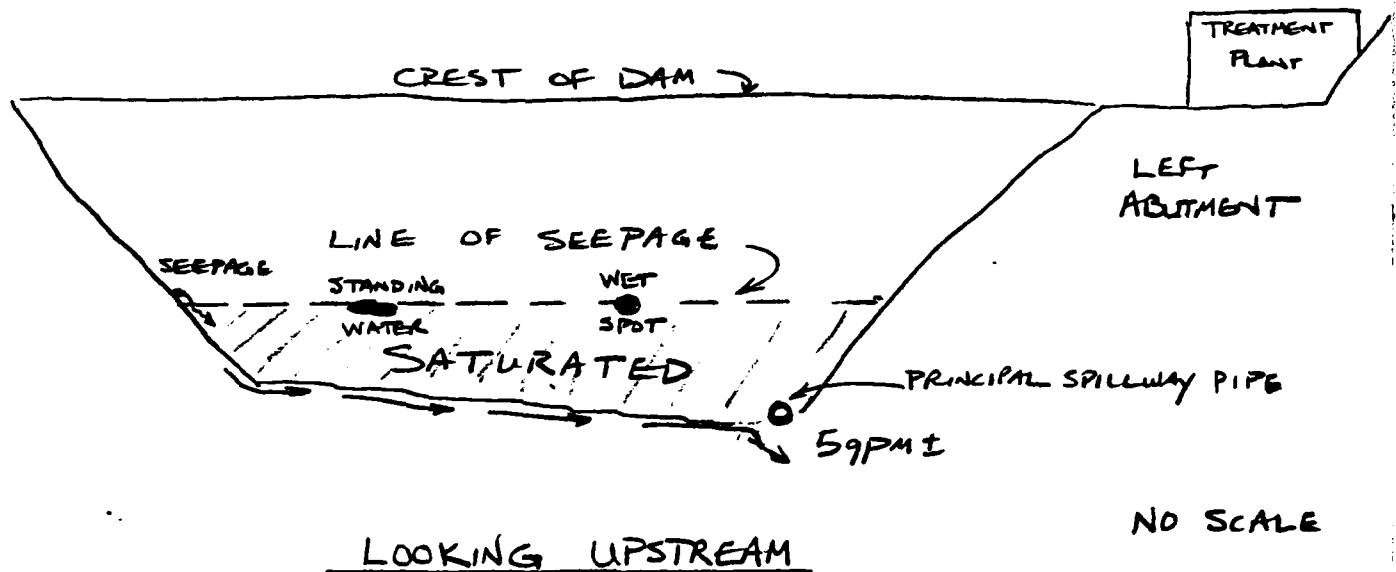
SUBJECT FIELD SKETCH  
BEAR CREEK RESERVOIR DAM

6.3.2 Embankment: The iron-stained saturated areas located along the right downstream toe and the continuous saturated zone present along the basal third of the downstream slope are indicators of long-term seepage. The origin of the seepage could not be specifically

| VISUAL EXAMINATION OF | OBSERVATIONS | REMARKS OR RECOMMENDATIONS |
|---|---|---|
| ANY NOTICEABLE SEEPAGE | <p>Scattered wet spots, standing water and iron-stained seepage were observed in a general line as shown on the accompanying field sketch. Essentially the entire basal 1/3 to 1/4 of the downstream slope is saturated and very spongy. This condition appears to be the result of long term seepage through the dam. Accumulated flow from the right side of the downstream slope was estimated at 5 gpm as the combined flow passed in front of the principal spillway pipe. Seepage observed during the site visit was clear and essentially free of turbidity.</p> | |

SEEPAGE -  $\frac{2}{3}$  WAY DOWN ON RIGHT ABUTMENT - DAM CONTACT  
STANDING WATER -  $\frac{2}{3}$  WAY DOWN - IRON STAINED SEEPAGE  
WET SPOT -  $\frac{2}{3}$  WAY DOWN - SMALL ZONE OF SEEPAGE WITH  
SWAMP GRASS. NO FLOW BUT SPONGY.

7.3.1 Seepage present along the downstream slope is of concern since it appears to indicate widespread seepage through the dam. The downstream slope should be monitored quarterly and after high pool levels in the reservoir to detect any increase in flow rates which may cause piping within the embankment. If increased flow rates should occur, a professional Geotechnical Engineer should be contacted to evaluate the problem and make recommendations for required corrective measures.
