## DELAWARE CITY BRIDGE

Re: Delaware City Bridge  
Bridge Inspection Report No. 11C  
Contract No. DACW61-79-C-0226

6  
**BRIDGE INSPECTION  
REPORT NO. 11 C.**

BRIDGE INSPECTION REPORT NO. 11C

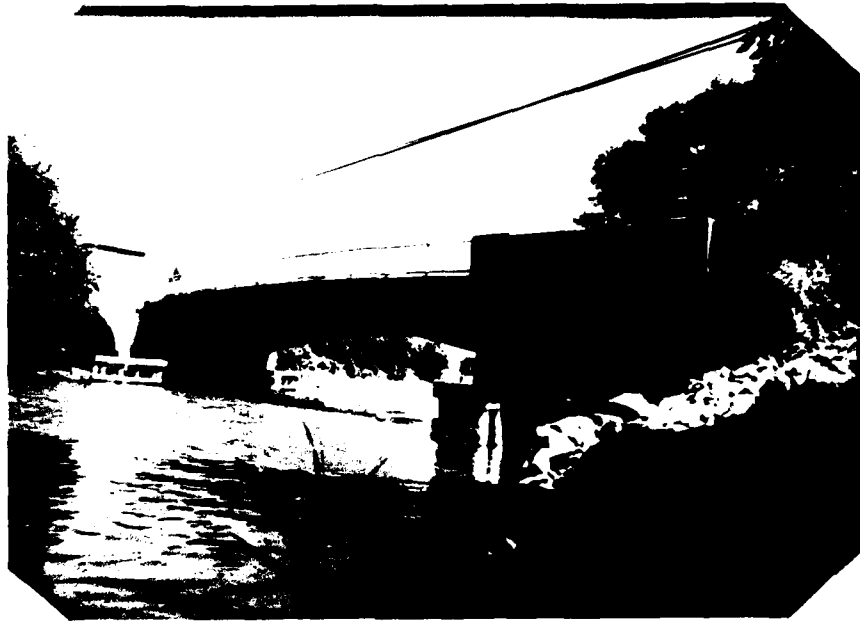
Photograph 1-1 - West elevation view.

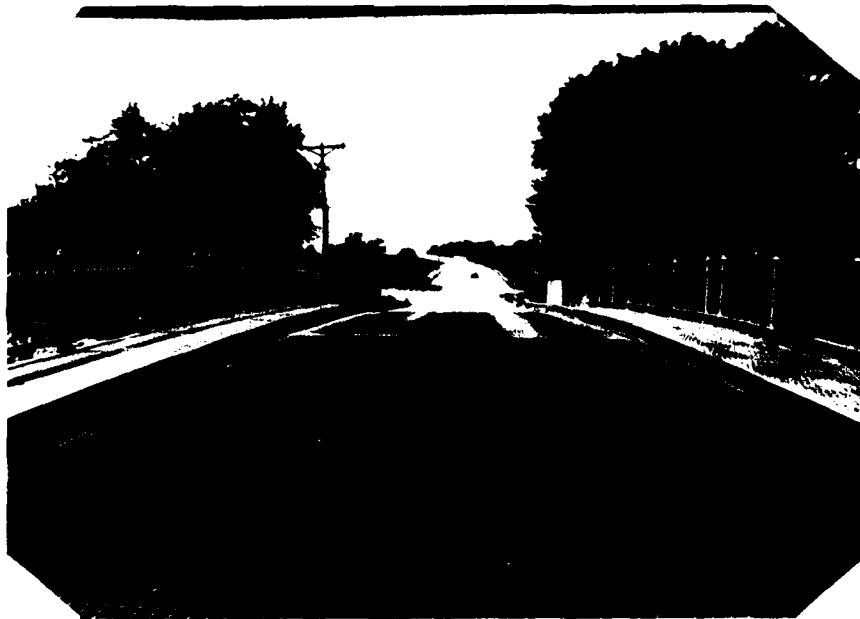
Photograph 1-2 - Roadway looking south

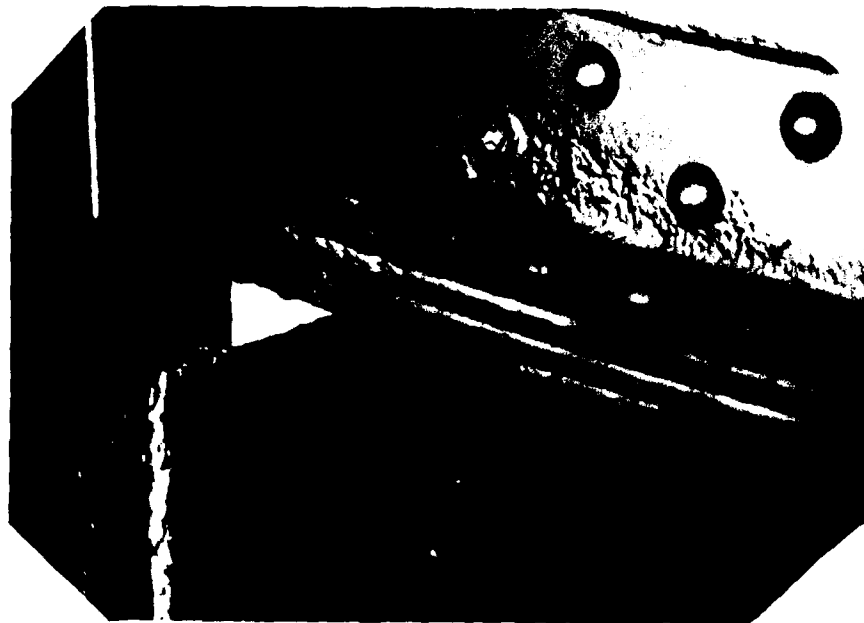
Inspection revealed corrosion of metal work at juncture of trunnion bearing and shaft (See photographs 1-7 and 1-8). The surfaces of bottom flanges of the main girders show signs of rust (See photograph 1-9). This is due to debris collected on the flanges. This can be avoided by installing a drip plate on the bottom flange in line with outside face of the piers. Paint on metal work in general appeared in good condition.

Photograph 1-9 - Rusted bottom flange, east of west girder, inside north pier.

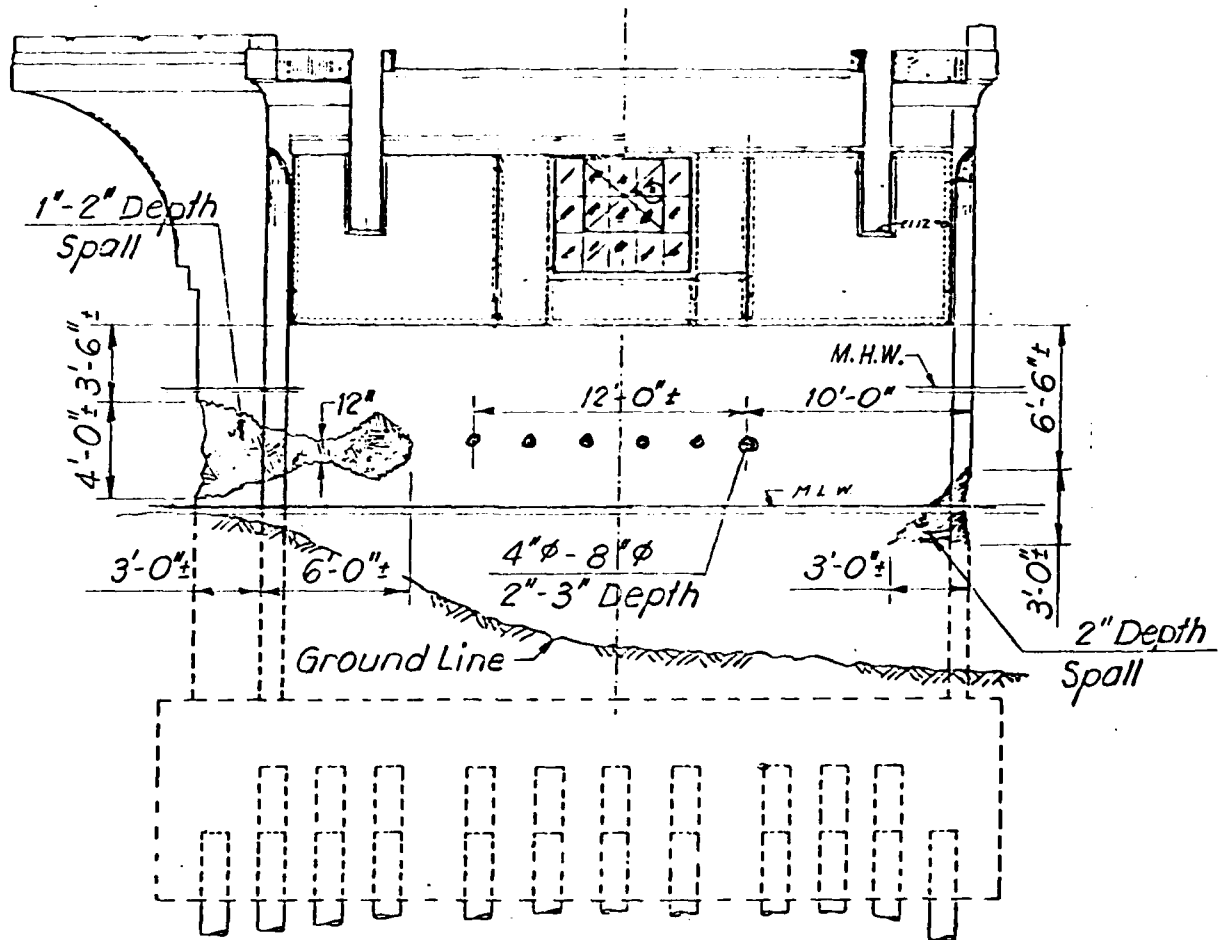
# NORTH PIER

1. Piers: There is no evidence of settlement or shifting of piers. Outside concrete surface at piers has spalls as shown in drawings 1-3 and 1-4. The inside concrete surface at north pier has spalls in the roof slab (See photograph 1-3). The concrete wall (well area) at west side of the north pier has a crack about 4' below top slab that runs horizontally (See photograph 1-4). The large chamber inside the pier (previously used to accommodate the counterweight) at the south pier had about 4' deep water and at the north pier about 2' deep water. This condition indicates possibility of cracks below channel water level. Access to the north pier chamber, was obtained through the abandoned operator's house at west side of bridge and to the south pier chamber through a manhole in the east sidewalk. The door in the operator's house and manhole cover are welded shut, the doors in pier channel faces are also closed, therefore preventing transients and children from gaining access to the pier chambers. Inside and outside trunnion columns are in good condition except for corrosion at lower half of the inside column. Most of the anchor bolts are rusted. The inside trunnion column support flanges

An underwater inspection of the piers was included in this inspection. Visual inspection at low water line and probing below water to the mud line revealed the need for subsurface repair (See Drawings 1-3 and 1-4).

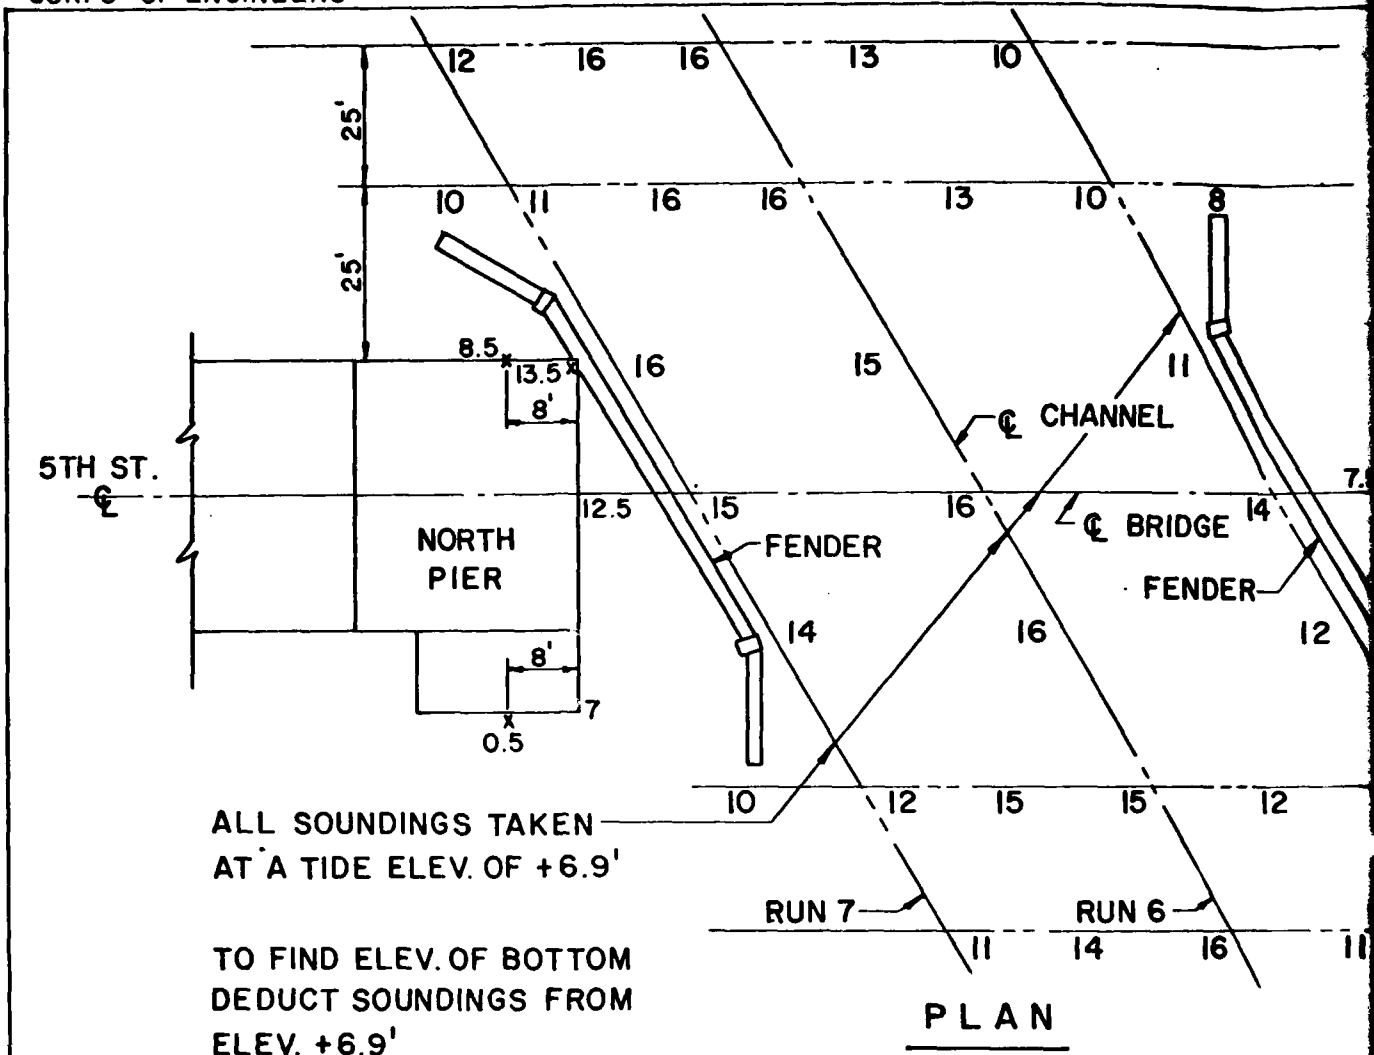
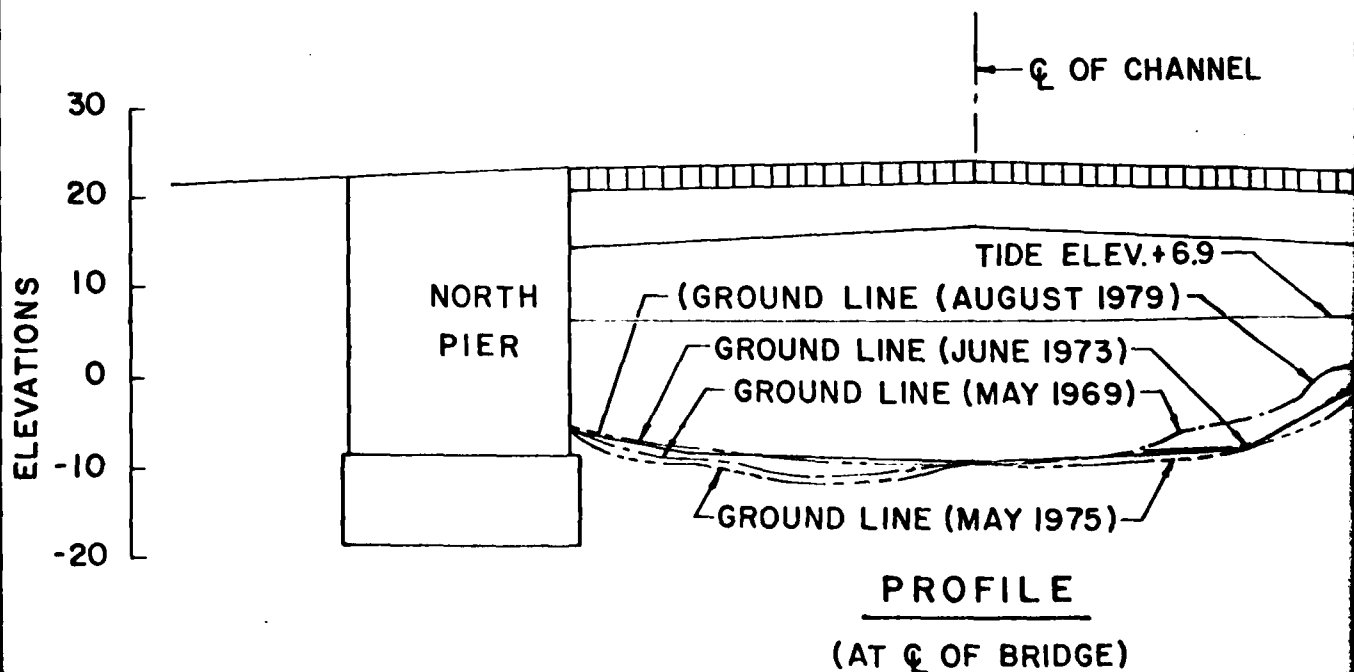
**DRAWING 1-5**

recorded on Drawing 1-5, appended. It can be observed that some silting has taken place around bank area.
