PHASE I INSPECTION REPORT

NATIONAL DAM SAFETY PROGRAM

*Stevens Lake Dam (VA-12509), James River Basin,  
Nelson County, State of Virginia.*

Name of Dam: Stevens Lake Dam  
State: Virginia  
County: Nelson  
USGS 7.5 Minute Quadrangle: Arrington, Virginia  
Stream: Unnamed Tributary to Brown Creek  
Date of Inspection: 30 November 1979

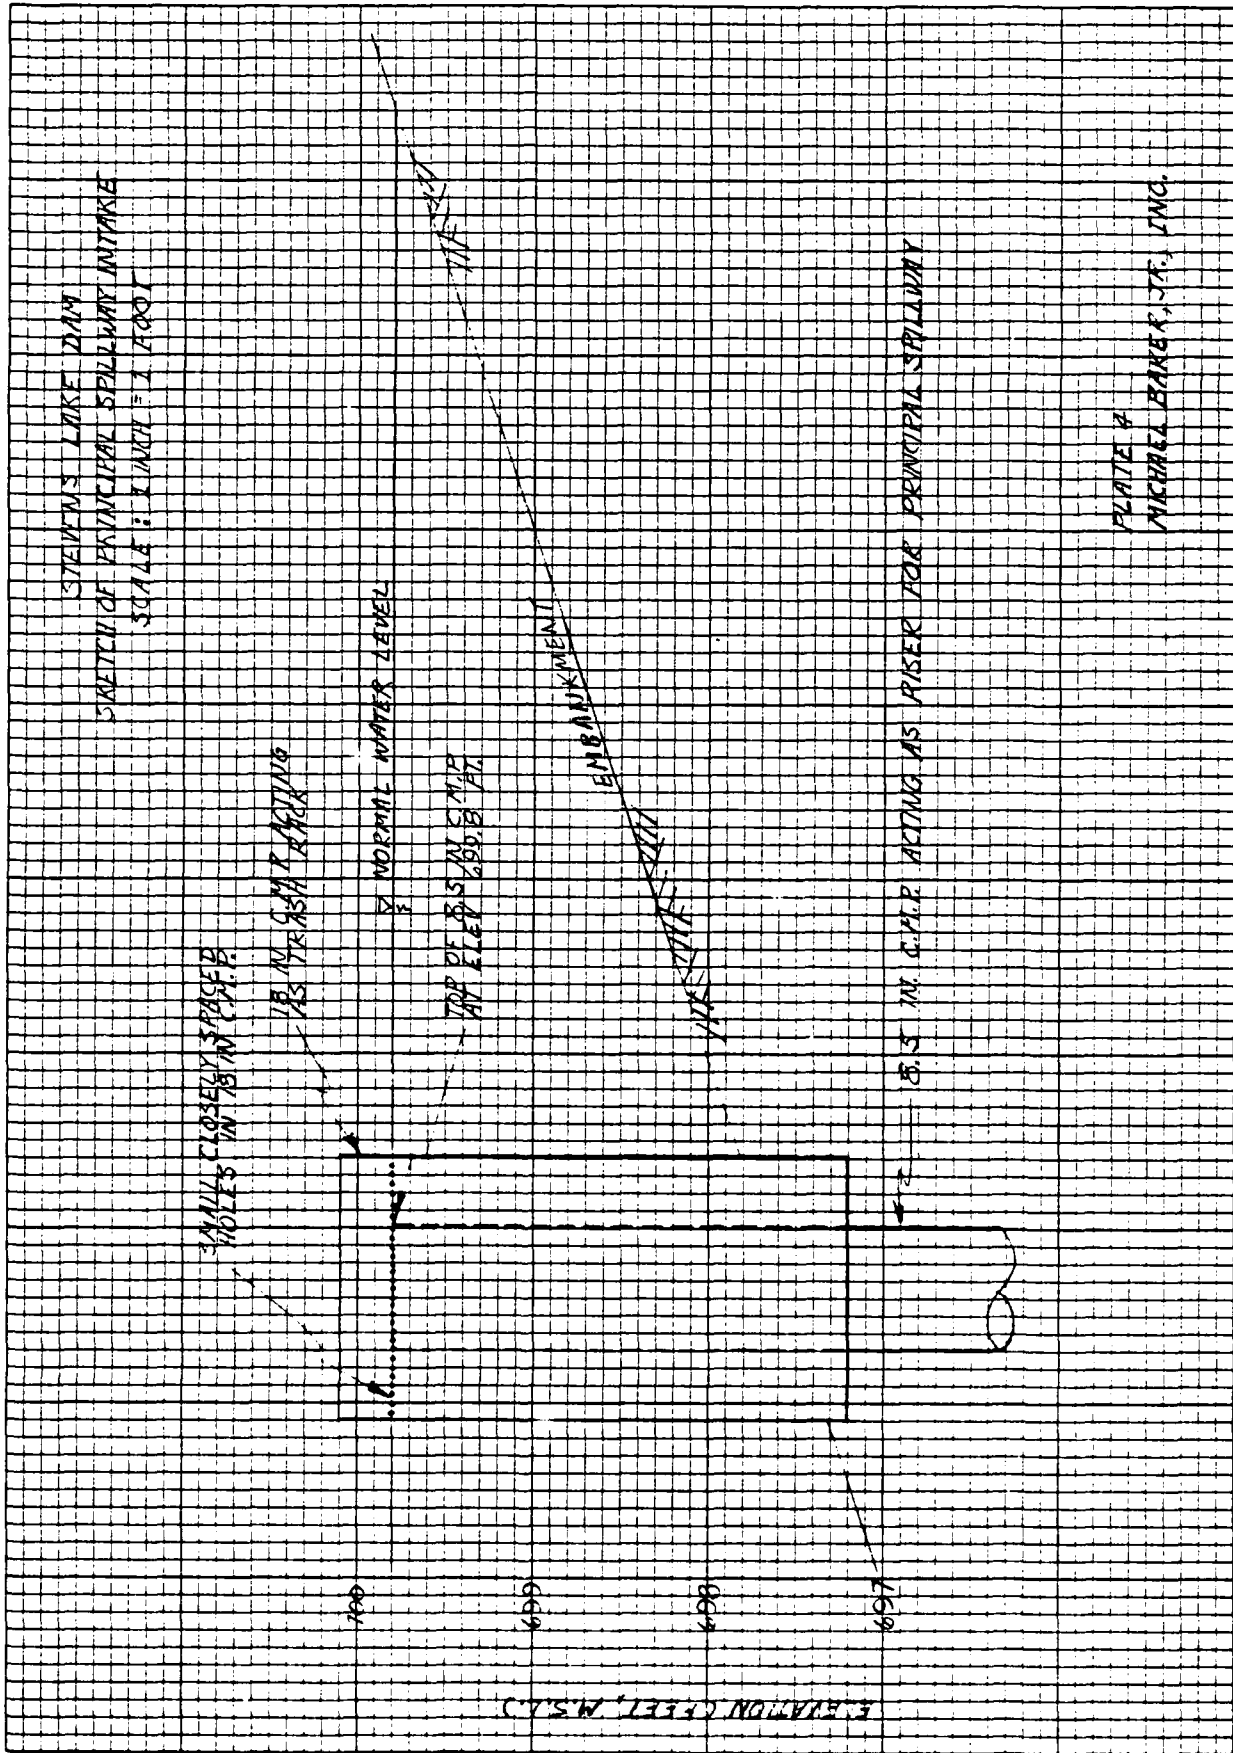
Plate 4: Sketch of Principal Spillway Intake

B.S. IN G.P.P. ACTING AS RISER FOR PRINCIPAL SPILLWAY
