| REPORT DOCUMENTATION PAGE | | READ INSTRUCTIONS<br>BEFORE COMPLETING FORM |
|---|---|---|
| 4. TITLE (and Subtitle) Phase I Inspection Report<br>National Dam Safety Program<br>BIRDWOOD DAM<br>ALBERMARLE COUNTY, VA | | 5. TYPE OF REPORT & PERIOD COVERED<br>Final |

# PHASE I INSPECTION REPORT NATIONAL DAM SAFETY PROGRAM

Name of Dam: Birdwood Dam  
State: Virginia  
County: Albemarle  
USGS 7.5 Minute Quadrangle: Charlottesville West, VA  
Stream: Morey Creek  
Date of Inspection: 13 November 1979

PHASE I INSPECTION REPORT  
NATIONAL DAM SAFETY PROGRAM  
NAME OF DAM: BIRDWOOD DAM ID# VA 00344

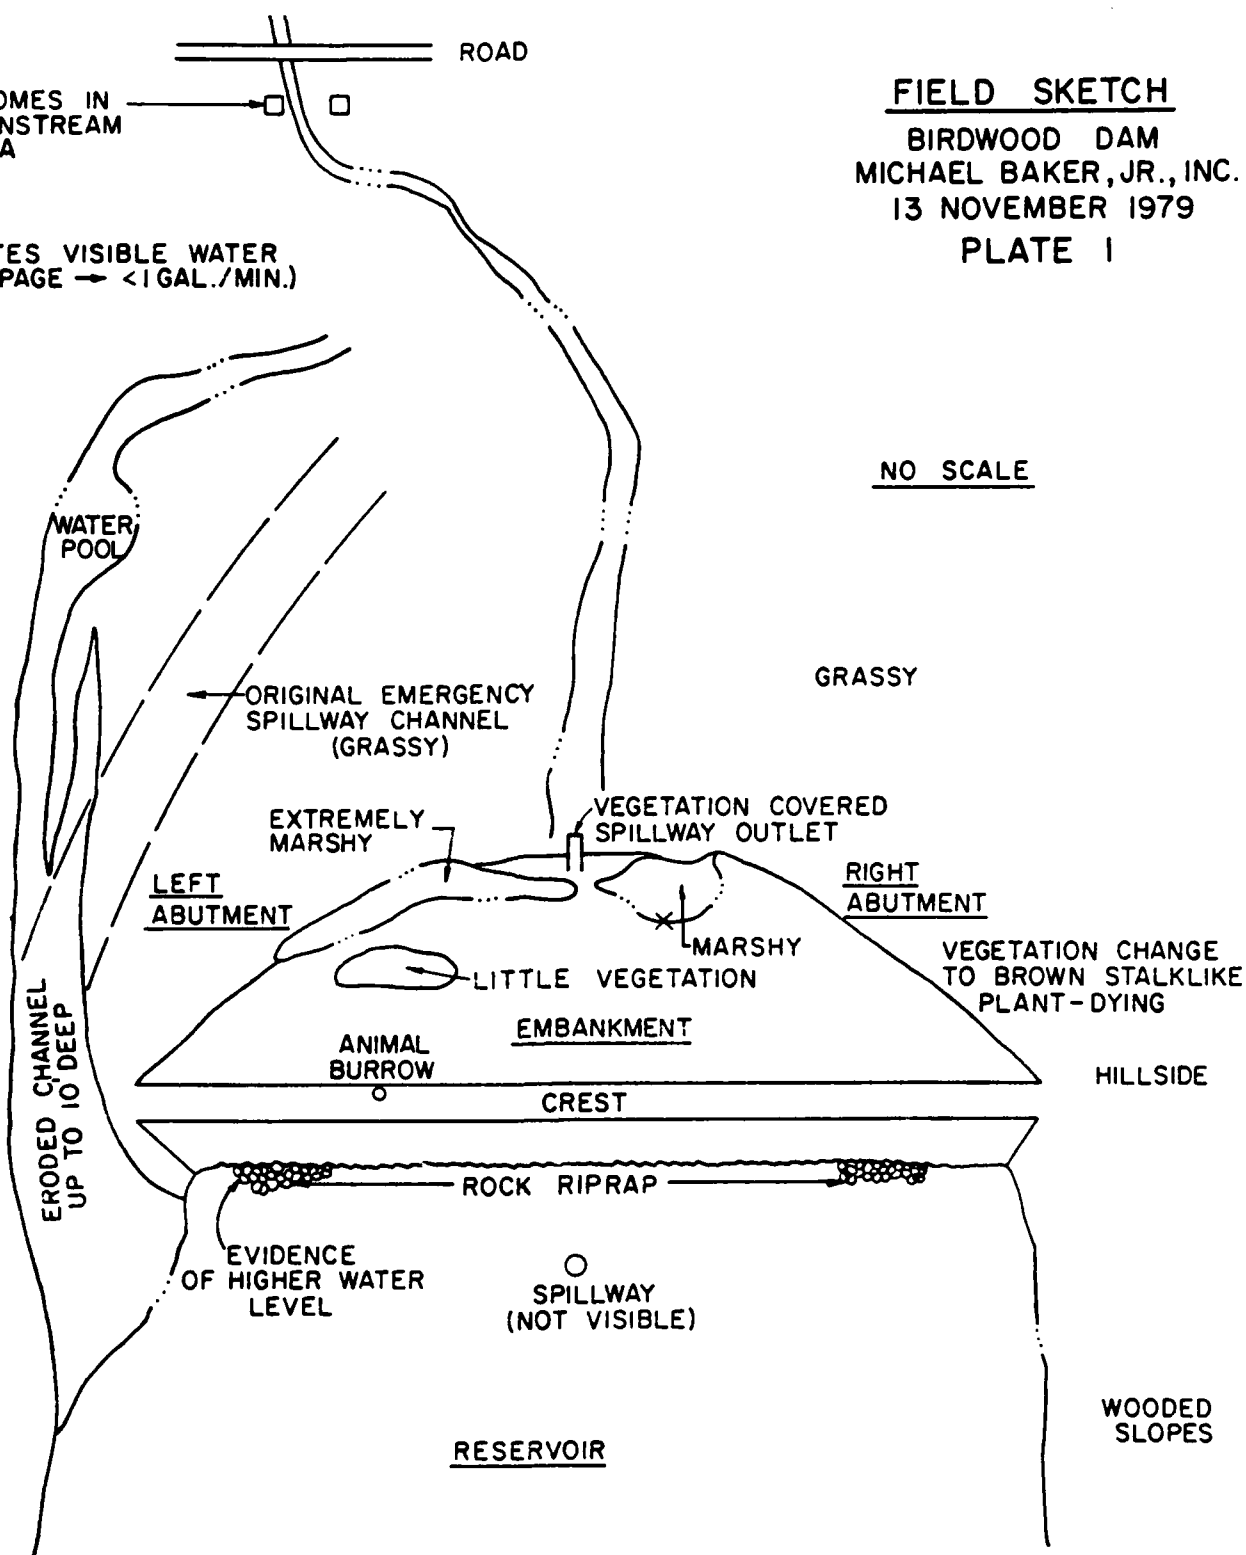
X - INDICATES VISIBLE WATER  
(SEEPAGE → <1 GAL./MIN.)

UPSTREAM AND DOWNSTREAM EMBANKMENT, ABUTMENTS, CREST, AND DOWNSTREAM CHANNEL ARE VERY OVERGROWN.  
DOWNSTREAM EMBANKMENT SURFACE SEEMED IRREGULAR - HOWEVER VEGETATION PREVENTED BETTER OBSERVATION.  
NO KNOWN TOE DRAINS.
