PHASE I INSPECTION REPORT

Grahams Dam (VA-00342), James River Basin, Albemarle County, State of Virginia

Name of Dam: Grahams Dam
State: Virginia
County: Albemarle
USGS 7.5 Minute Quadrangle: Charlottesville East, VA
Stream: Unnamed Tributary to Camp Branch
Date of Inspection: 12 November 1979

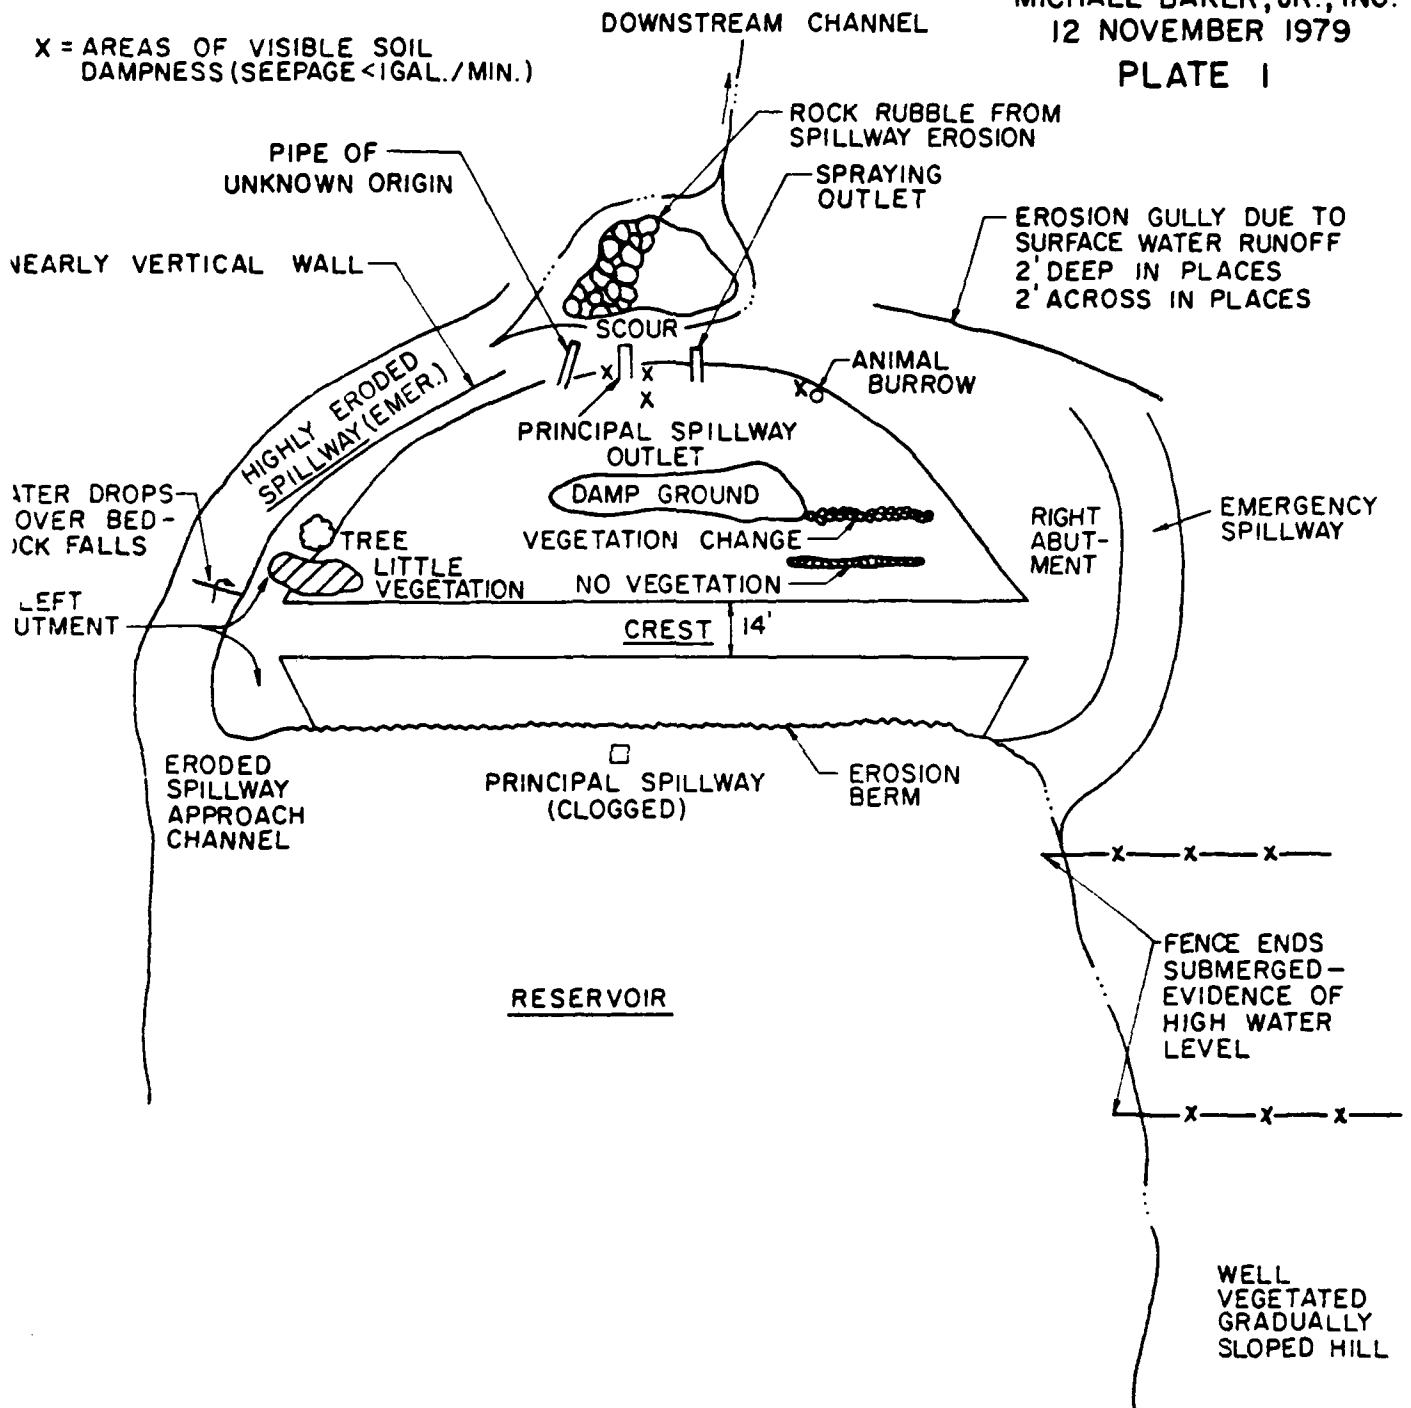
PLATE I

NOTE:
 DOWNSTREAM EMBANKMENT SOMEWHAT IRREGULAR / SLIGHTLY GULLIED
 BEDROCK OF SPILLWAY HIGHLY FRACTURED
 STRIKE - 60° E DIP - 68°
 WATER FLOWING THROUGH LEFT EMERGENCY SPILLWAY AT TIME OF INSPECTION

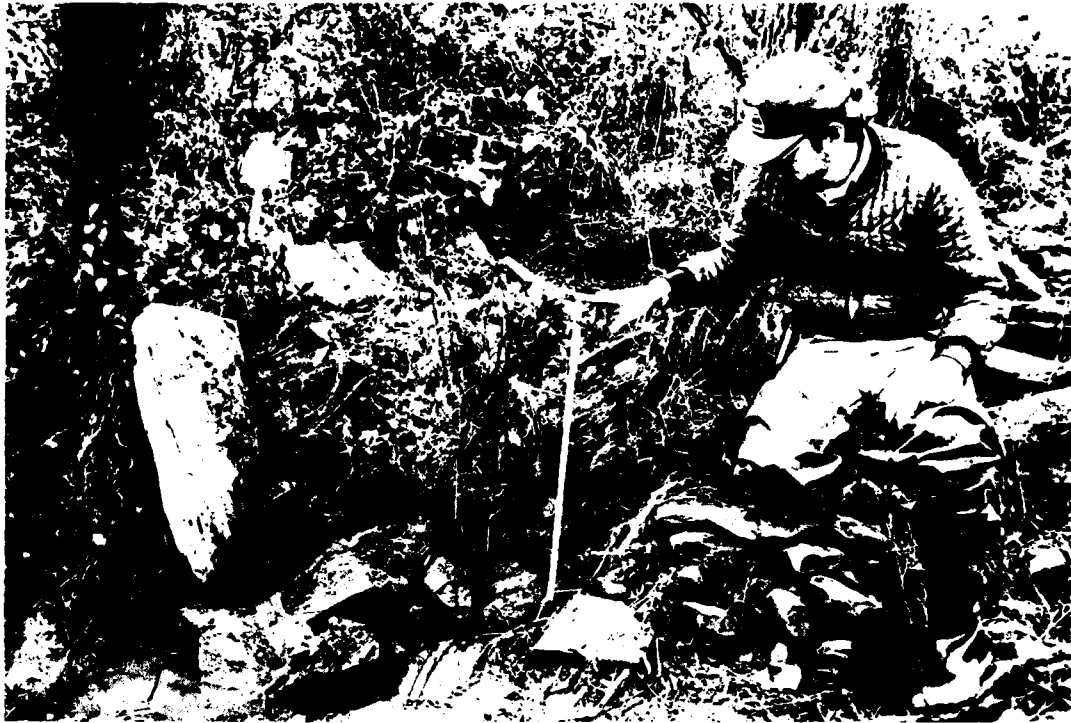
PHOTO 5. Unidentified Pipe Fifteen Feet Left of Principal Outlet
