PHASE I INSPECTION REPORT

NATIONAL DAM SAFETY PROGRAM

Lanier Dam (VA-08910), Roanoke River Basin.

Henry County
Virginia, Phase I
Inspection Report

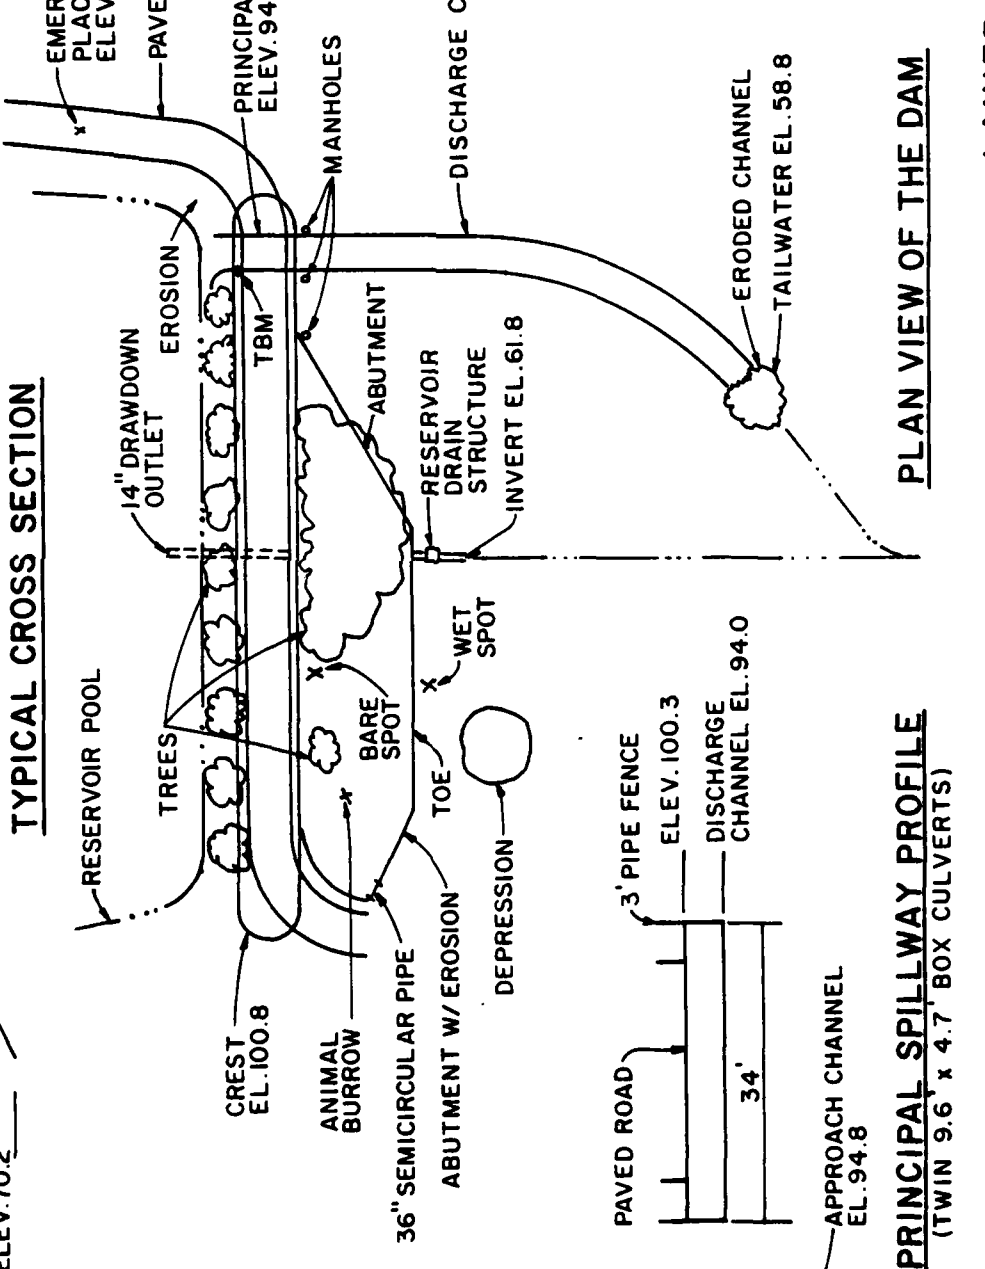
LANIER DAM
HENRY COUNTY, VA.
12 DEC. 1979
NOT TO SCALE
PLATE II

3.1.2 Embankment: The embankment is in good condition. A sketch showing a plan view and cross section is provided on Plate II, Appendix I. Overall views of the crest and downstream slope are provided at the beginning of the report.

There is a wet spot in the downstream area at the toe of the embankment, a bare spot and an animal burrow on the downstream slope, all as located on Plate II. The wet spot is as shown in Photo 5 and the animal burrow in Photo 4.

d. The bare spot noted on Plate II should be reseeded.

e. The animal burrow, noted in Plate II, should be backfilled with compacted fill and seeded.

f. The wet spot noted on Plate II should be monitored for seepage or boils during a regular maintenance program. Should seepage occur, a professional geotechnical engineer should be consulted.

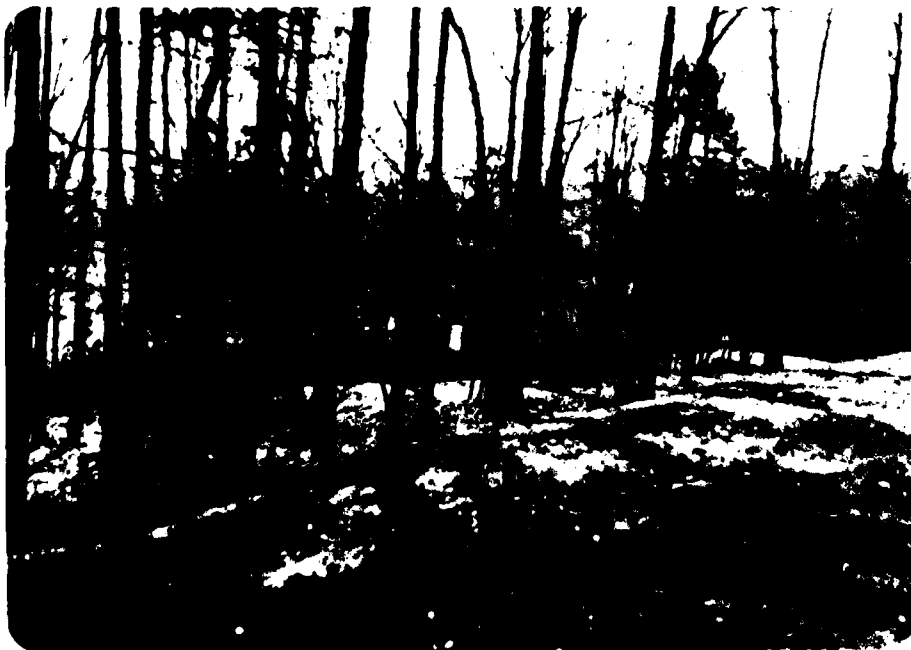
PHOTO # 6 : HABITABLE STRUCTURE DOWNSTREAM
OF DAM
