INTERIM REPORT OF FIELD TEST  
OF EXPEDIENT PAVEMENT REPAIRS  
(TEST ITEMS 1-15).

RAYMOND S. ROLLINGS  
ENGINEERING RESEARCH DIVISION

MARCH 1980

ENGINEERING AND SERVICES LABORATORY  
AIR FORCE ENGINEERING AND SERVICES CENTER  
TYNDALL AIR FORCE BASE, FLORIDA 32403

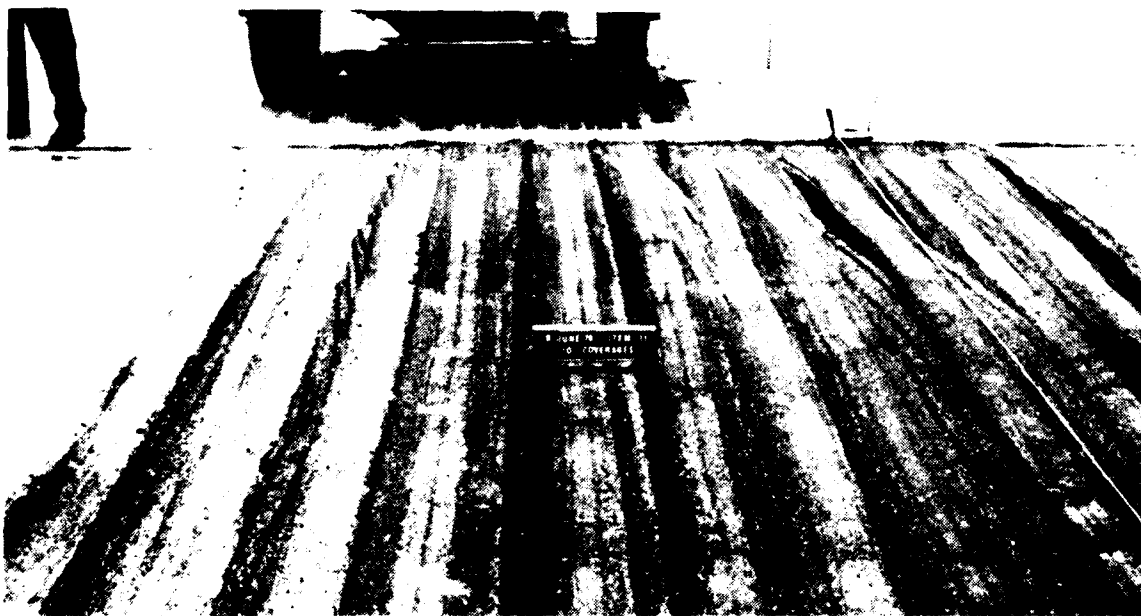
A total 20 coverages of F-4 load cart traffic was applied to the item. During traffic the Amalgapave® shoved and rutted badly (Figure 48) and worked out of the repair area (Figure 49.) This item was considered unusable under traffic because of low stability.

Figure 48. Rutting in Almalgapave® Surface, Item 11
