| REPORT DOCUMENTATION PAGE | | READ INSTRUCTIONS<br>BEFORE COMPLETING FORM |
|---|---|---|
| 4. TITLE (and Subtitle)<br>FAILURE ANALYSIS OF ROLLER CHAIN DRIVES | | 5. TYPE OF REPORT & PERIOD COVERED |
| 7. AUTHOR(s)<br>F. R. Stonesifer, H. L. Smith, and D. A. Meyn | | 6. PERFORMING ORG. REPORT NUMBER |
| 9. PERFORMING ORGANIZATION NAME AND ADDRESS<br>Naval Research Laboratory<br>Washington, D.C. 20375 | | 8. CONTRACT OR GRANT NUMBER(s) |
| 14. MONITORING AGENCY NAME & ADDRESS (if different from Controlling Office) | | 12. REPORT DATE<br>April 4, 1980 |

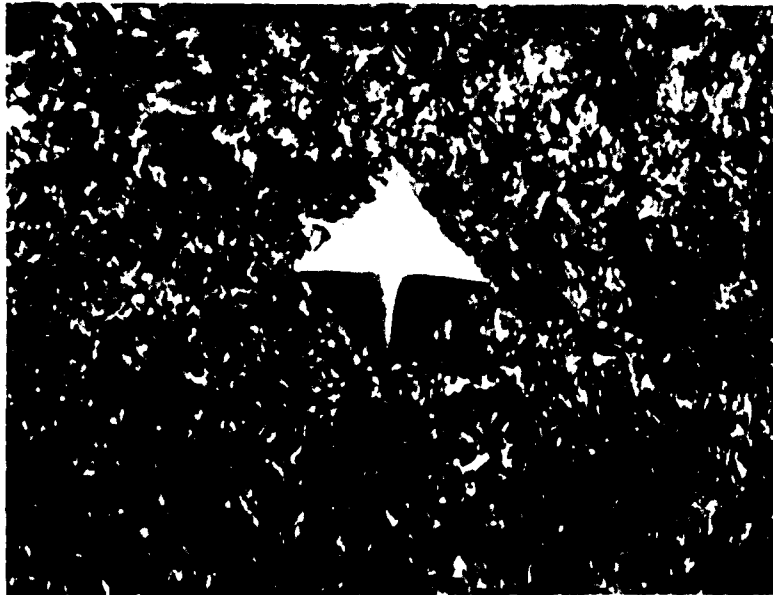
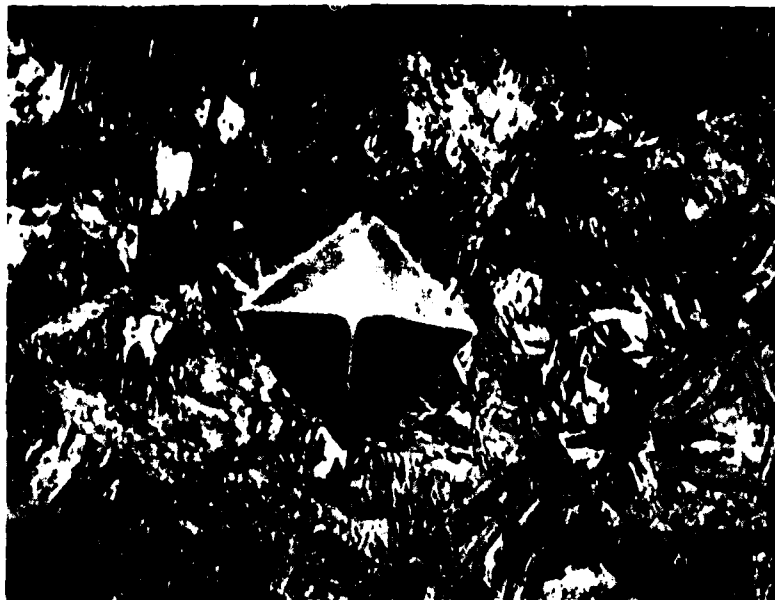
(a) Fine martensite in hardened area 0.006 in. from the pin surface. Small indent connotes high hardness.

(b) Coarser martensite in core of pin. Larger indent connotes lower hardness.

Fig. 3 — Polished and etched cross-section of the June failed pin shows structure and microhardness indents. (1000X).

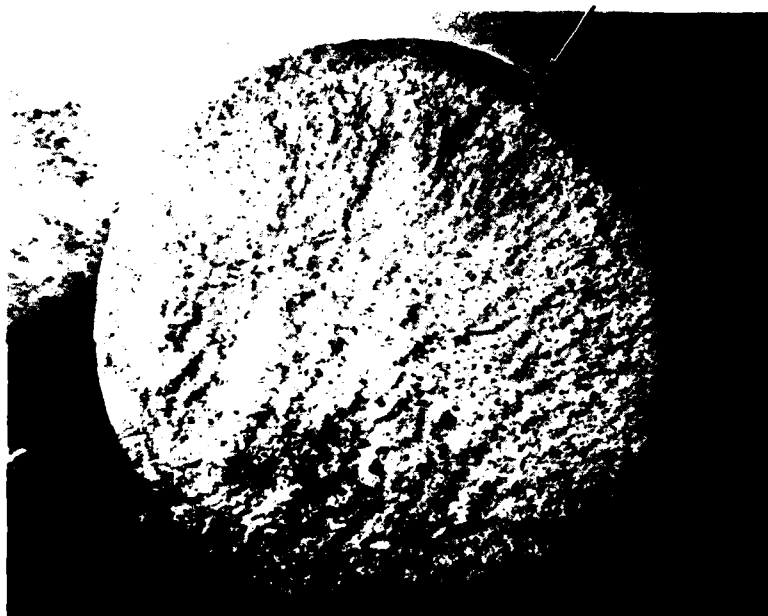
The pin at the support block end of the connecting link broke near its peened end, about 0.130" inside the link plate. Origin is at a corrosion pit, about 0.0016" deep, on the side of the pin subjected to tensile bending stress when the chain is loaded in simple tension, Figs. 6, 7 and 8. In this case, no permanent bend deformation was evident. The case fracture is intergranular to within a few mils of the origin pit where the surface becomes too corroded to determine the cracking mode. The case hardening depth is 0.020" to 0.025". Probable cause of failure is stress corrosion cracking, with some corrosion fatigue.

**Fig. 6 — Macro photograph of fracture surface of pin from the July failure. The fracture origin is indicated by the arrow and is associated with a pit existing before the crack initiated. (16X).**

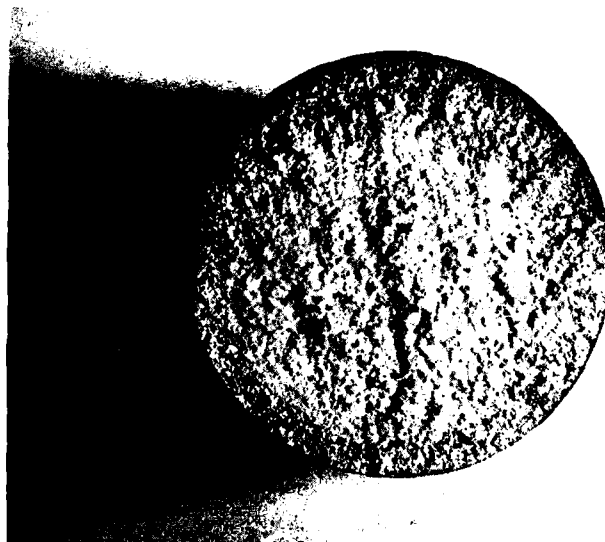
The fracture surface was intergranular in the hardened case and in the adjacent core where the stress corrosion crack had penetrated, Fig. 13 and 14. No corrosion pit was evident at the origin. General corrosion was obvious from the thick black oxide scale on the pin and a red-orange precipitate in the solution.

Fig. 13 — Macrograph of stress corrosion cracked pin tested in 3 point bending. The fracture origin area is near the top of the figure. Intergranular cracking goes well into the core in some spots. (12X).
