NDI No. PA 00208
PENN DER No. 26-70

FAIRCHANCE RESERVOIR DAM
BOROUGH OF FAIRCHANCE

PHASE I INSPECTION REPORT
NATIONAL DAM INSPECTION PROGRAM

APRIL 1980

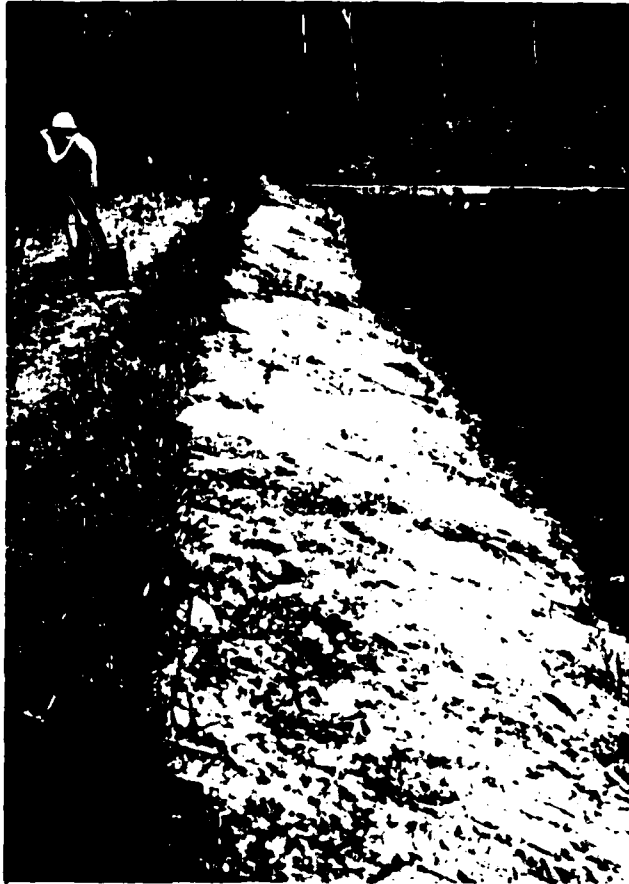
(2) Upstream Slope: The upstream slope was entirely covered by cemented riprap, which contained minor cracks and a small amount of vegetation growing. The slope protection was in good condition.

PHOTO 1. VIEW OF EMBANKMENT, CEMENTED RIPRAP, AND SPILLWAY TRAINING WALL

(d) Repair cracks in the spillway walls, slab and weir and in the cemented riprap on the upstream slope.
