6 National Dam Inspection Program.  
BEAVER CREEK DAM  
(SCS PA 433).

(NDS I.D. Number PA 88903,  
DER I.D. Number 15-301)

PHASE I INSPECTION REPORT,  
NATIONAL DAM INSPECTION PROGRAM

WOODWARD-CLYDE CONSULTANTS  
5120 Butler Pike  
Plymouth Meeting, Pennsylvania 19462

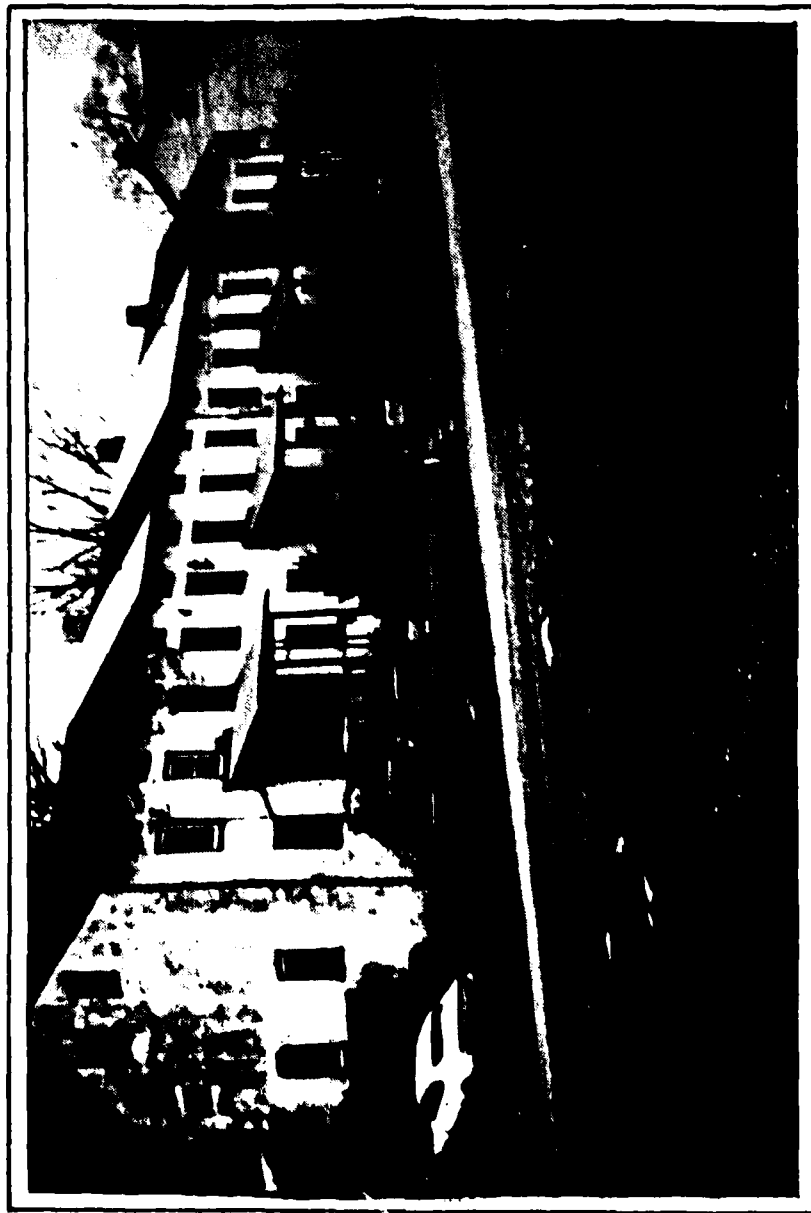
PHOTOGRAPH NO. 12

*In the first two river miles below the dam are 4 or 5 houses subject to damage in the event of failure of the dam. At Bondsville, 2 miles below the dam, additional homes and an unoccupied factory would be damaged.*

DOWNSTREAM HAZARD CENTER AT BONDSVILLE.
