LAUREL RUN NO. 2 DAM.

NDI ID NO. PA-00550,

PHASE I INSPECTION REPORT,

APRIL 1980

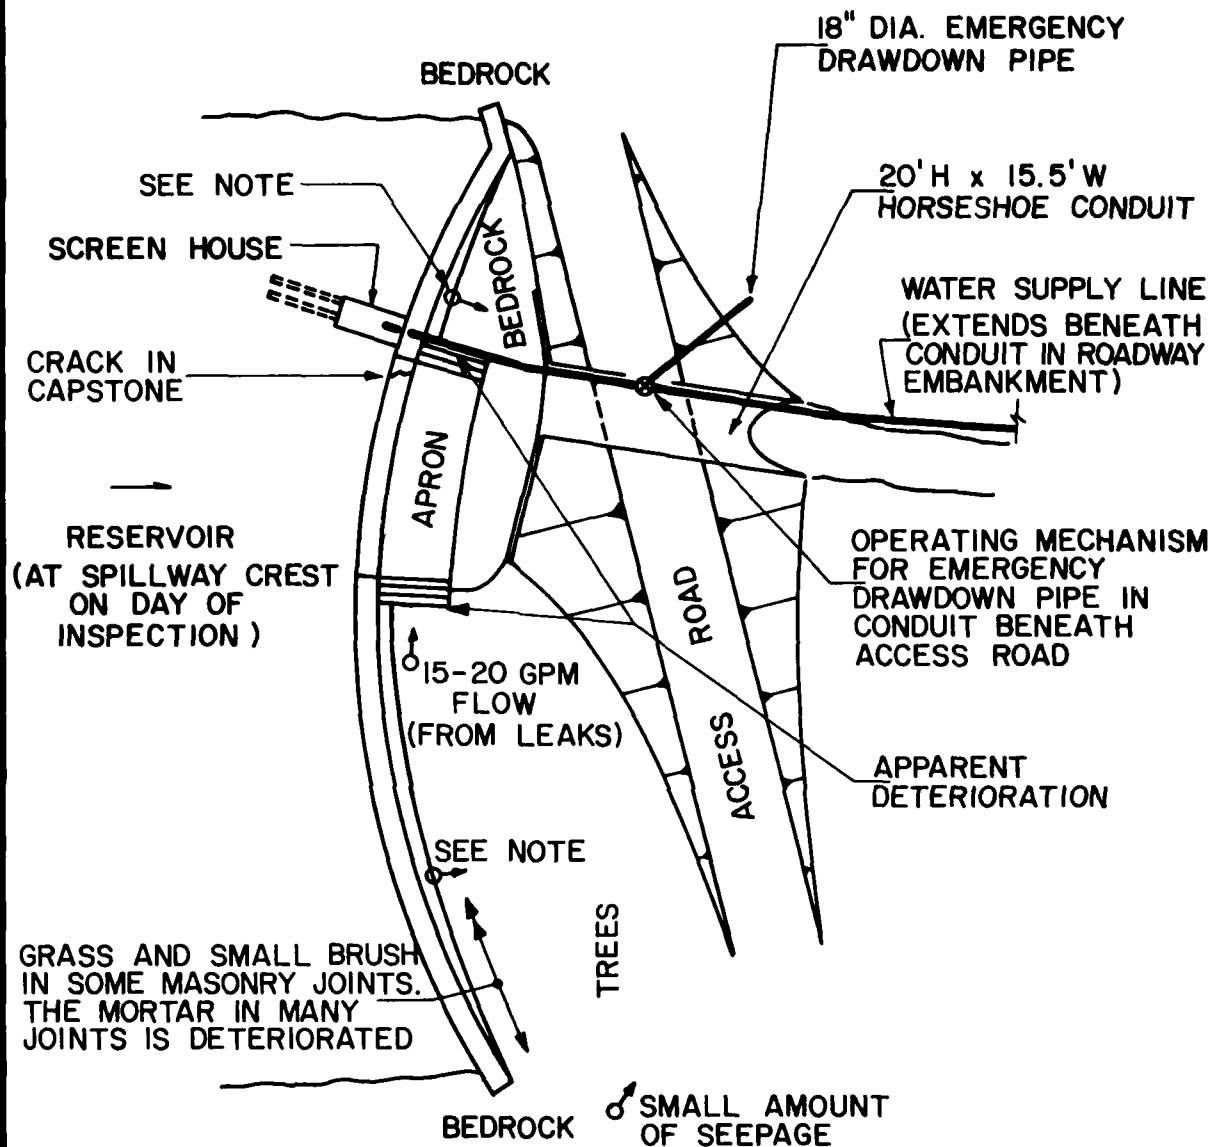
THERE ARE MANY LEAKS IN THE MASONRY JOINTS OF THE DAM. THE LARGEST LEAK WAS ESTIMATED AT 100 GPM +.

(3) Monitor the leakage at the masonry joints of the dam. If a significant increase in the leakage is noted, take appropriate action as required.
