CLAYSVILLE No. 1 DAM

NDI No. PA 00491  
PennDER No. 63-35

PHASE I INSPECTION REPORT  
NATIONAL DAM INSPECTION PROGRAM

MICHAEL BAKER, JR., INC.

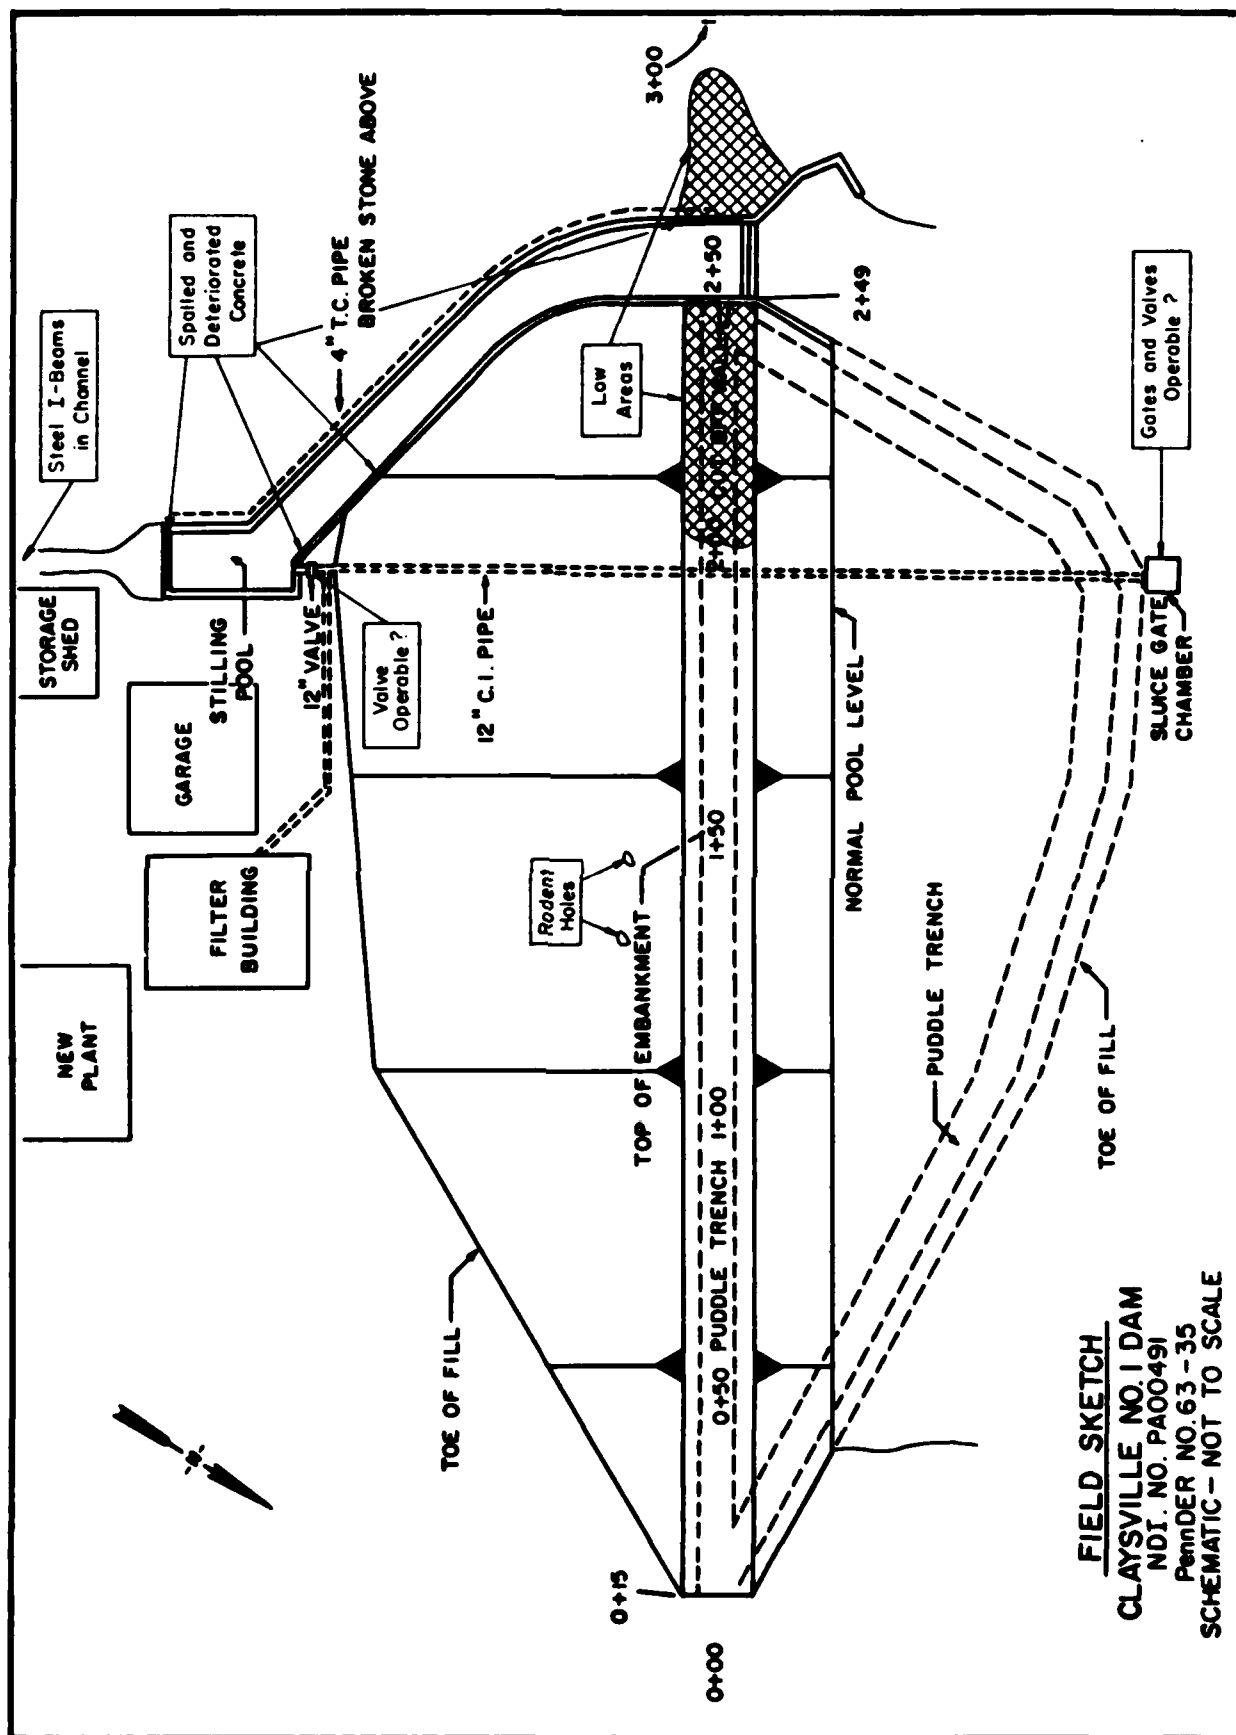
FIELD SKETCH  
 CLAYSVILLE NO. 1 DAM  
 NDI. NO. PA00491  
 PENNER NO. 63-35  
 SCHEMATIC - NOT TO SCALE

| VISUAL EXAMINATION OF | OBSERVATIONS | REMARKS OR RECOMMENDATIONS |
|---|---|---|
| ANIMAL BURROWS/<br>RODENT HOLES | <p>Two animal borrows/rodent holes were observed at Station 1 + 33 and 1 + 49 (the stationing using during the visual inspection is shown on the field sketch), approximately 10 ft. below the crest of the dam.</p> | <p>These animal burrows/rodent holes should be filled.</p> |
