LEBANON RESERVOIR DAM No. 1

Number  
NDI ID. PA-00595,  
PENNDER ID. No. 38-1.

Susquehanna River Basin, West Branch of  
Hammer Creek, Lebanon County, Pennsylvania.  
PHASE I INSPECTION REPORT,  
NATIONAL DAM INSPECTION PROGRAM

GAI CONSULTANTS, INC.  
570 BEATTY ROAD  
MONROEVILLE, PENNSYLVANIA 15146

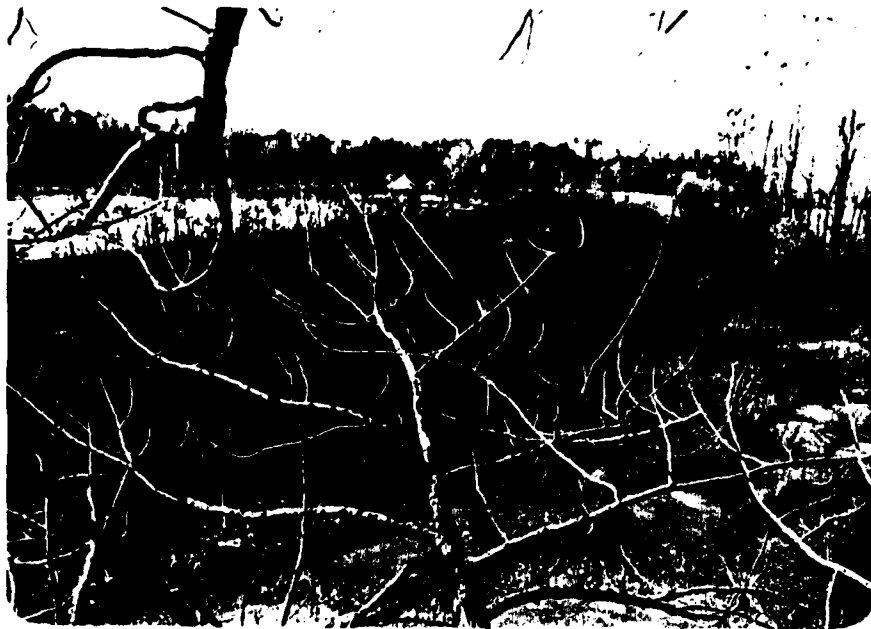
Downstream Face

b. Embankment. Based on observations made during the visual inspection, the embankment is considered to be in fair condition. No evidence of seepage through the downstream embankment face or signs of slope distress were observed. The entire embankment, however, is heavily overgrown and lacks adequate maintenance (see Overview Photographs). At least two small rodent burrows were encountered along the downstream embankment face near the chlorination house. The riprap provided across the upstream embankment face is patchy; however, no evidence of significant erosion was observed.

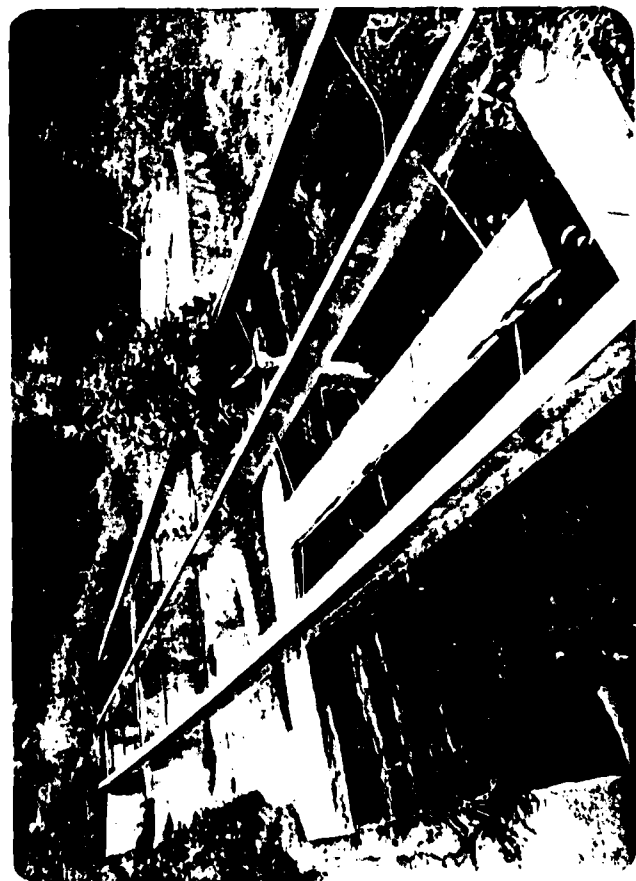
1. Service Spillway. The service spillway (see Photograph 3) is considered to be in good condition. No evidence of concrete or masonry deterioration was observed.

PHOTOGRAPH 3 View of the spillways as seen from atop the right wingwall of the service spillway.

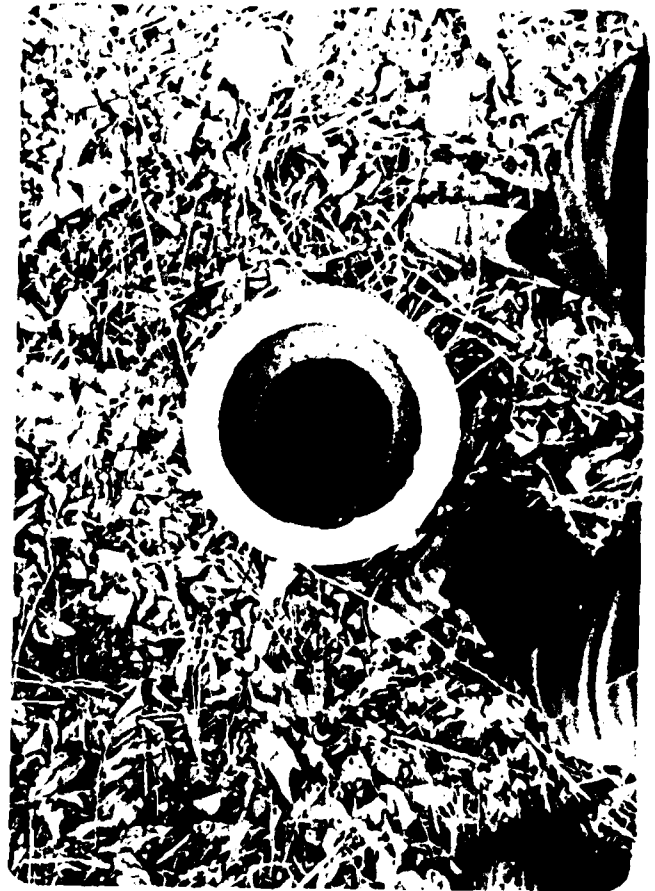
through the conduit is controlled by a valve located about midway along the downstream slope and to the right (looking downstream) of the chamber. Operation of the upstream valve is provided through a curb box opening (see Photograph 8). Some minor seepage ( $\approx$  2 gpm) was observed around the conduit at the base of the chamber.

PHOTOGRAPH 8 View of the curb box accessing the stem of an outlet conduit valve near the middle of the downstream slope to the right (looking downstream) of the valve chamber.

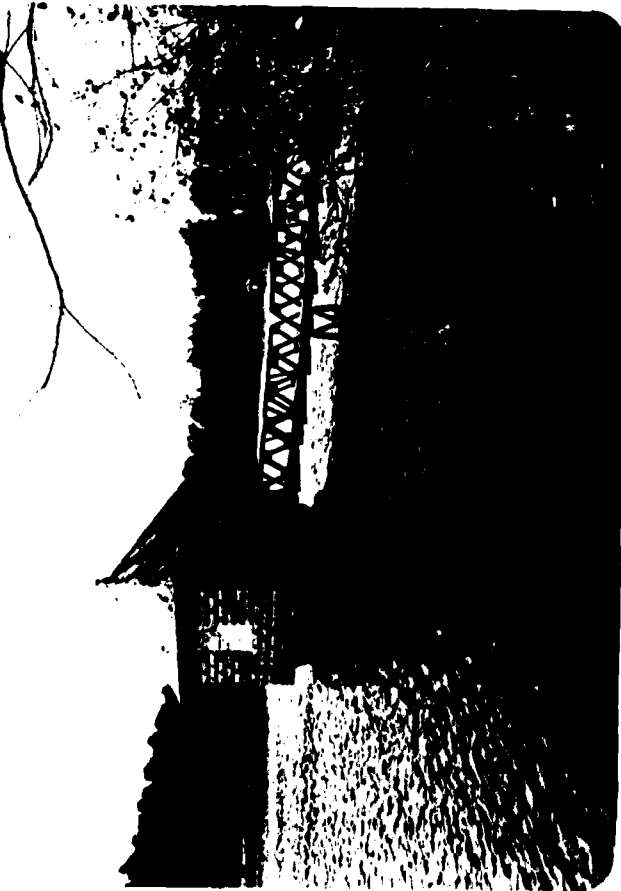
PHOTOGRAPH 5 View of the boarded-up masonry gate house located along the upstream embankment slope.

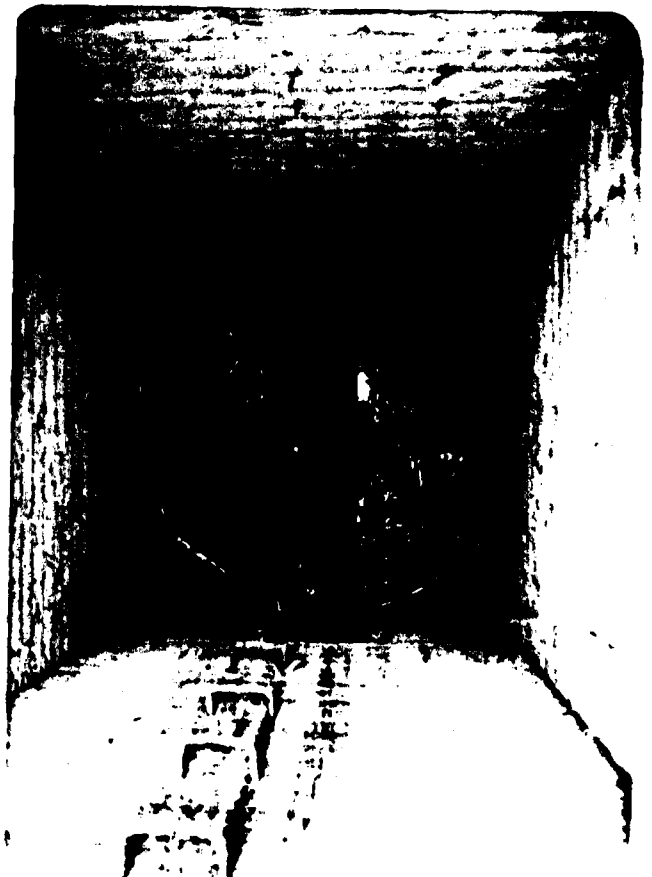
3. Outlet Conduit. The outlet conduit is reportedly functional; however, it was not operated in the presence of the inspection team. Minor seepage ( $\approx 2$  gpm) was observed emanating around the conduit within the downstream valve chamber. This condition should be specifically addressed in future inspection and changes in flow rate and/or turbidity recorded. It is noted that control is not provided at the upstream end of the pipe. Should a leak or rupture develop within the conduit upstream of the gate valve along the downstream slope, there presently is no means of stopping the flow and thus, it is possible that serious erosion and/or instability could result.

PHOTOGRAPH 7 View of the interior of the valve chamber located at the downstream embankment toe. Leakage observed around the outlet conduit within the chamber was estimated at about 2 gpm. The valve within the chamber is reportedly inoperable.

f. Provide upstream (inlet end) control of flow through the outlet conduit or develop a plan to control flow through the conduit at the inlet in the event emergency conditions develop in the pipe within the embankment.
