KENDA DAM  
WESTMORELAND COUNTY, COMMONWEALTH OF PENNSYLVANIA

(NDI No. PA 00459,  
PennDER No. 65-118), Old River Bridge  
Number

PHASE I INSPECTION REPORT  
NATIONAL DAM SAFETY PROGRAM

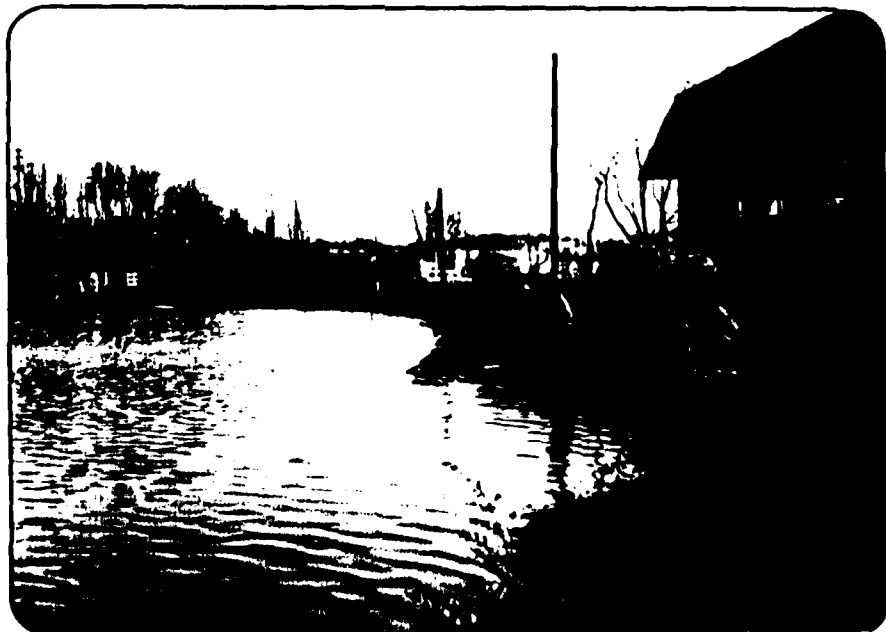
**View of Upstream Side of Dam from the Right Abutment**
