COAL DAM

NDI No. PA 00464
PennDER No. 65-45

PHASE I INSPECTION REPORT
NATIONAL DAM INSPECTION PROGRAM

Coal Dam, Westmoreland County, Pennsylvania
NDI No. PA 00464, PennDER No. 65-45
Tributary of Brush Creek
Inspected 14 December 1979

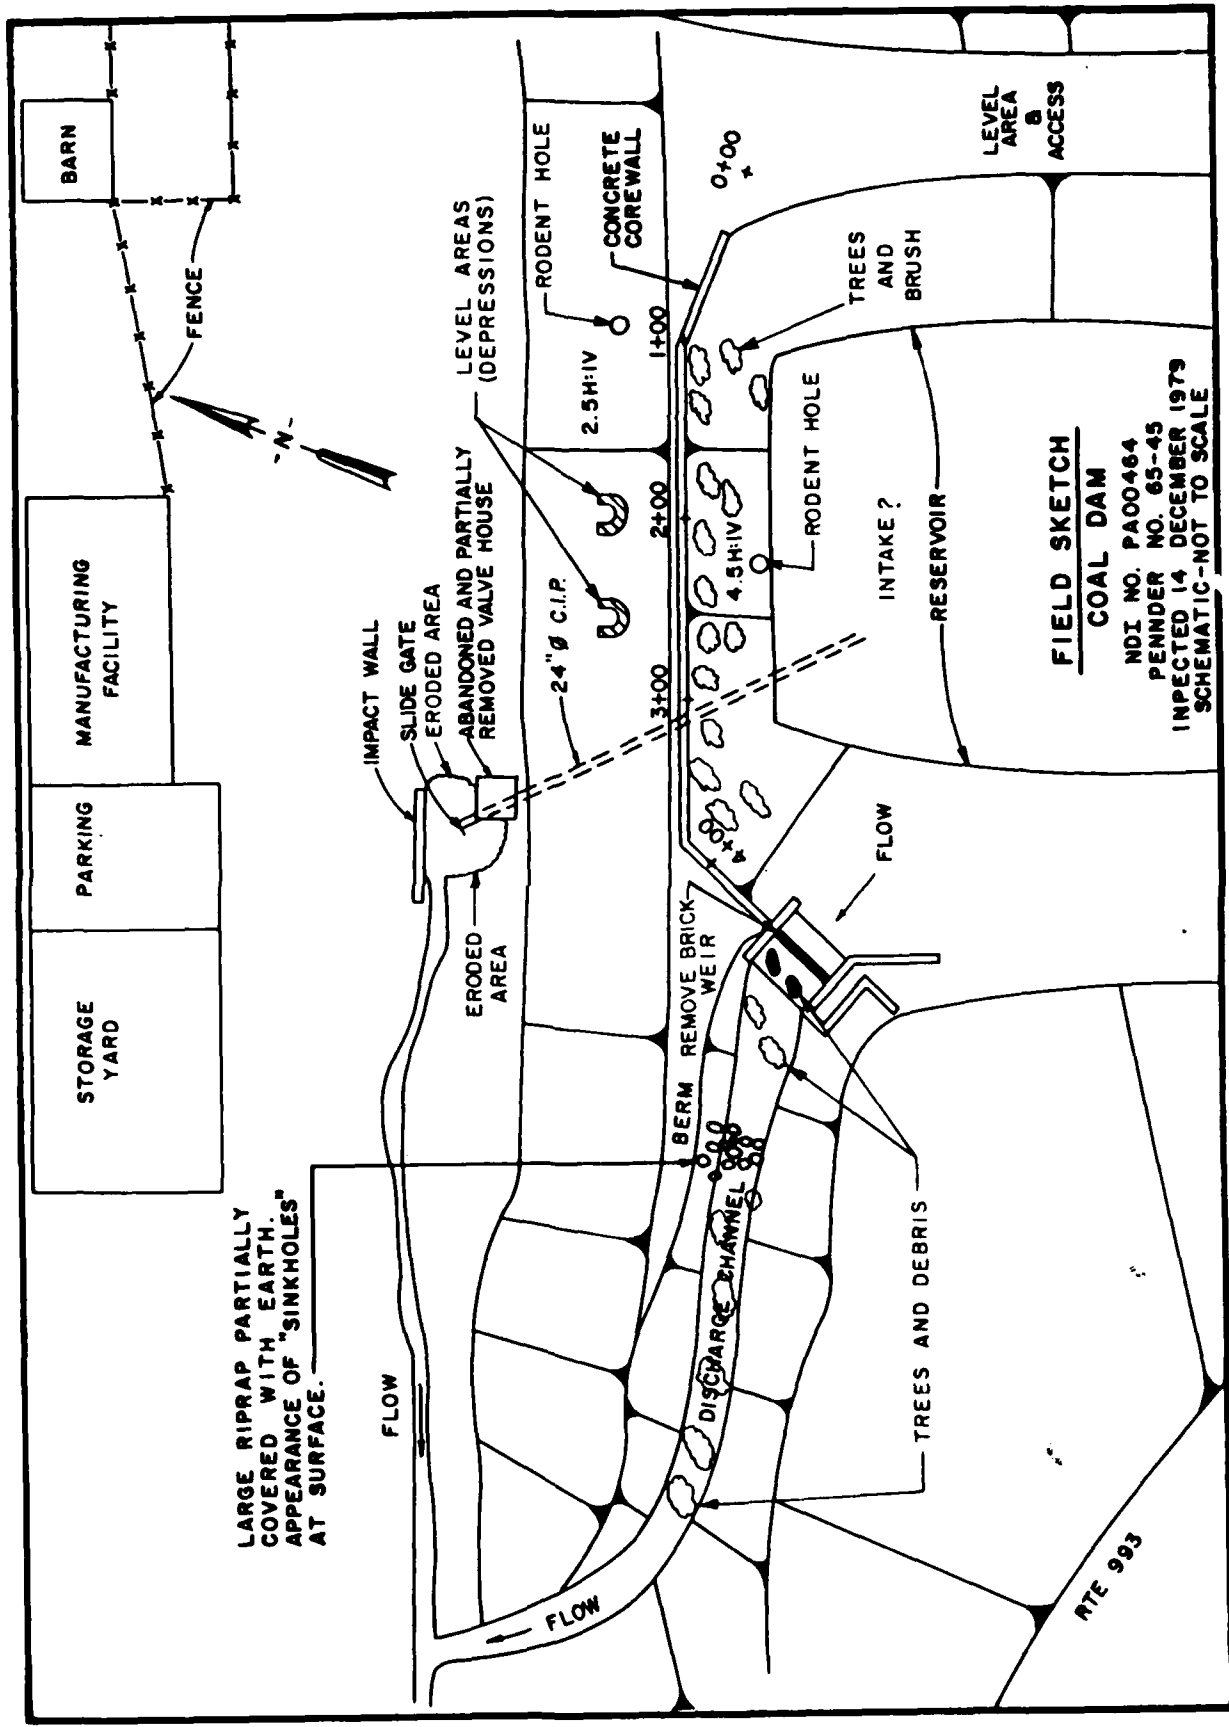
FIELD SKETCH
COAL DAM

LARGE RIPRAP PARTIALLY COVERED WITH EARTH. APPEARANCE OF "SINKHOLES" AT SURFACE.
