# PINE RUN DAM (PA 491)

NDI No. PA 00737  
PennDER No. 43-55  
SCS No. PA 491

## PHASE I INSPECTION REPORT NATIONAL DAM INSPECTION PROGRAM

May 1980

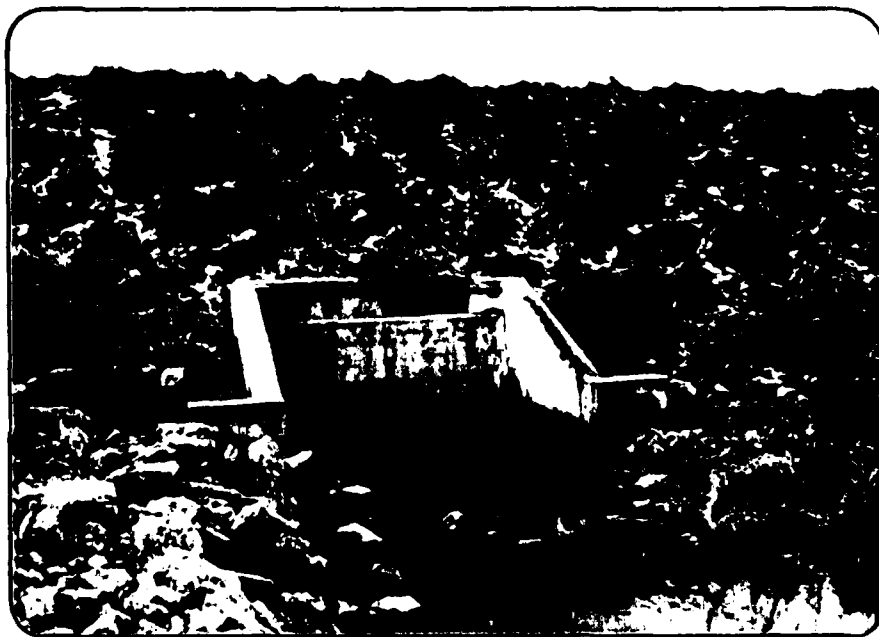
| VISUAL EXAMINATION OF | OBSERVATIONS | REMARKS OR RECOMMENDATIONS |
|---|---|---|
| OUTLET STRUCTURE | The concrete impact basin was in good<br>condition. | |

**PHOTO 2. View of the Principal Spillway Outlet Structure**
