LAKE JO-ANN DAM (BRACCO DAM)  
WASHINGTON COUNTY, COMMONWEALTH OF PENNSYLVANIA  
NDI No. PA 00504  
PennDER No. 63-60

PHASE I INSPECTION REPORT  
NATIONAL DAM SAFETY PROGRAM

Prepared by: MICHAEL BAKER, JR., INC.  
Consulting Engineers  
4301 Dutch Ridge Road  
Beaver, Pennsylvania 15009

Lake Jo-Ann Dam, Washington County, Pennsylvania  
NDI No. PA 00504, PennDER No. 63-60  
Inspected 28 March 1980

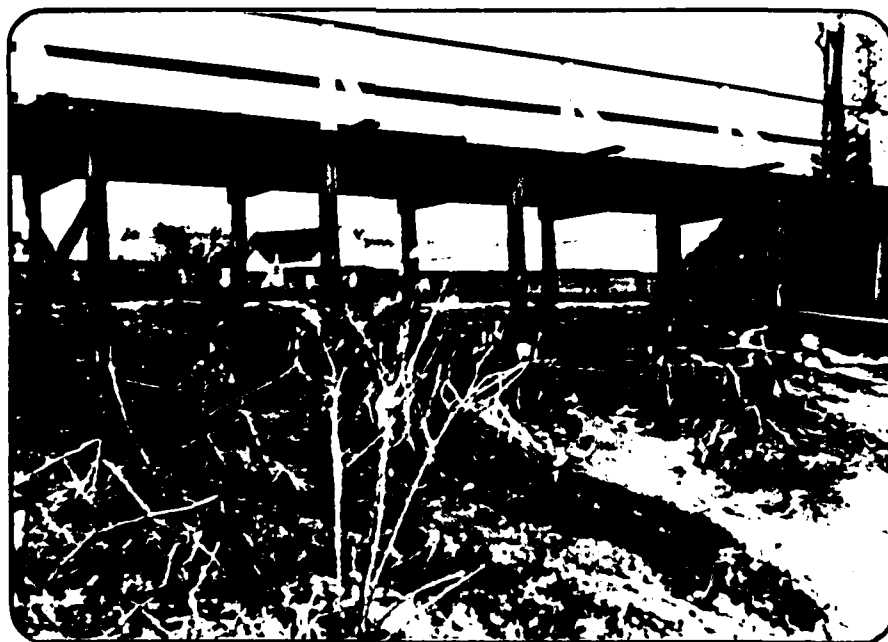
| VISUAL EXAMINATION OF | OBSERVATIONS | REMARKS OR RECOMMENDATIONS |
|---|---|---|
| CONCRETE WEIR | The weir is in fair condition. There are some surface irregularities and minor spalling on the downstream face of the weir. | Repair the spalled areas. |

**PHOTO 4. View of the Spillway Looking Upstream**
