POLK DAM

NDI No. PA 00253  
PennDER No. 61-7

PHASE I INSPECTION REPORT  
NATIONAL DAM INSPECTION PROGRAM

Polk Dam, Venango County, Pennsylvania  
NDI No. PA 00253, PennDER No. 61-7  
Piffer Run of Little Sandy Creek  
Inspected 10 December 1979

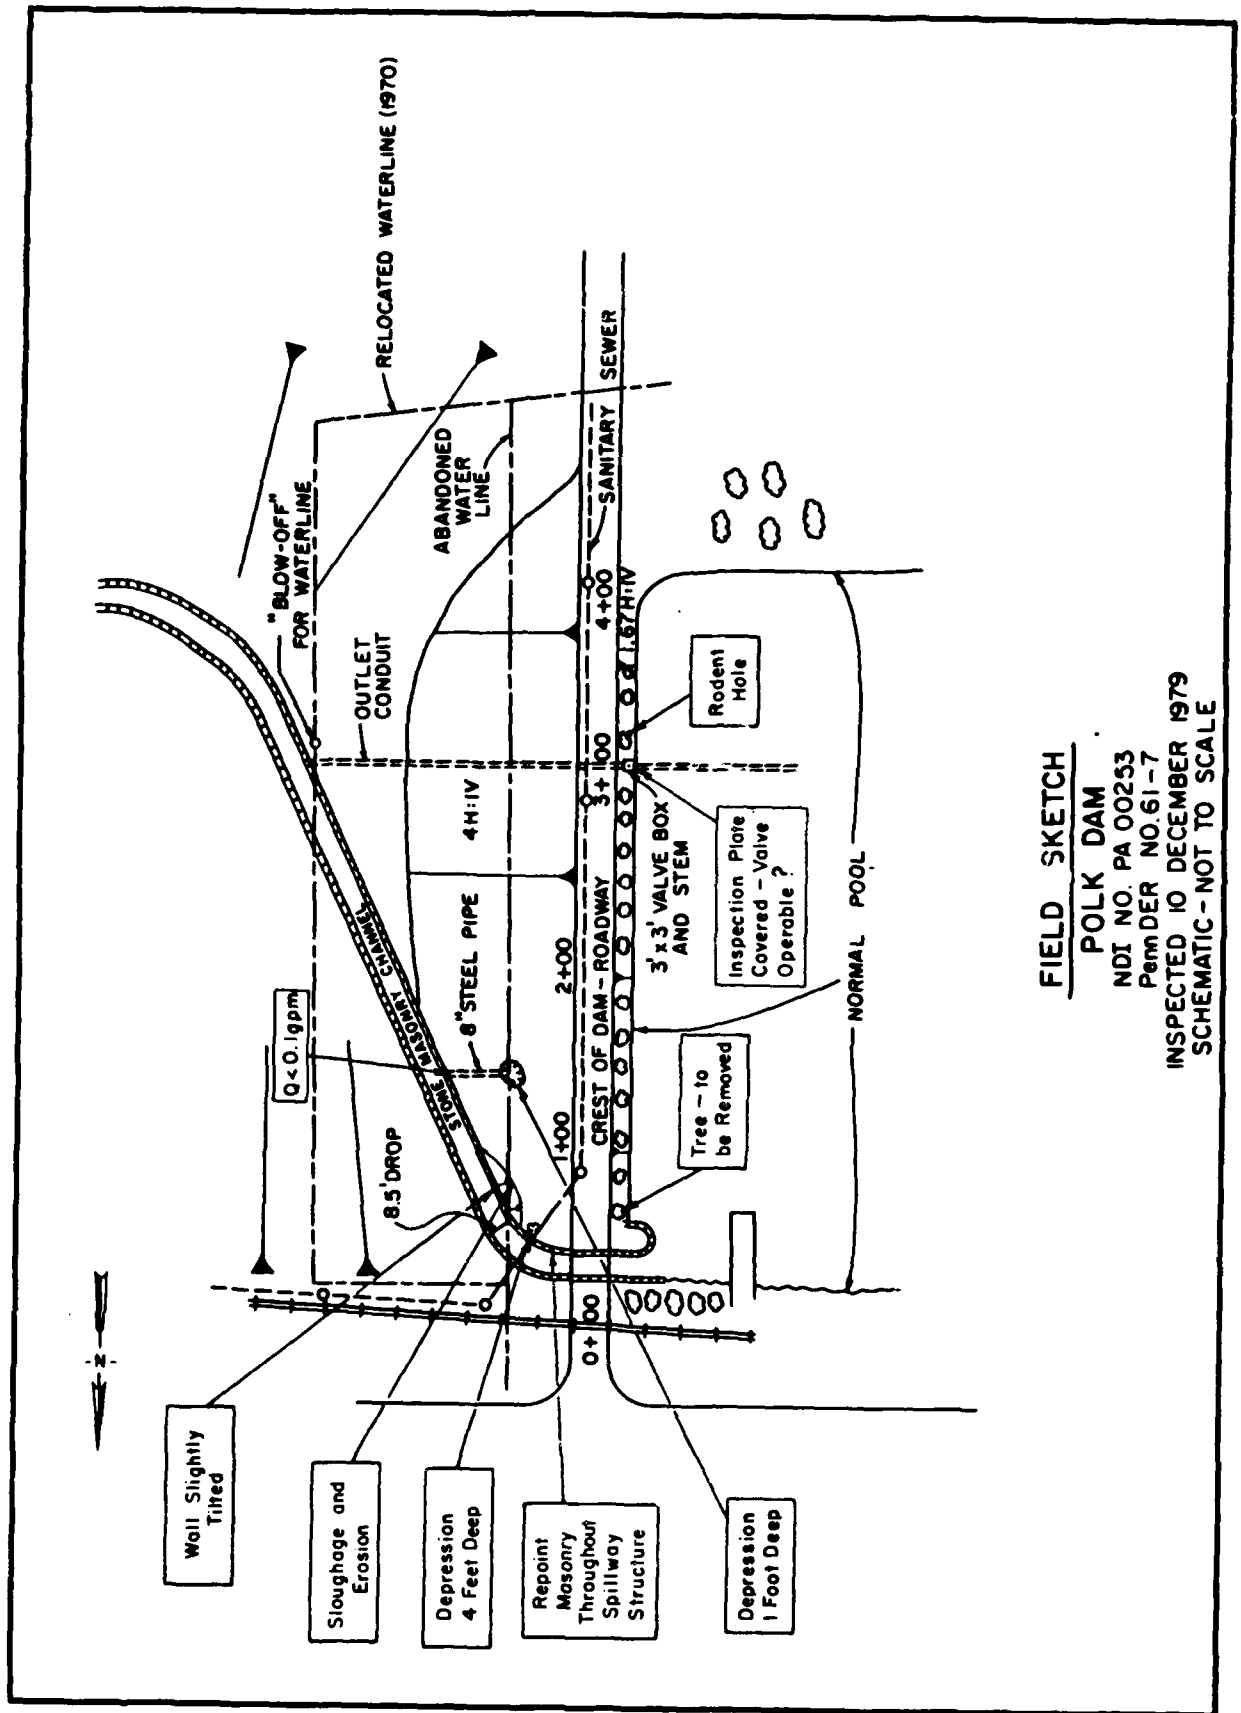
# FIELD SKETCH

| VISUAL EXAMINATION OF | OBSERVATIONS | REMARKS OR RECOMMENDATIONS |
|---|---|---|
| SLOUGHING OR EROSION OF<br>EMBANKMENT AND ABUTMENT<br>SLOPES | A depression 12 in. deep in the embankment was observed at Station 1+40 (see Field Sketch) on the downstream slope. There are several possible reasons for this (1) A waterline valve was removed from this location, (2) A void was left in the slope flattening fill in 1965, (3) A hole was left in the abandoned waterline in the embankment. | The depression should be filled in and graded level with the rest of the slope and observed in the future to see if the depression reoccurs. |

| VISUAL EXAMINATION OF | OBSERVATIONS | REMARKS OR RECOMMENDATIONS |
|---|---|---|
| RODENT HOLES/<br>ANIMAL BURROWS | A rodent hole/animal burrow was observed on the upstream slope to the right of the valve box and under a bush (see Field Sketch). | The rodent hole/animal burrow should be filled. |

| VISUAL EXAMINATION OF | OBSERVATIONS | REMARKS OR RECOMMENDATIONS |
|---|---|---|
| JUNCTION OF EMBANKMENT<br>AND ABUTMENT, SPILLWAY<br>AND DAM | No problems were observed on the left<br>and right abutments. Some erosion has<br>occurred along the junction of the right<br>downstream spillway training wall and<br>the embankment (see Field Sketch for<br>location). | The eroded areas should be<br>filled/repaired. |
