DELAWARE RIVER BASIN
TRIBUTARY TO MAIDEN CREEK
BERKS COUNTY
PENNSYLVANIA
NDS ID PA. 00721
DER ID 6-460

CHRISTMAN DAM

PHASE I INSPECTION REPORT NATIONAL DAM INSPECTION PROGRAM

MARCH 1980

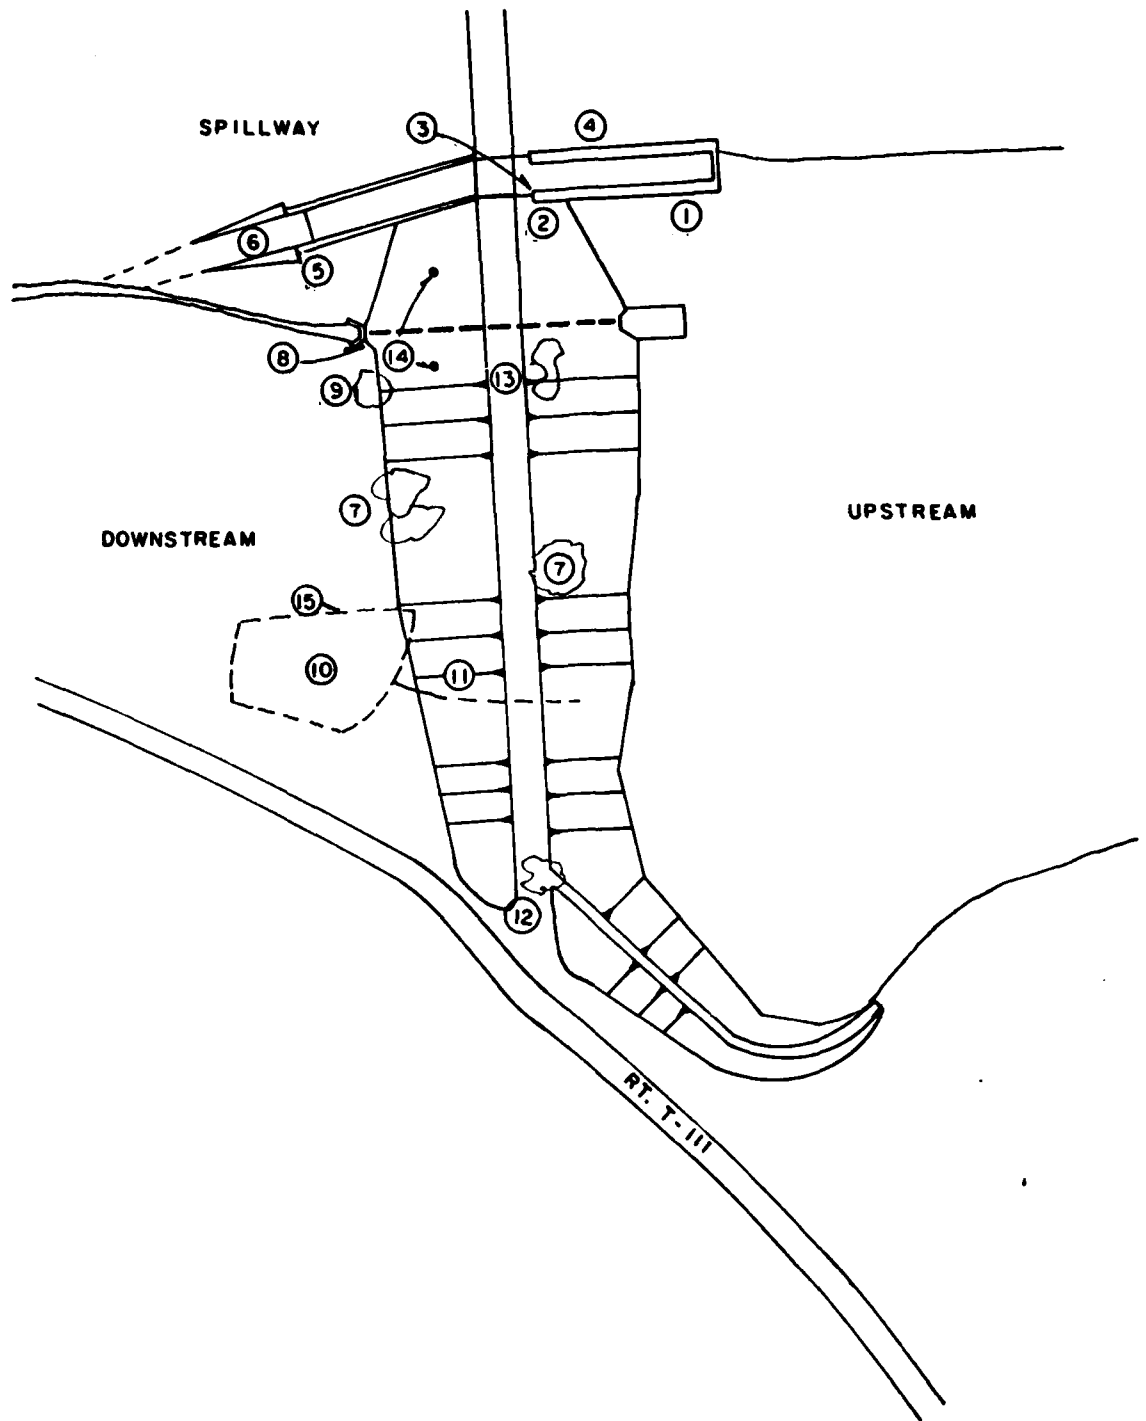
SHEET 5B OF 11

- ⑫ Access road not built as shown. (See Overview Photograph).
- ⑬ Crest is lower than design elevation for more than 350 feet.
- ⑭ Piezometers installed, embankment damaged and should be repaired. (See Photographs No. 8 and 9).

- ⑮ Seepage emerging from base of fish pond embankment.

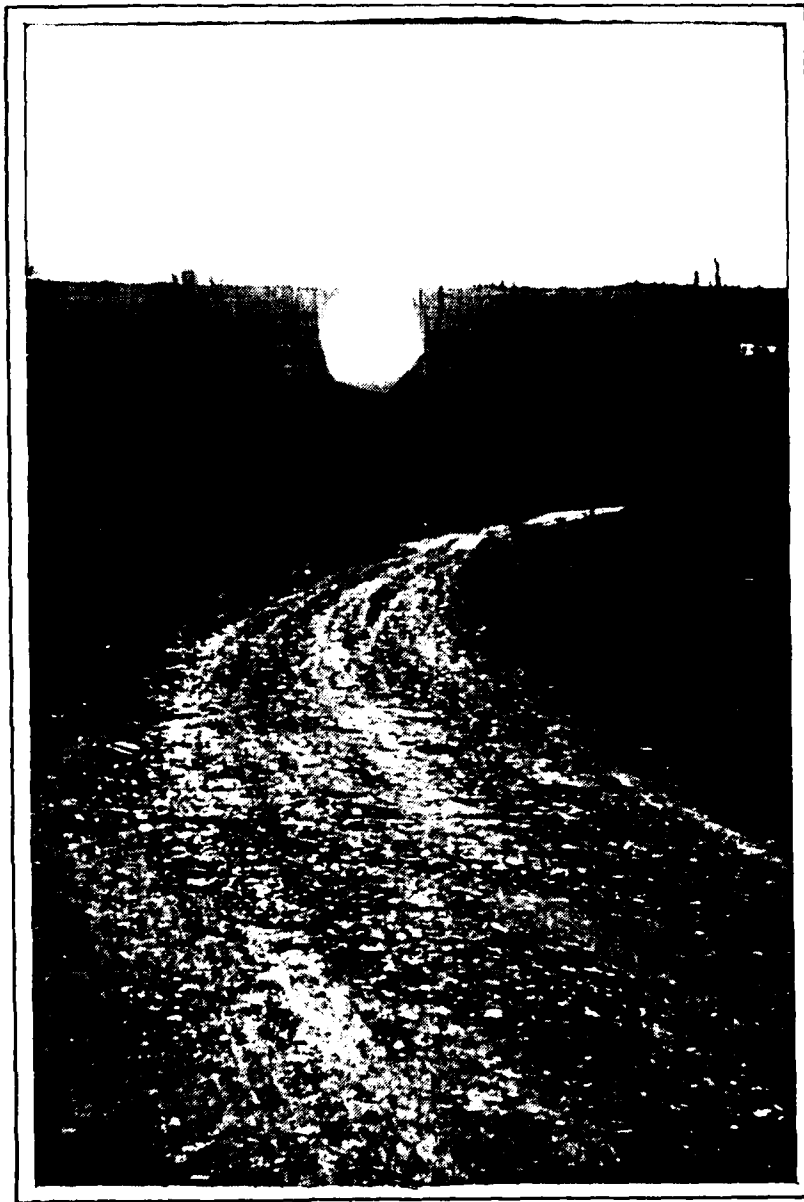
PHOTOGRAPH NO. 6

ROADWAY OVER DAM. GRAVEL
WAS RECENTLY ADDED TO A LOW
SPOT.
