DELAWARE RIVER BASIN
DEEP CREEK, MONTGOMERY COUNTY
PENNSYLVANIA
NDS ID PA. 00200
DER ID 46-8

DEEP CREEK DAM

PHASE I INSPECTION REPORT NATIONAL DAM INSPECTION PROGRAM

WOODWARD-CLYDE CONSULTANTS
DACW31-80-C-0018

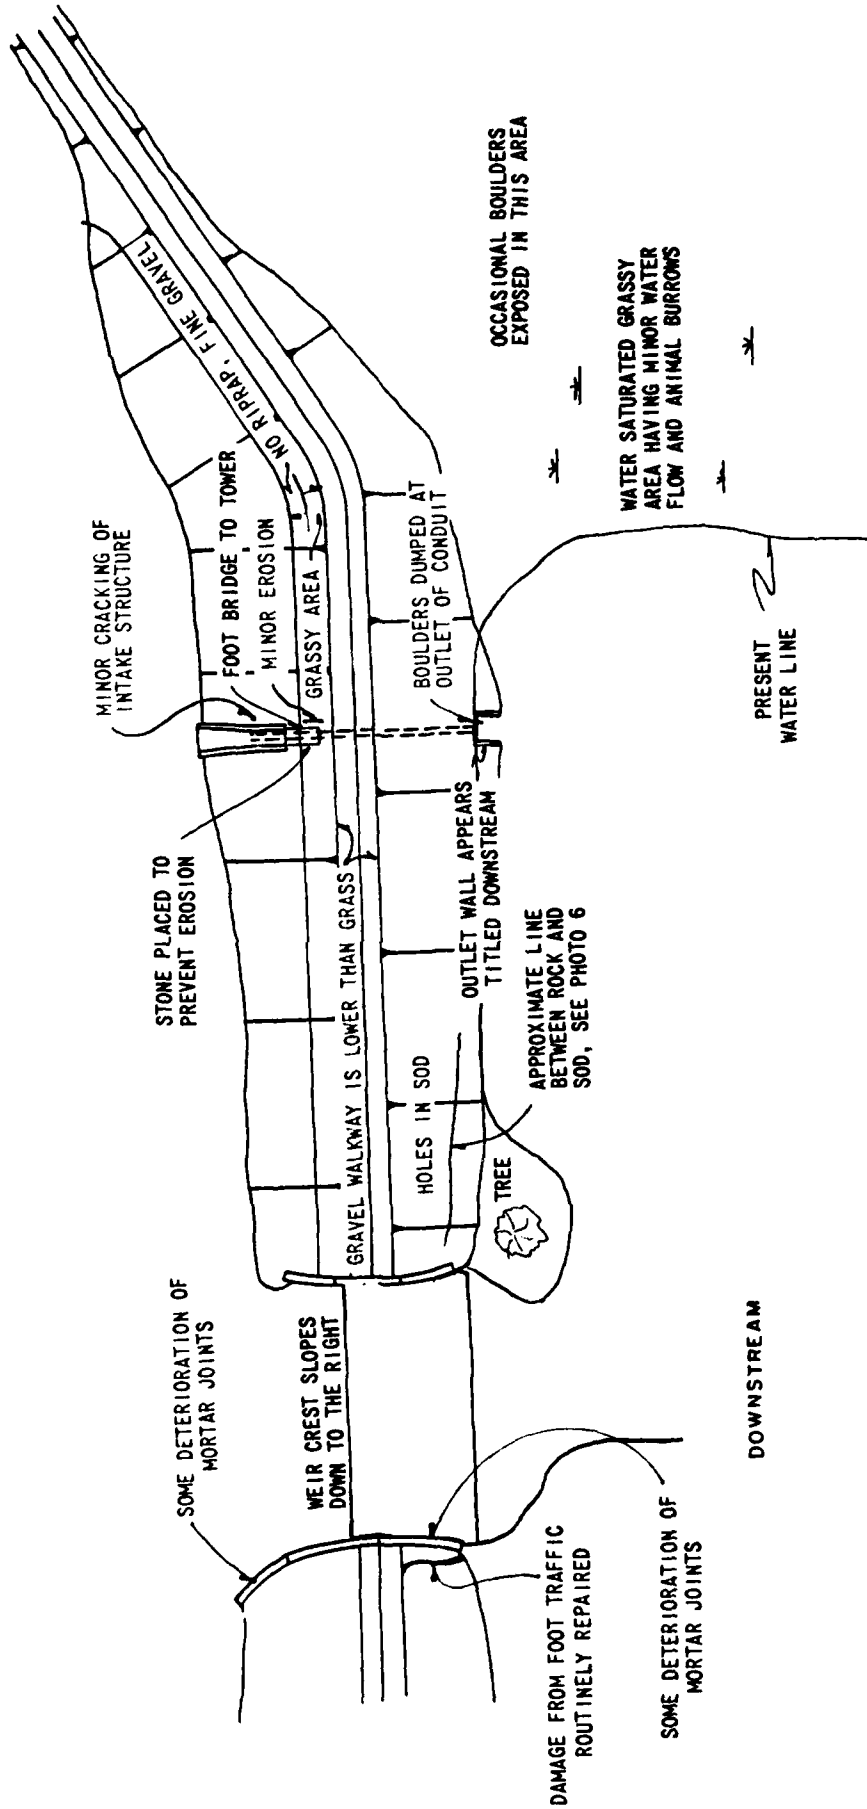
FIELD OBSERVATION PLAN
 DEEP CREEK DAM
 SHEET 5A OF 11

Seepage noted at left downstream junction, see Sheet 5a of 11.

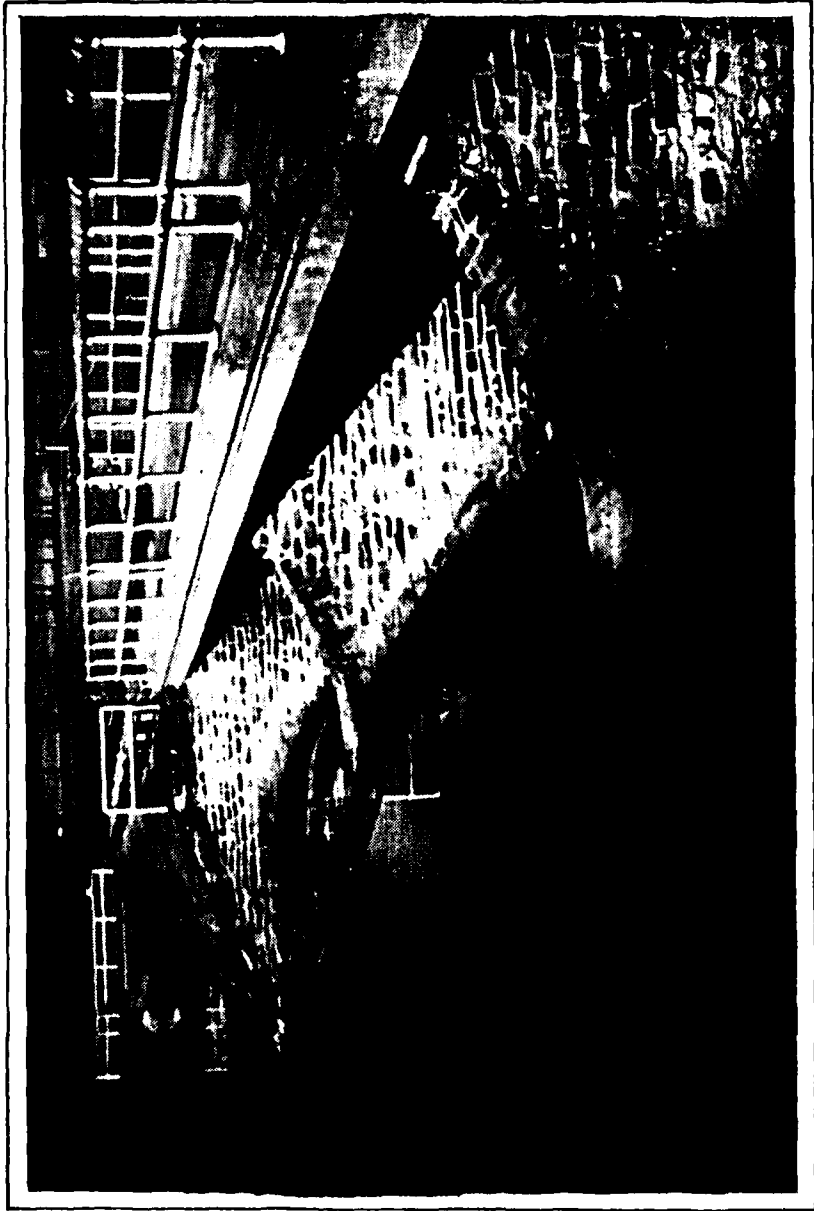
The weir appeared in good condition. The weir crest sloped uniformly with the right end about 1.3 inches below the left end.

SPELLWAY CREST.

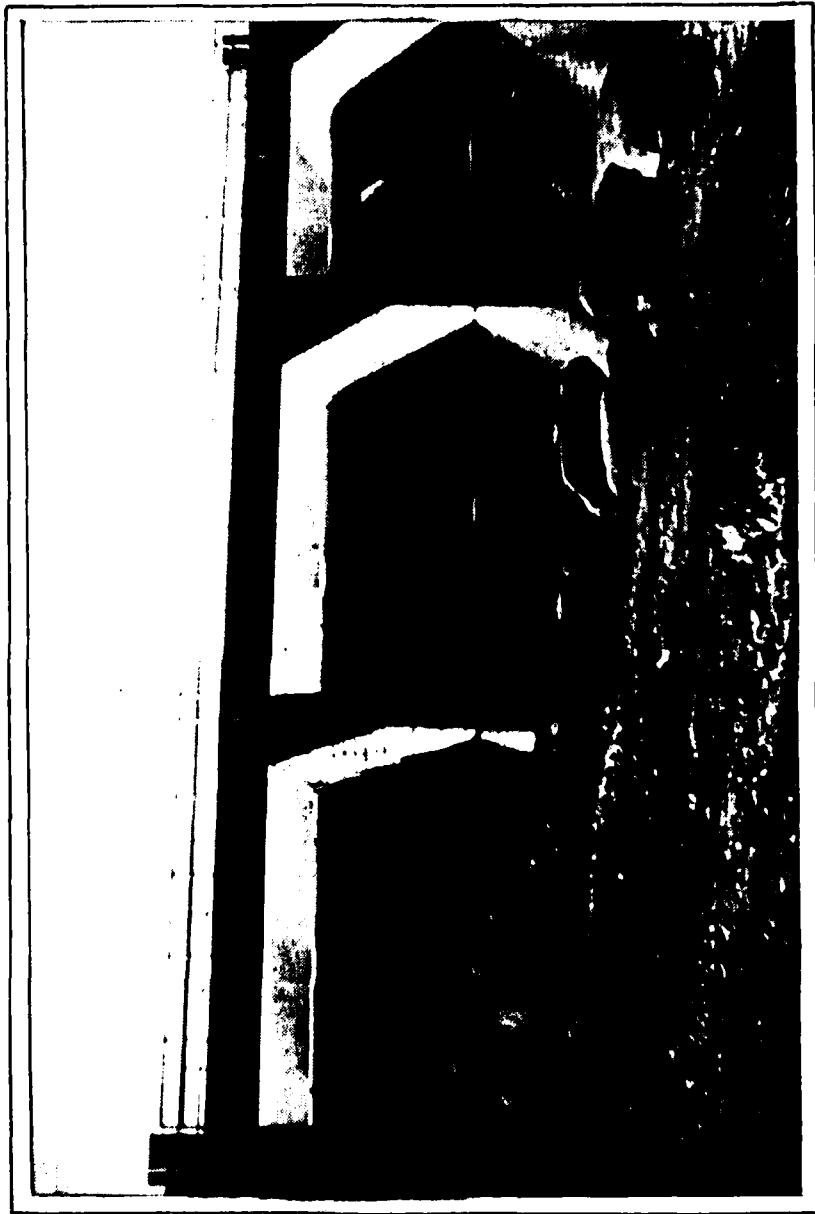
PHOTOGRAPH NO. 2

VIEW OF SPILLWAY FROM DOWNSTREAM.

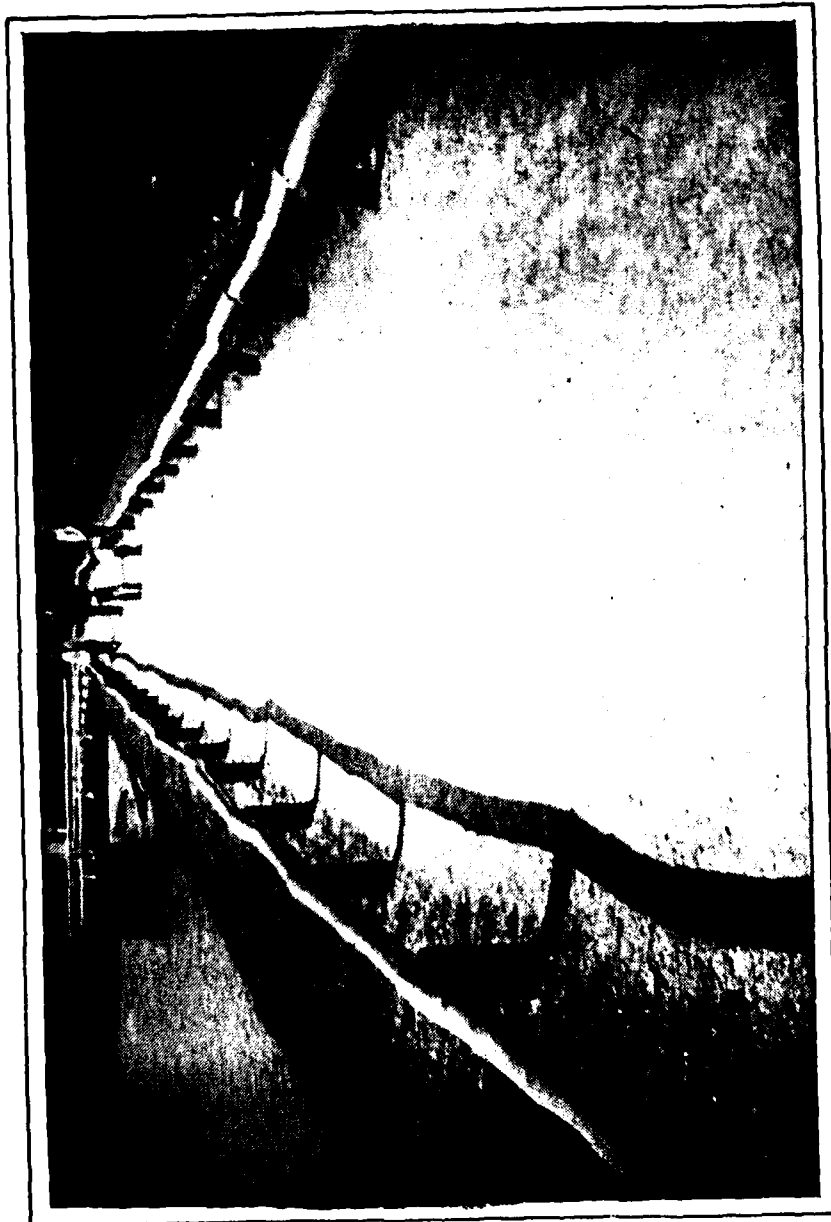
VIEW OF CREST TAKEN WHERE UPSTREAM
EDGE IS ABOUT SIX INCHES ABOVE CREST
CENTERLINE.

- (2) The embankment crest should be restored to its original elevation and crowned to allow surface drainage.
- (3) The right abutment should be raised to the embankment elevation.
- (4) The drainage swale at the left end of the embankment and the downstream slope should be frequently monitored, at least visually, for evidence of uncontrolled seepage through the dam or turbidity in the seepage, and for evidence of rotting timbers within the older timber crib dam.
- (5) The minor erosion under the footbridge to the intake tower should be repaired. Any large stones blocking the pond drain outlet should be removed.

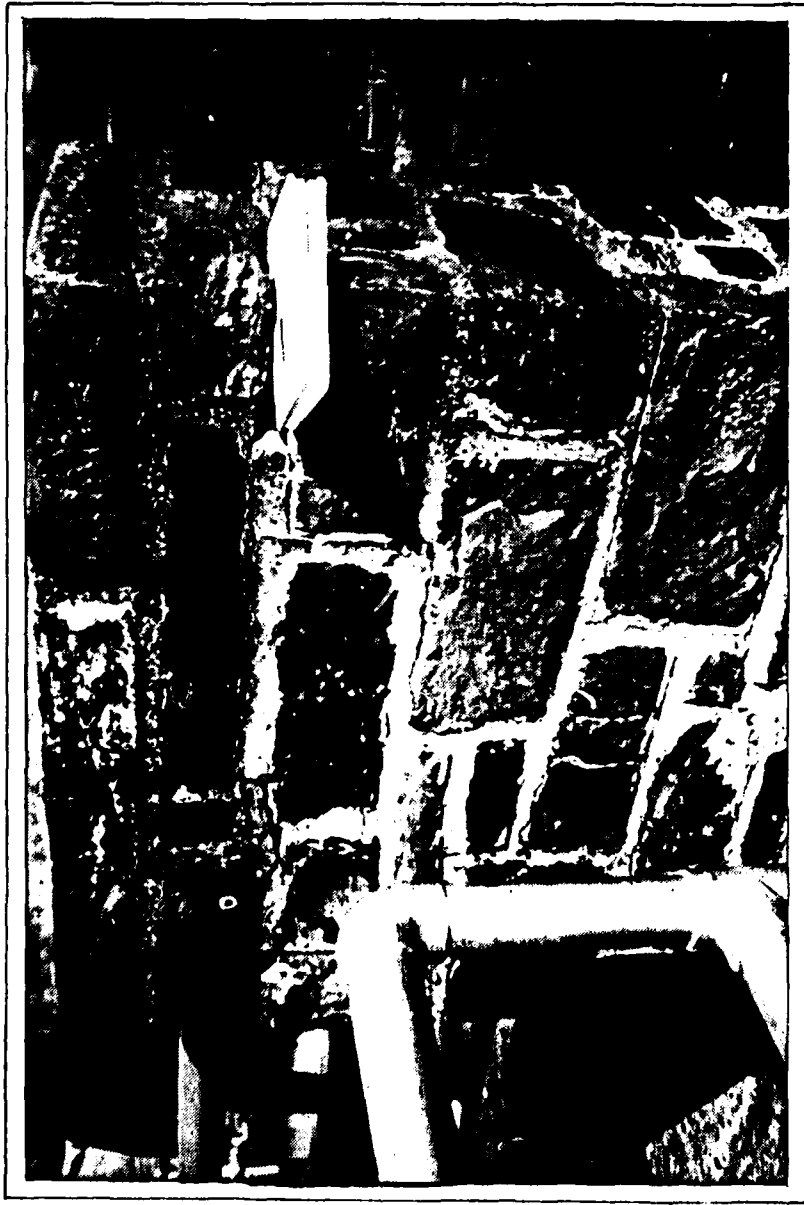
PHOTOGRAPH NO. 10

N/A, the stone walls appear in fairly good condition with some deterioration of the mortar joints.

N/A. spillway discharges directly into downstream lake. The stone masonry shows some joint deterioration. Note: the spillway walls are stone faced concrete.

DETERIORATION OF MOTARED JOINTS.
