AD-A085 269

WOODWARD-CLYDE CONSULTANTS PLYMOUTH MEETING PA F/G 13/13
NATIONAL DAM INSPECTION PROGRAM. MILL WATER DAM (NDS T.D. NUMBE--ETC(U)
MAR 80 M F BECK, J H FREDERICK DACW31-80-C-001A
NL

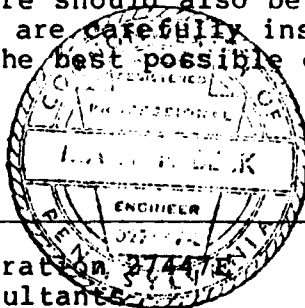
Mary F. Beck
Mary F. Beck, P.E.
Pennsylvania Registration No. 3747E
Woodward-Clyde Consultants

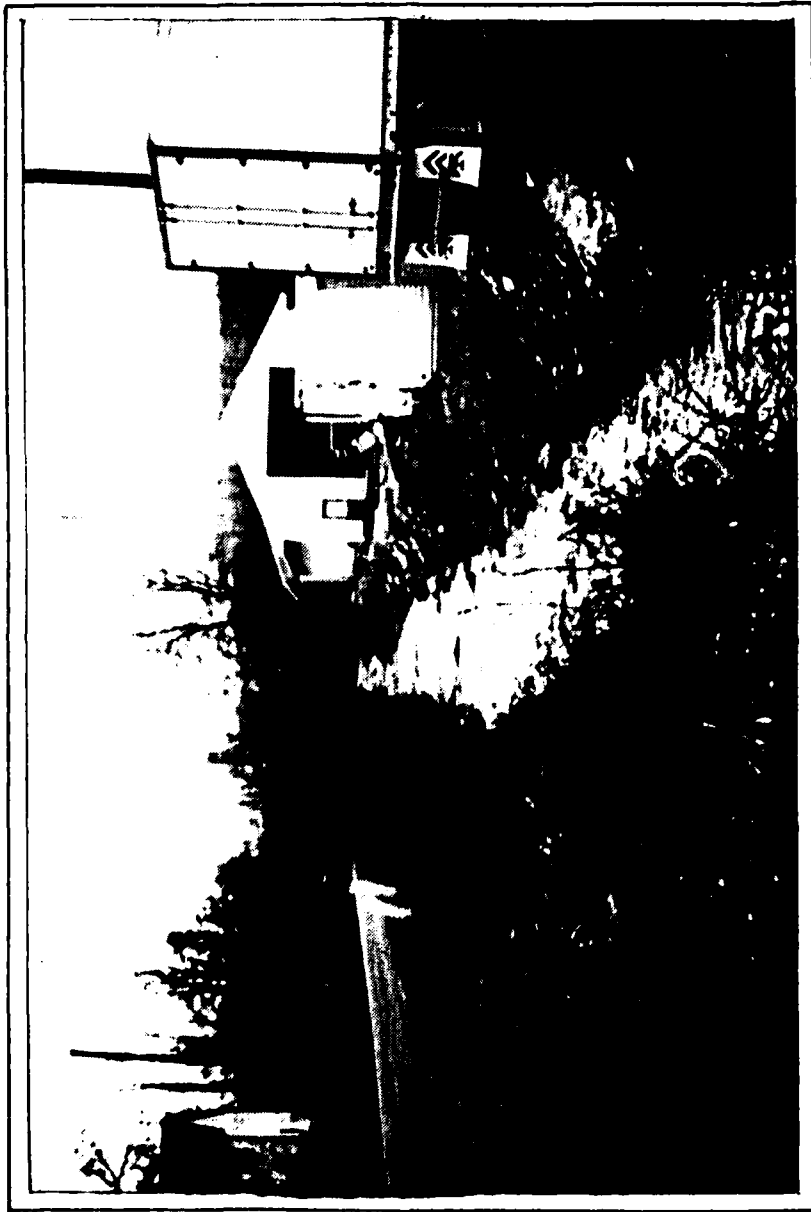
DOWNSTREAM HAZARD CENTER, MORGANTOWN
TRAILER MANUFACTURER.

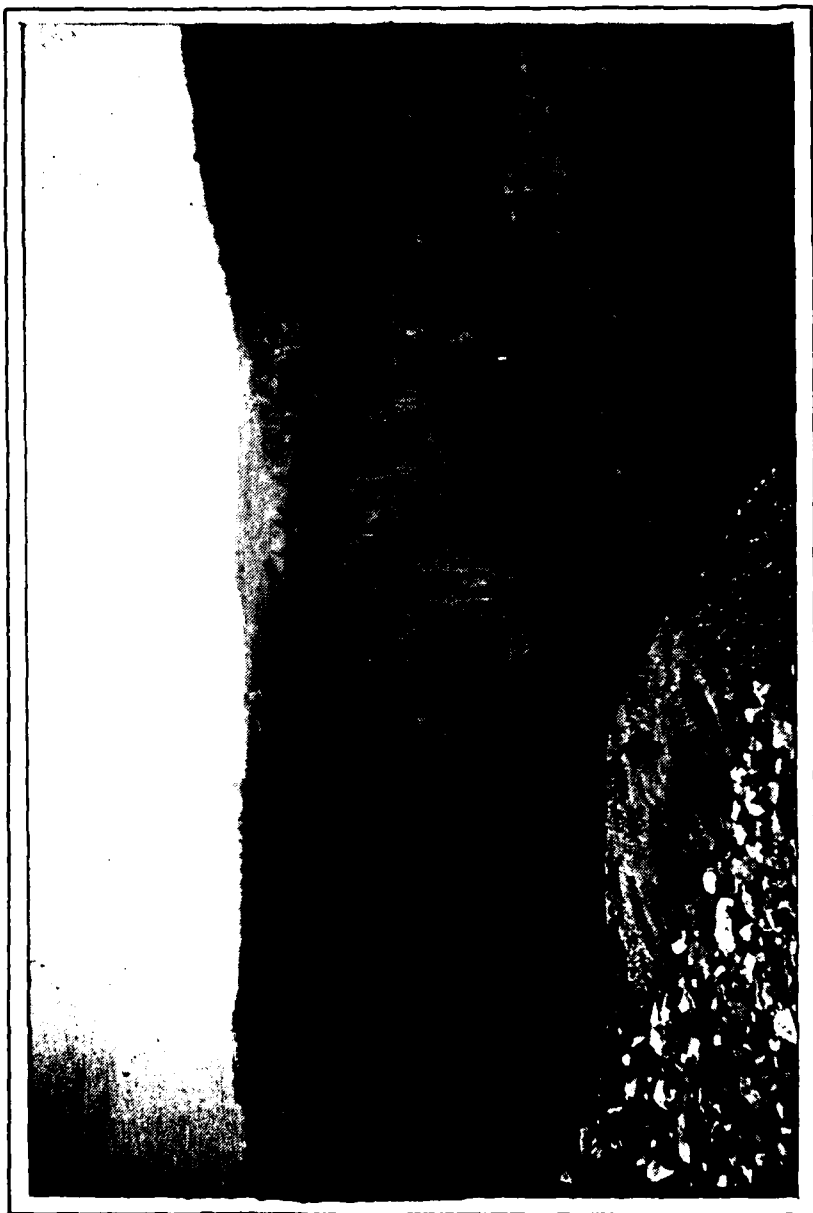
WATERSHED AREA ABOVE THE DAM HAS BEEN
REDUCED AS A RESULT OF SUBSIDENCE
RESULTING FROM THE DEEP IRON ORE MINE.

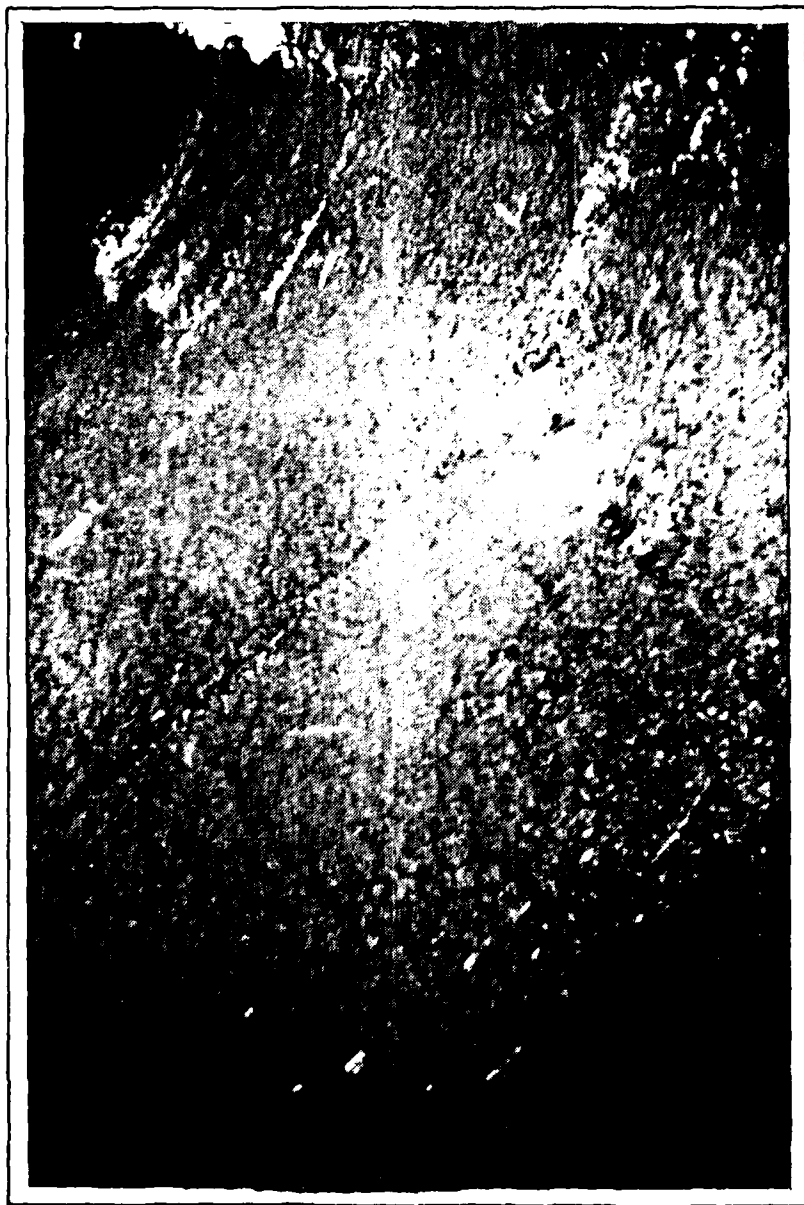
CRACKS AND SURFACE IRREGULATIES AT
BASE OF OGEE WEIR.

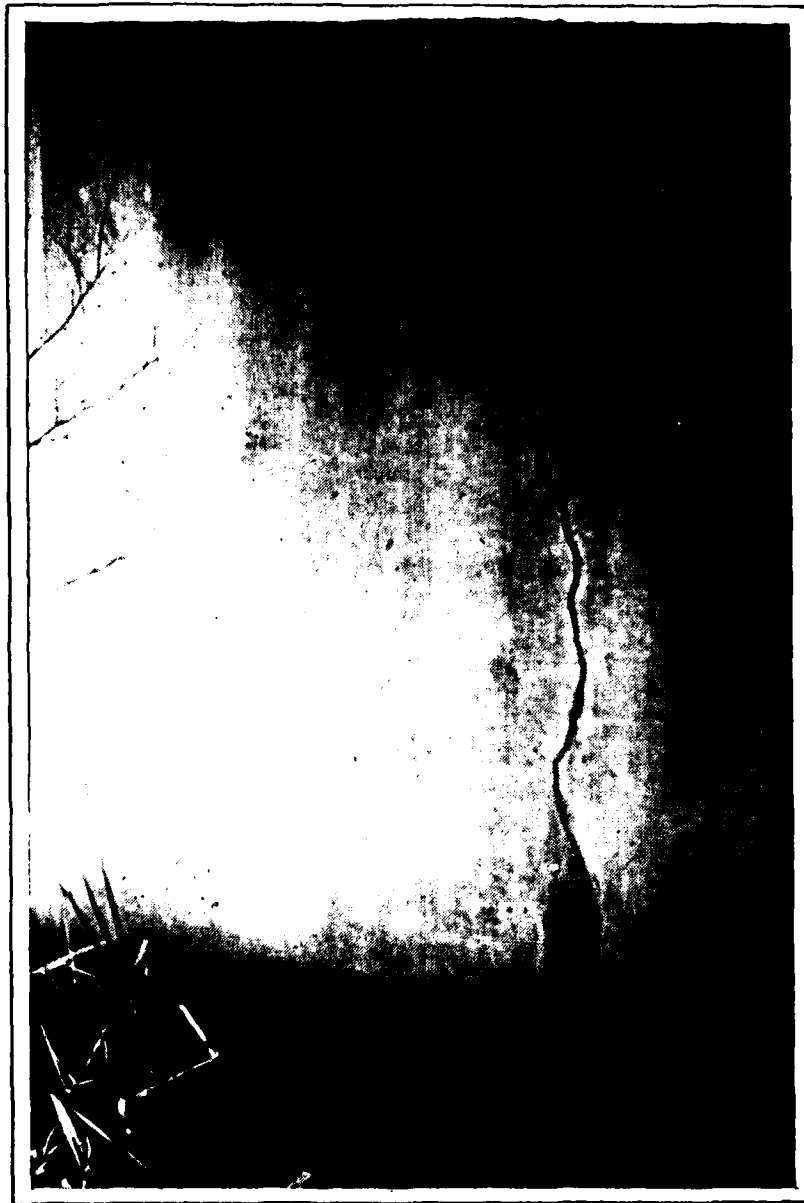
CRACK IN RIGHT BRIDGE ABUTMENT.
THE CRACK IS ABOUT ONE INCH WIDE
AND SIX INCHES DEEP AT THE TOP.

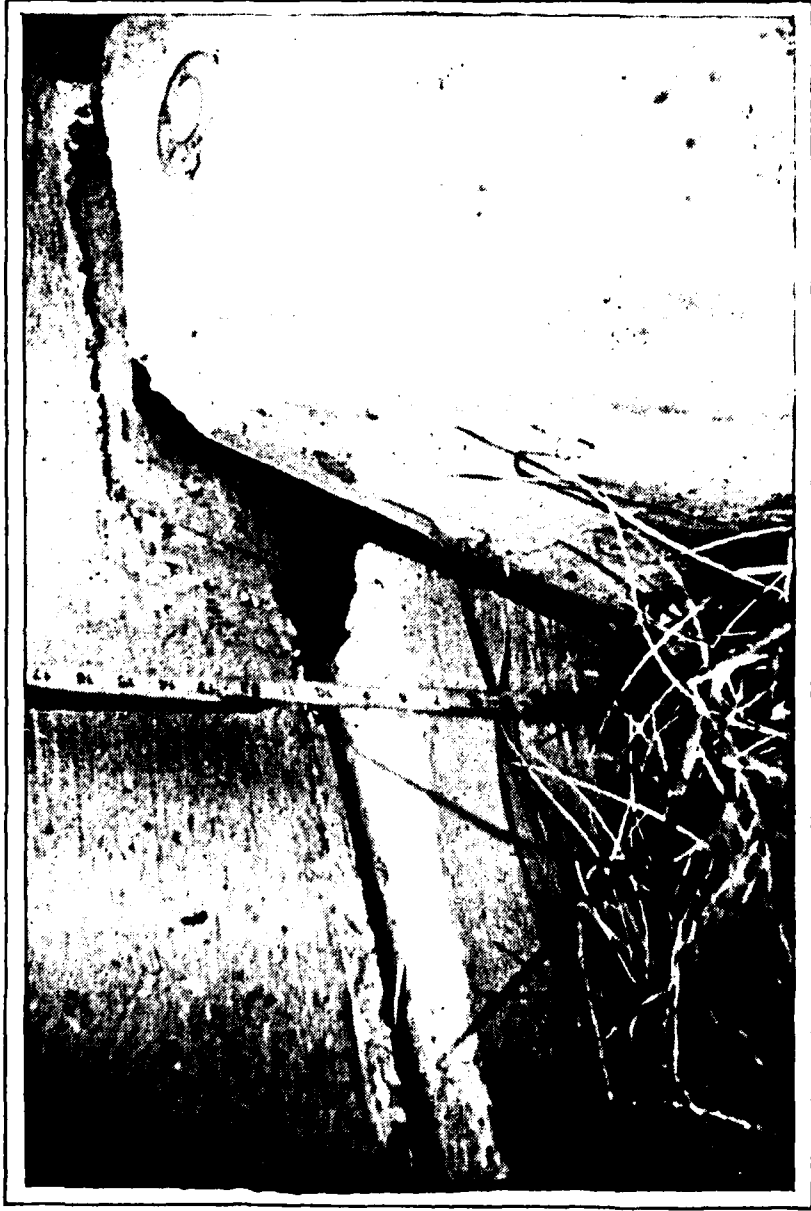
MOVEMENT OF BRIDGE WINGWALL. ALL
FOUR WINGWALLS HAVE MOVED.
