SPRING MILL DAM

LEHIGH COUNTY, PENNSYLVANIA

PHASE I INSPECTION REPORT  
NATIONAL DAM INSPECTION PROGRAM

Name of Dam: Spring Mill Dam  
County Located: Lehigh County  
State Located: Pennsylvania  
Stream: Spring Creek  
Coordinates: Latitude 40° 42.0'  
Longitude 75° 31.1'  
Date of Inspection: November 16, 1979

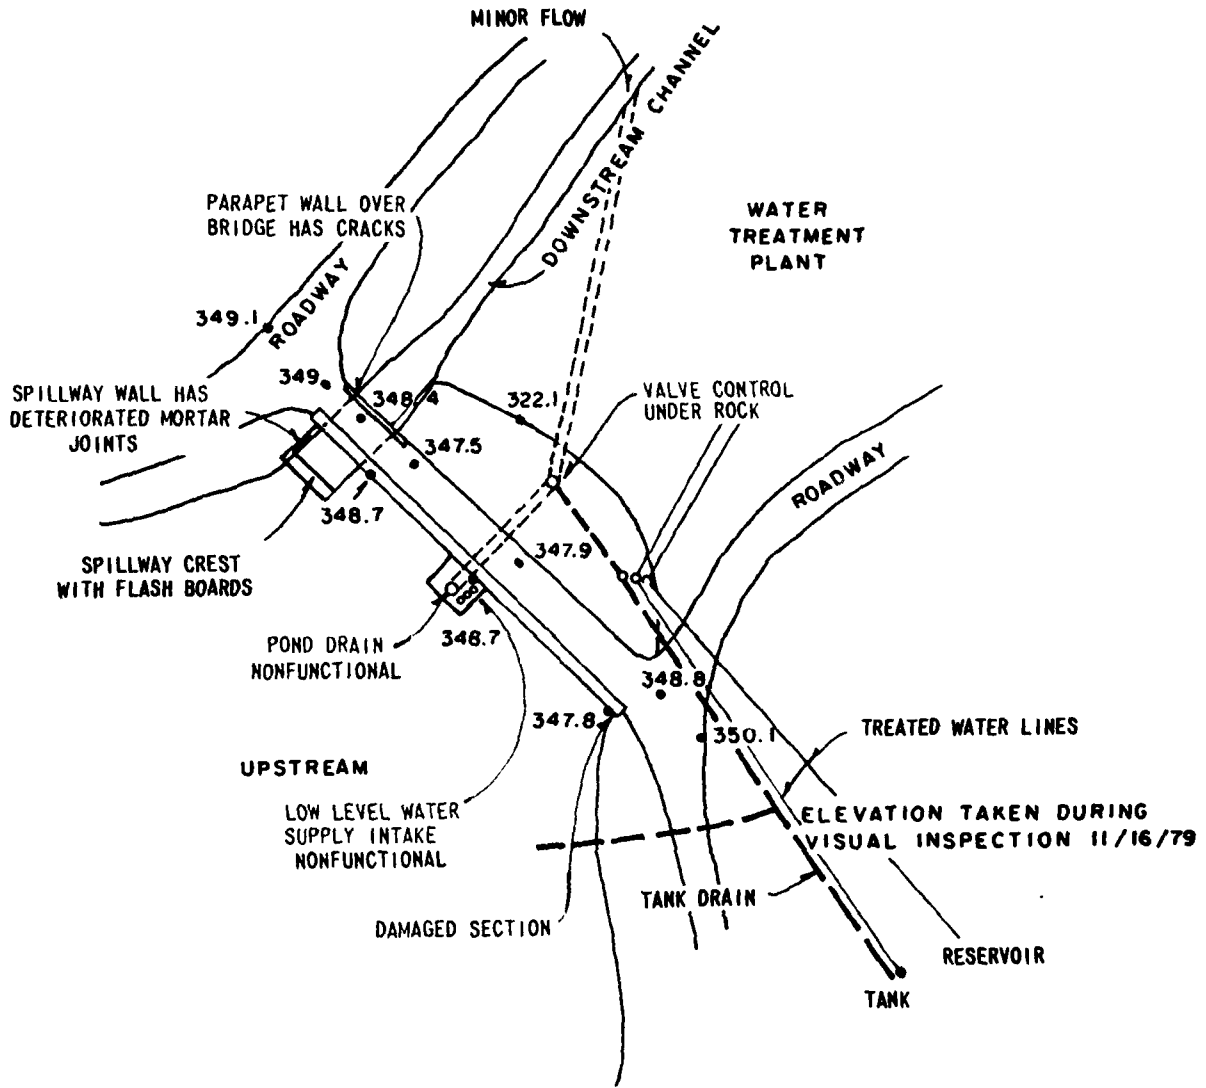
FIELD OBSERVATION PLAN  
 SPRING MILL DAM  
 SHEET 5A OF 11

1. Spillway. The spillway is "L"-shaped, as shown on sheet 5a, Appendix A, with the shorter leg perpendicular to the masonry dam. The longer leg is perpendicular to a retaining wall, which is parallel to the left abutment. Flashboards have been added to the spillway, as shown on Photograph 1. These flashboards are about 10 to 14 inches high and are held in place by pipes driven into the stone. It is assessed that these would fail during a large storm.

2. Outlet Works. The exposed portions of the masonry screen chamber, shown in Photograph 5, were inspected and appear to be in good condition. The wooden top could not be removed to inspect the interior of the chamber. The upper two intakes were exercised; the lower intake is inoperable. The pond drain conduit is gated at the upstream end and at the downstream toe. The upstream gate is nonfunctional, and flow through the pond drain is controlled at the downstream valve. A small amount of water was flowing through the pond drain conduit at the time of the inspection, as shown in Photograph 6. The original cast iron conduit has been extended by reinforced concrete pipe, and this discharges into the stream channel about 135 feet beyond the dam. Two other valves at the toe of the dam control the flow of water between the treatment plant and the reservoir and tank on top of the hill. A third valve controls the drain line from the tank. The drain line from the tank can also draw off water from upstream of the dam. A schematic diagram, as reported by the plant operator, is included on sheet 5a.

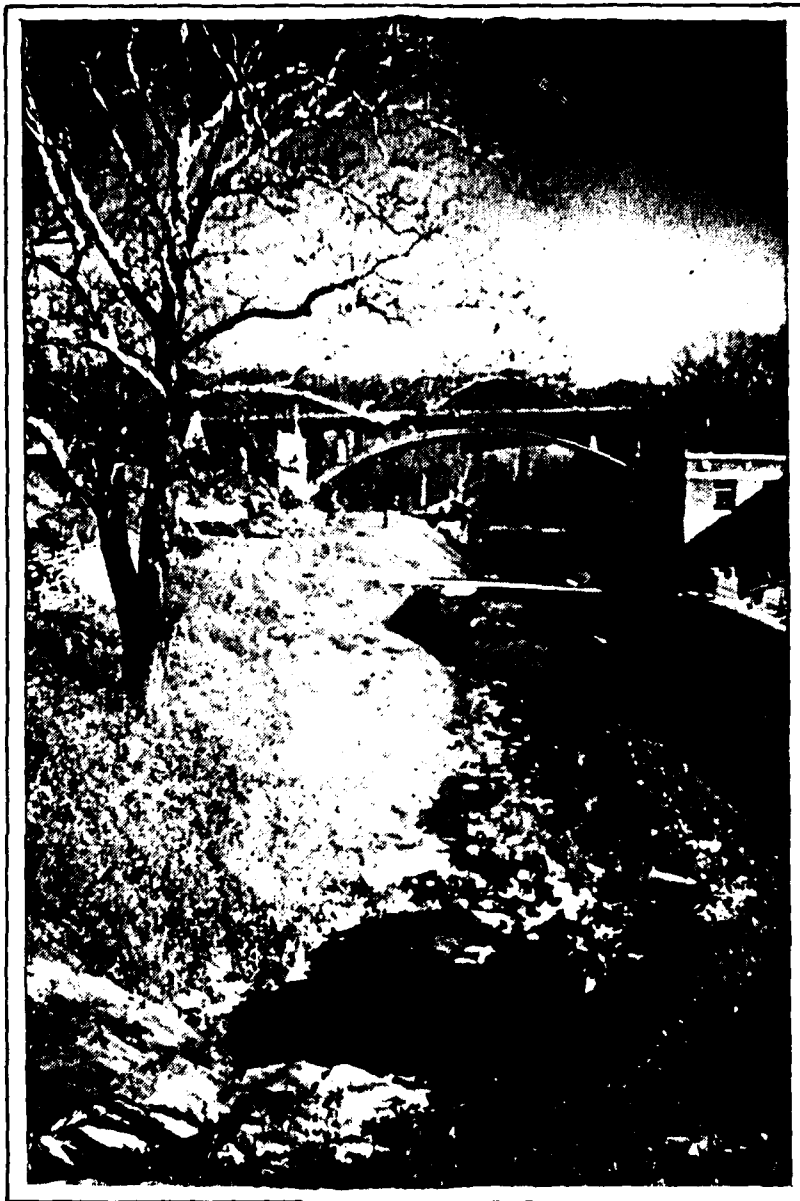
P H O T O G R A P H   N O .   3

f. Downstream Conditions. About 200 feet downstream from the dam is the major downstream hazard center, the water treatment plant. About 500 feet beyond the dam, the channel flows under a large concrete arch highway bridge, as shown in Photograph 3. About 800 feet below the dam, the channel passes under Conrail tracks, through the culvert shown in Photograph 4, and then discharges into the Lehigh River. Sudden failure of the dam would flood the water treatment plant shown in Photograph 3, and could possibly damage the plant and cause loss of life, as well as result in loss of the secondary water supply serving about 40,000 people. Therefore, because of the appreciable potential economic loss, a "Significant" hazard potential classification is justified.

V I E W   O F   D O W N S T R E A M   C H A N N E L  
A N D   D A M A G E   C E N T E R .
