**STORAGE RESERVOIRS NO. 1 & NO. 2**

NDS ID NO. PA-653  
DER ID NO. 49-21

MT. CARMEL MUNICIPAL WATER AUTHORITY

PHASE I INSPECTION REPORT  
NATIONAL DAM INSPECTION PROGRAM

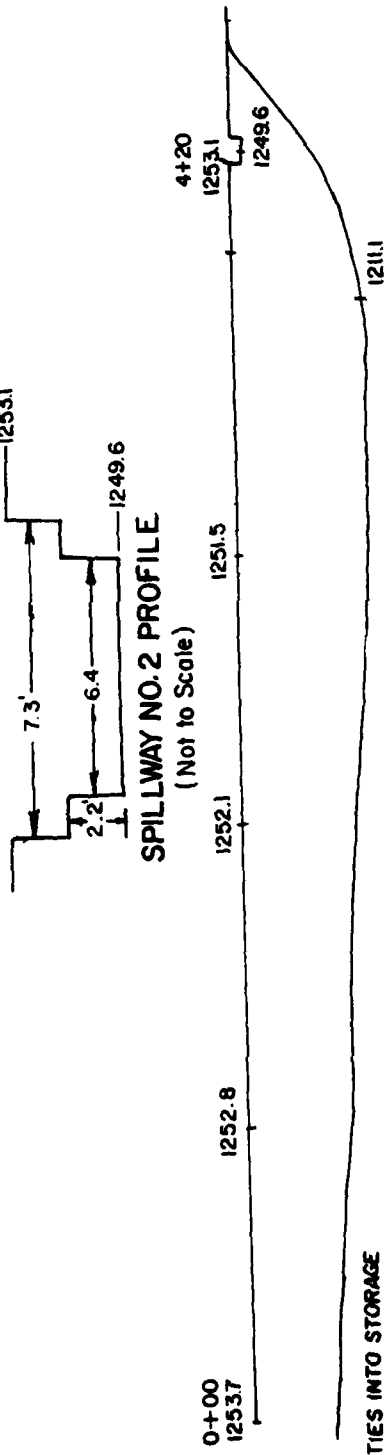
STORAGE RESERVOIR NO. 2 PROFILE  
LOOKING UPSTREAM

Storage Reservoir No. 2 contained a low spot approximately 120 feet to the right of the spillway. The crest width was measured at 14 feet. The upstream slope is 1.75H:1V and covered with grass. The downstream slope is 1.5H:1V. The lower portion of the downstream slope is covered with trees. No slope movements were noted on either reservoir slopes.

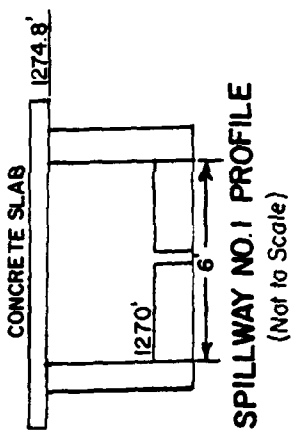
SPILLWAY NO. 1 PROFILE  
(Not to Scale)

exit channel consists of a masonry channel, 120 feet long, which discharges into Storage Reservoir No. 2. Both the spillway and exit channel appear to be in fair condition.

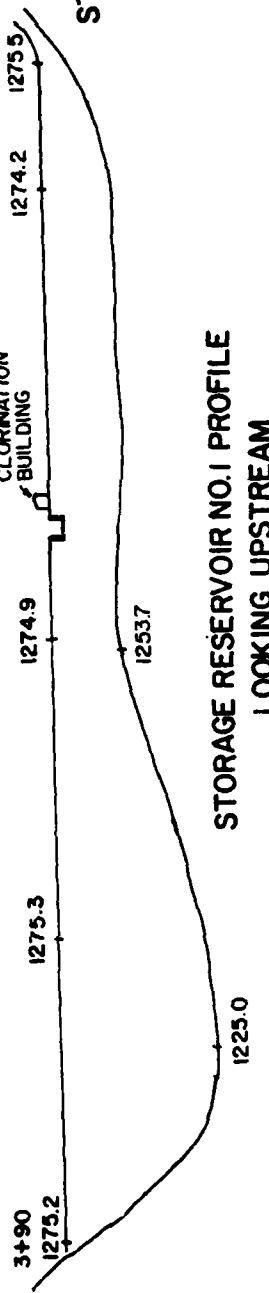
STORAGE RESERVOIR NO. 1 PROFILE  
LOOKING UPSTREAM

b. Dam. Storage Reservoirs No. 1 and No. 2 both appear to be in fair condition. From a brief survey conducted during the inspection, it was noted that a low spot was present to the left of the spillway on the crest of Storage Reservoir No. 1. The crest width was measured to be 16 feet. The upstream slope was measured at 1.75H:1V and grass covered. The upper portion of the downstream slope was measured at 1.25H:1V. A 16 foot wide berm is located approximately 22 feet (coincides with the crest elevation of Storage Reservoir No. 2) below the crest of Storage Reservoir No. 1. The lower portion of the downstream slope was measured at 1.5H:1V and covered with numerous large trees.
