MISCELLANEOUS PAPER SL-80-4

# CONCRETE AND ROCK TESTS, MAJOR REHABILITATION AND COMPLIANCE LOCKPORT LOCK, ILLINOIS WATERWAY CHICAGO DISTRICT

Structures Laboratory

April 1980

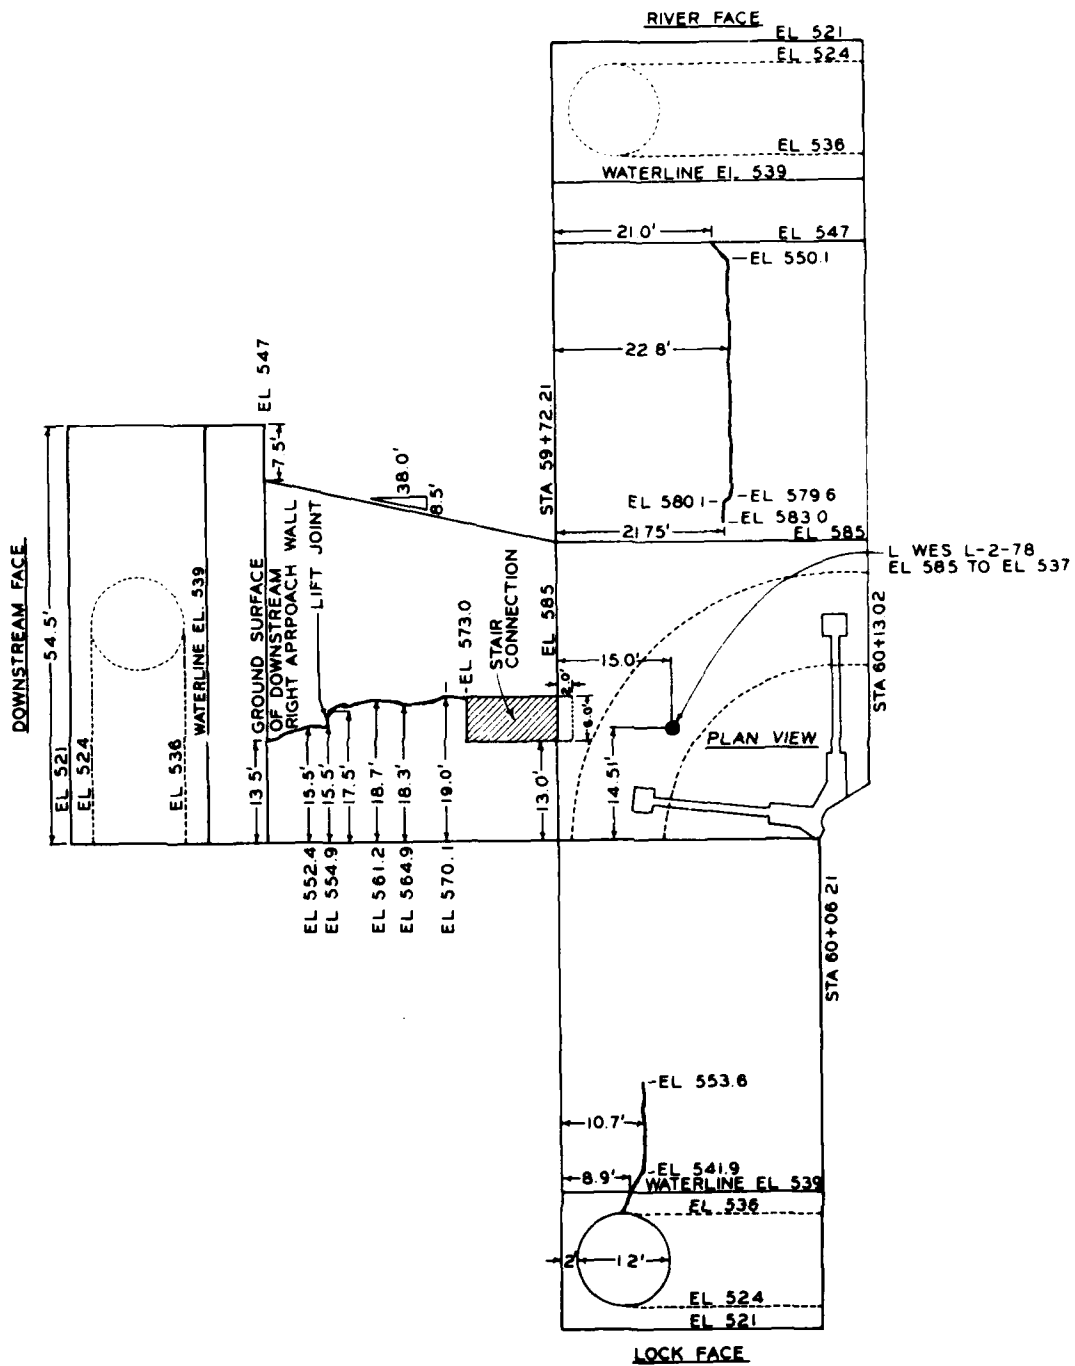
Figure 3. Results of crack survey, river wall, monolith 57, Lockport Lock.

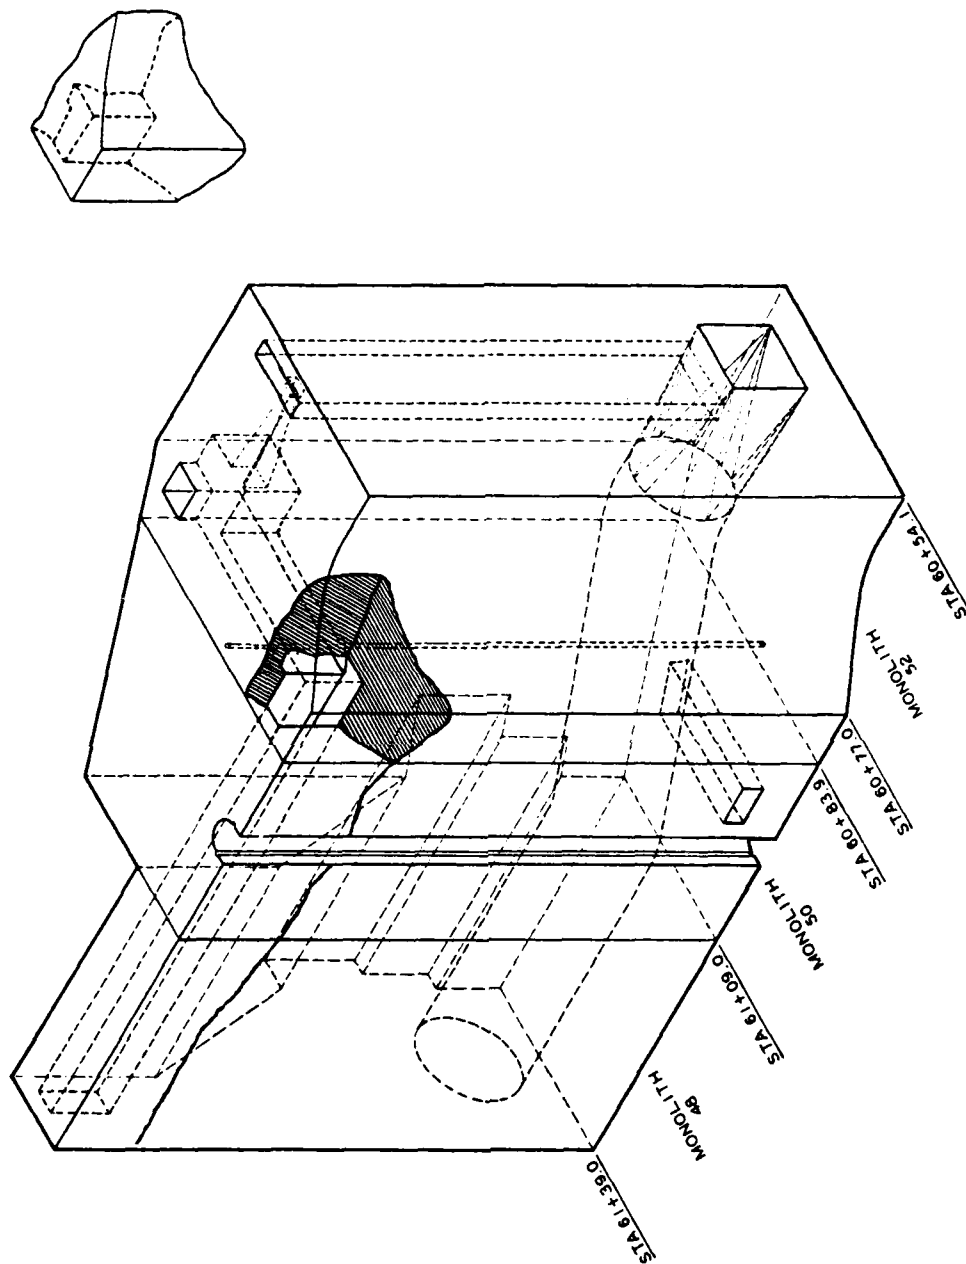
55. Figures 12 and 13 present graphic interpretations of structural cracks based on data obtained in the crack survey, velocity survey, and boring L-1. Figure 14 presents sections showing cracks at the corner of the cable gallery. The horizontal crack in the chamber side of the land wall is connected to the floor corner crack of the cable gallery in monoliths 48, 50, and 52. A land-side roof corner crack extends upward and is covered by a recently placed concrete overlay. In monolith 52 a wedge-shaped mass of concrete with an irregular base inclined about  $45^{\circ}$  exists with limits as shown in Figure 14. A similar wedge of concrete exists in monoliths 50 and 48, but the irregular base makes a transition from a  $45^{\circ}$  inclined base to a nearly zero incline base in monolith 48. Again the roof crack is present.

Figure 12. Interpretation of velocity data, land wall monoliths 48, 50, and 52

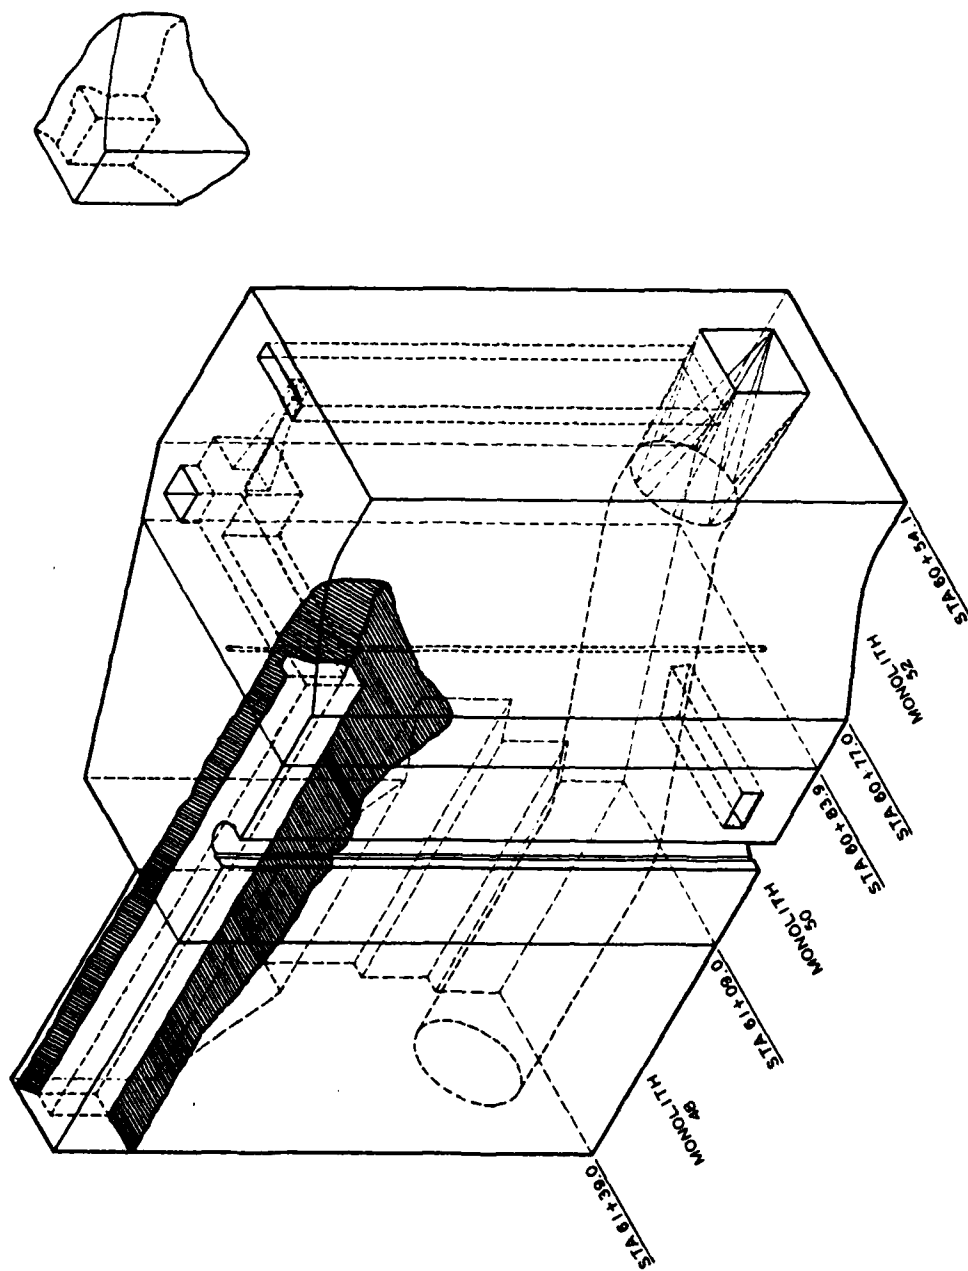
Figure 13. Interpretation of crack survey and velocity data, land wall monoliths 48, 50, and 52

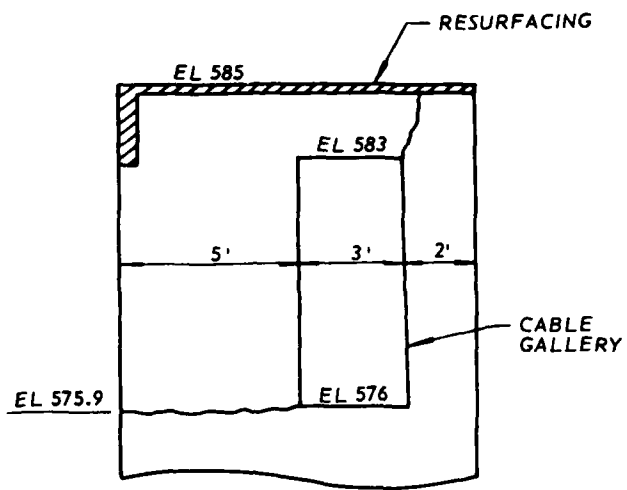
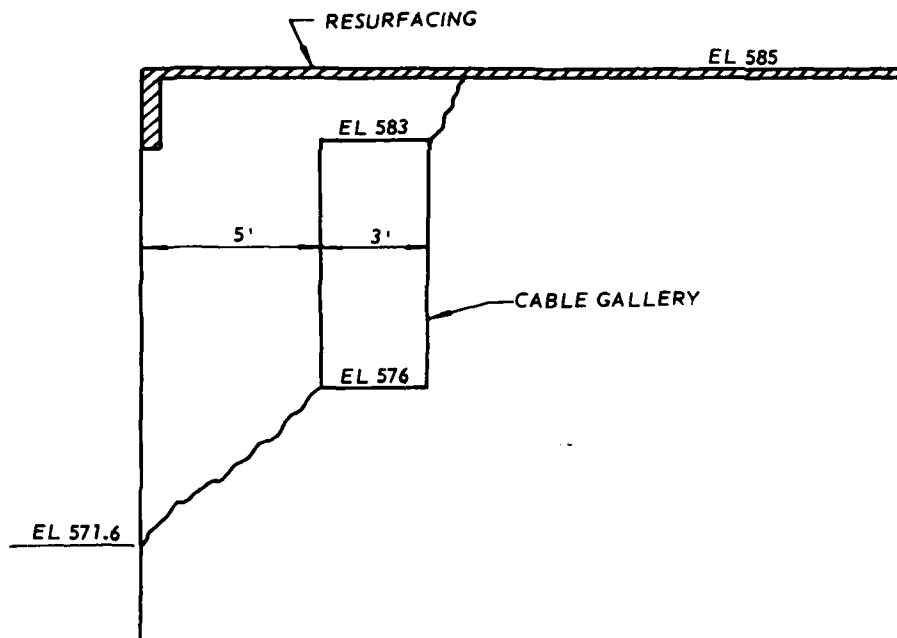
Figure 14. Sections showing crack location interpreted from crack and velocity survey data, land lock wall

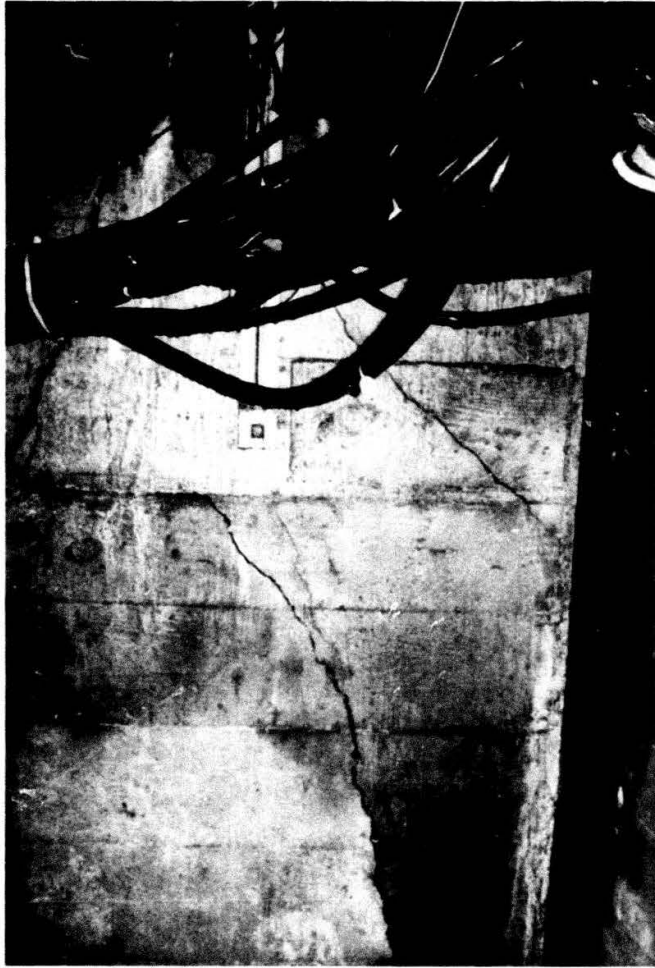
25. The upstream face of the cable gallery in river wall monolith 11 has several cracks near the lock side corner where the gallery makes a 90° turn. These cracks are shown in Figure A3 of Appendix A. The cracks are 2 mm (0.08 in.) or less in width and extend from within the ceiling of the gallery to the floor. This type of cracking is typical for many older lock structures where the pipe gallery makes a 90° turn. At present, these cracks appear to be limited in depth and pose no significant threat to the integrity of the structure.

Figure A3. Upstream face at lockside turn of  
river wall, cable gallery, monolith 11

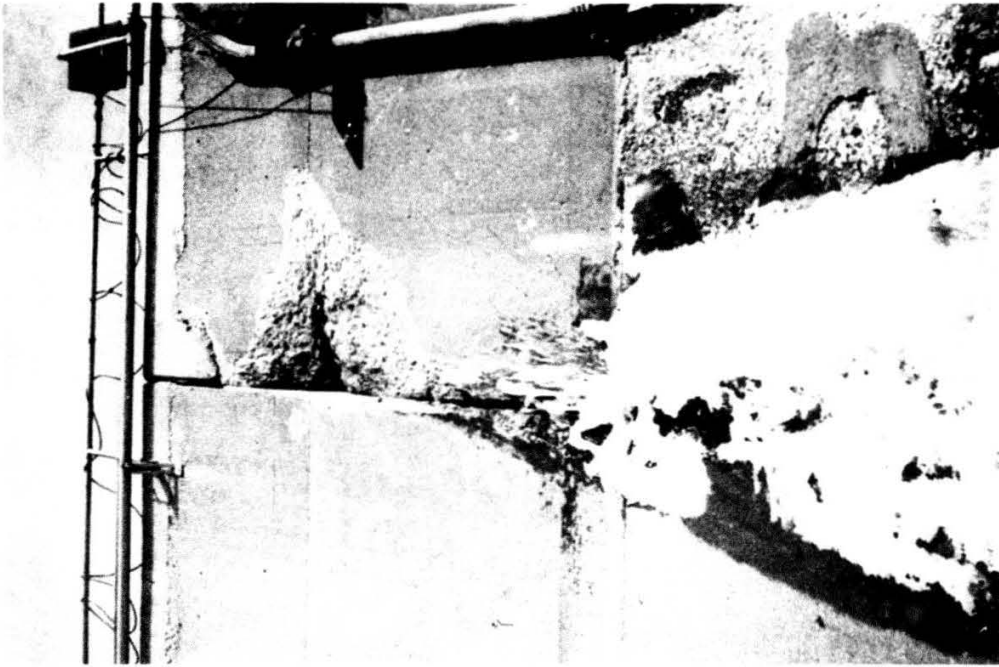
27. From a detailed investigation it was noted that for most joints the maximum loss of concrete was less than 6 in. in depth. However, for monolith joints 29-31 (Figure A11 of Appendix A) and 37-39 (Figure A12 of Appendix A), the maximum loss of concrete was approximately 12 in. in depth.

Figure Al2. River face, river wall mono-  
lith joint 37-39

29. At present, the deterioration at these monolith joints does not present a serious threat to the structural integrity of the lock. However, this could change if remedial measures are not implemented to correct the seepage problem at the joints and to protect the existing surfaces from further deterioration due to frost action.

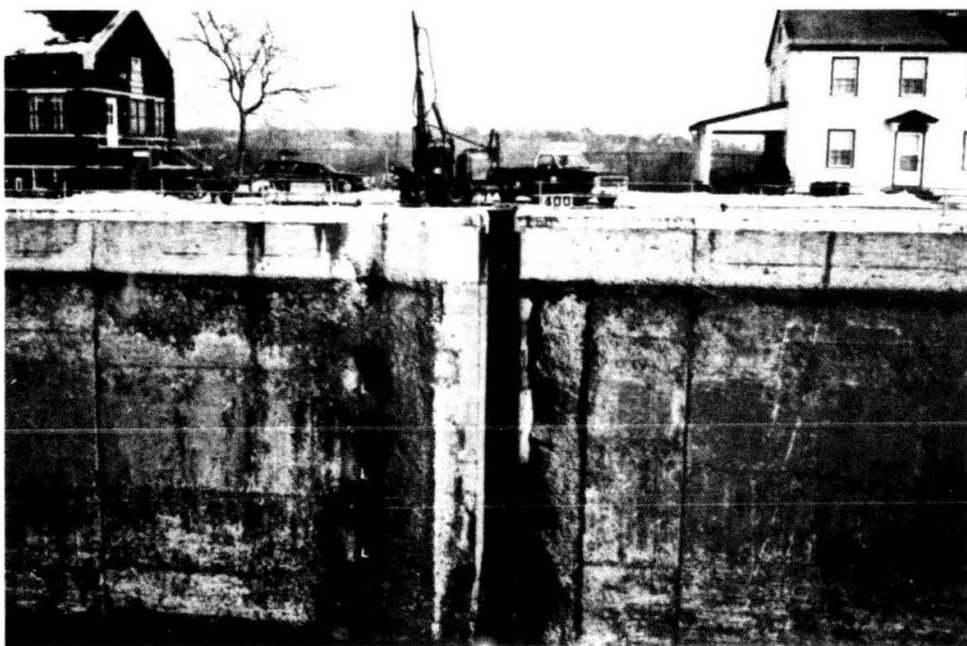
distance of 240 ft). The crack appears to follow a lift joint at approximately el 576. Top elevation of lock wall is 585. The maximum width of the crack is less than 2 mm (0.08 in.). The crack is depicted in part in Figure A20 of Appendix A.

Figure A20. Lock face, land wall monoliths 34, 36, 38, and 40
