MISCELLANEOUS PAPER SL-80-6

**CONCRETE AND ROCK TESTS, MAJOR  
REHABILITATION OF STARVED ROCK LOCK AND  
DAM, ILLINOIS WATERWAY, CHICAGO DISTRICT  
PHASE II COMPLIANCE, SCOUR DETECTION**

R. L. Stowe, B. A. Pavlov

April 1980

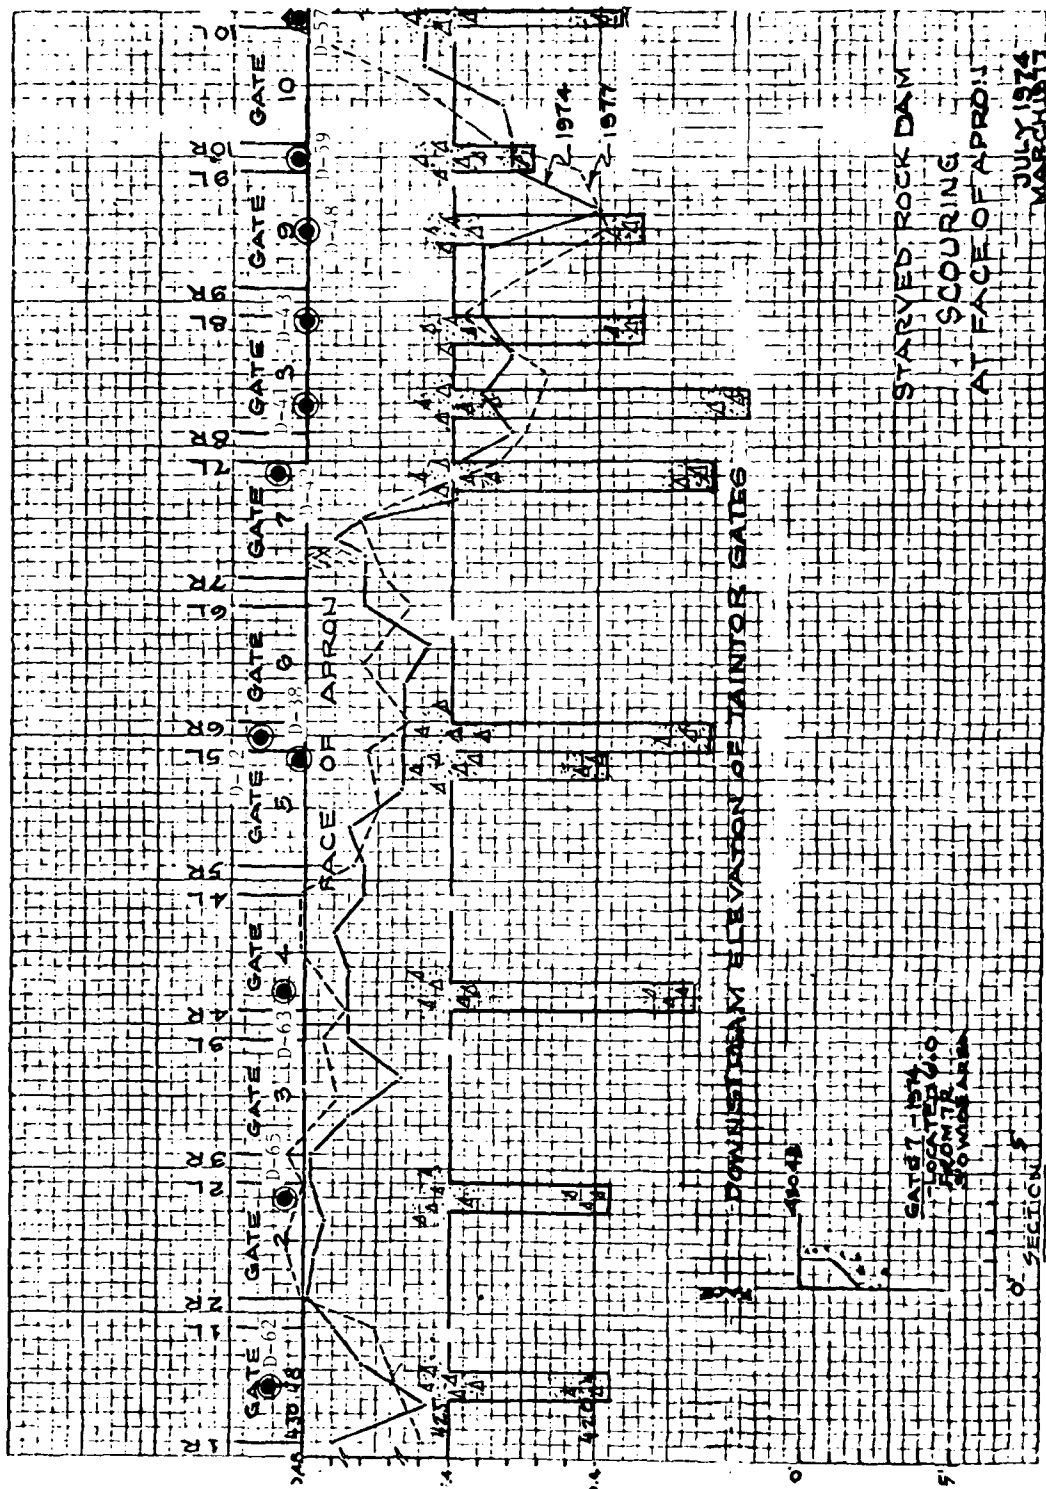
Figure 6. Scouring at face of apron

Figure 6 shows the scouring at the face of the apron in the taintor gate dam as plotted by NCC. Superimposed on this graph are the actual base elevations of concrete at boring locations given in the above tabulation. Figures 7, 8, and 9 show the scouring at the apron face in the head gate dam. These figures illustrate the base elevation of the concrete as

revealed in borings. Indications are that the 1977 scouring has not undercut the apron for the full length of the two dam sections. The base elevation of the taintor gate dam section is variable, and extrapolation of these actual base elevations to other sections of the taintor gate should be done with caution. The head gate dam appears to have been built using two different design criteria. The first 16 gate bays are founded on weakly cemented and friable sandstone, the 17th pier founded on a shale seam, while the remaining gate bays appear to be founded on competent dolomite. Because of the variable foundation elevations in the head gate dam section, extrapolation of foundation elevations to other sections of the head gates, notably bays 17 through 30, could be misleading. It is suggested that an NX boring be put through the bays already not drilled to determine actual base elevations. A figure for the ice chute is not presented. The one boring in the ice chute overflow section shows the base of concrete at el 419.5 ft; working drawings indicate the base of this structure to be el 430.0 ft.

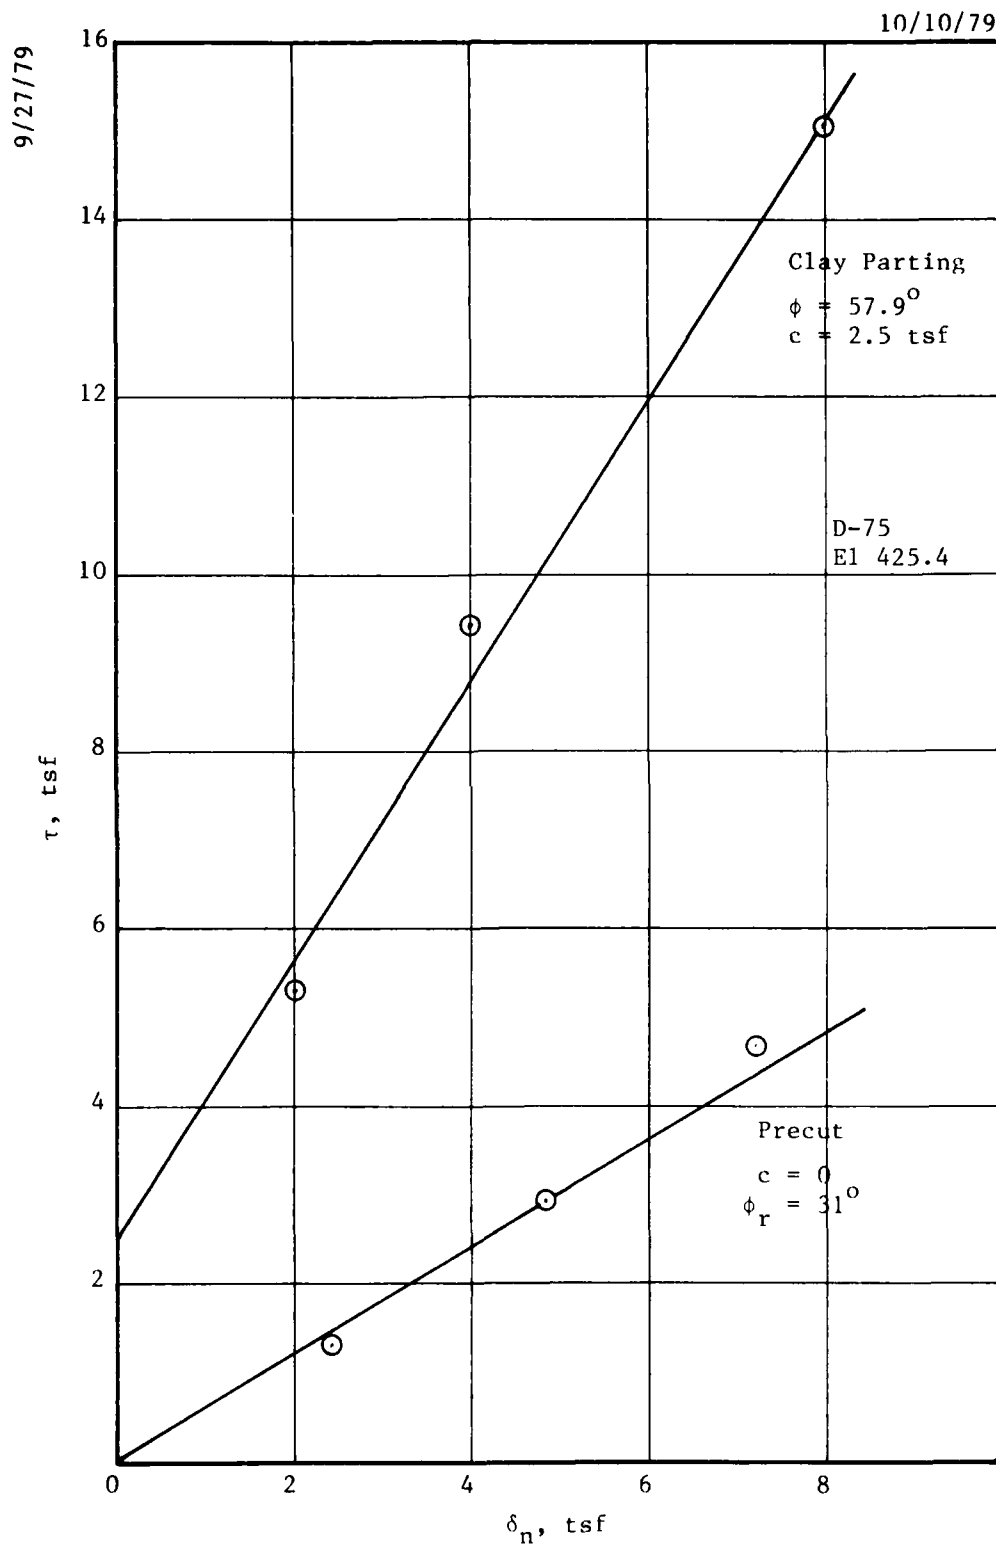
Plate 23. Multiload direct shear, clay parting competent sandstone

69. The specimen was tested using the multistage loading technique because other specimens were not available. The normal load versus shear load is presented in Plate 23. The peak shear strength value of  $\phi$  is 57.9 deg and cohesion (c) is 2.5 tsf. The  $\phi$  of 57.9 deg is a reasonable value when it is compared to the lowest peak  $\phi$  obtained for the intact competent sandstone (51.7 deg); see Part VII under "Recommended Design Values for Rock." The relatively thin sandy clay filler apparently did not affect the shear strength of the discontinuity.
