**POHATCONG LAKE**

**DAM LEVEL II**  
**NJ 00504**

**PHASE 1 INSPECTION REPORT  
NATIONAL DAM SAFETY PROGRAM**

**MARCH 1980**

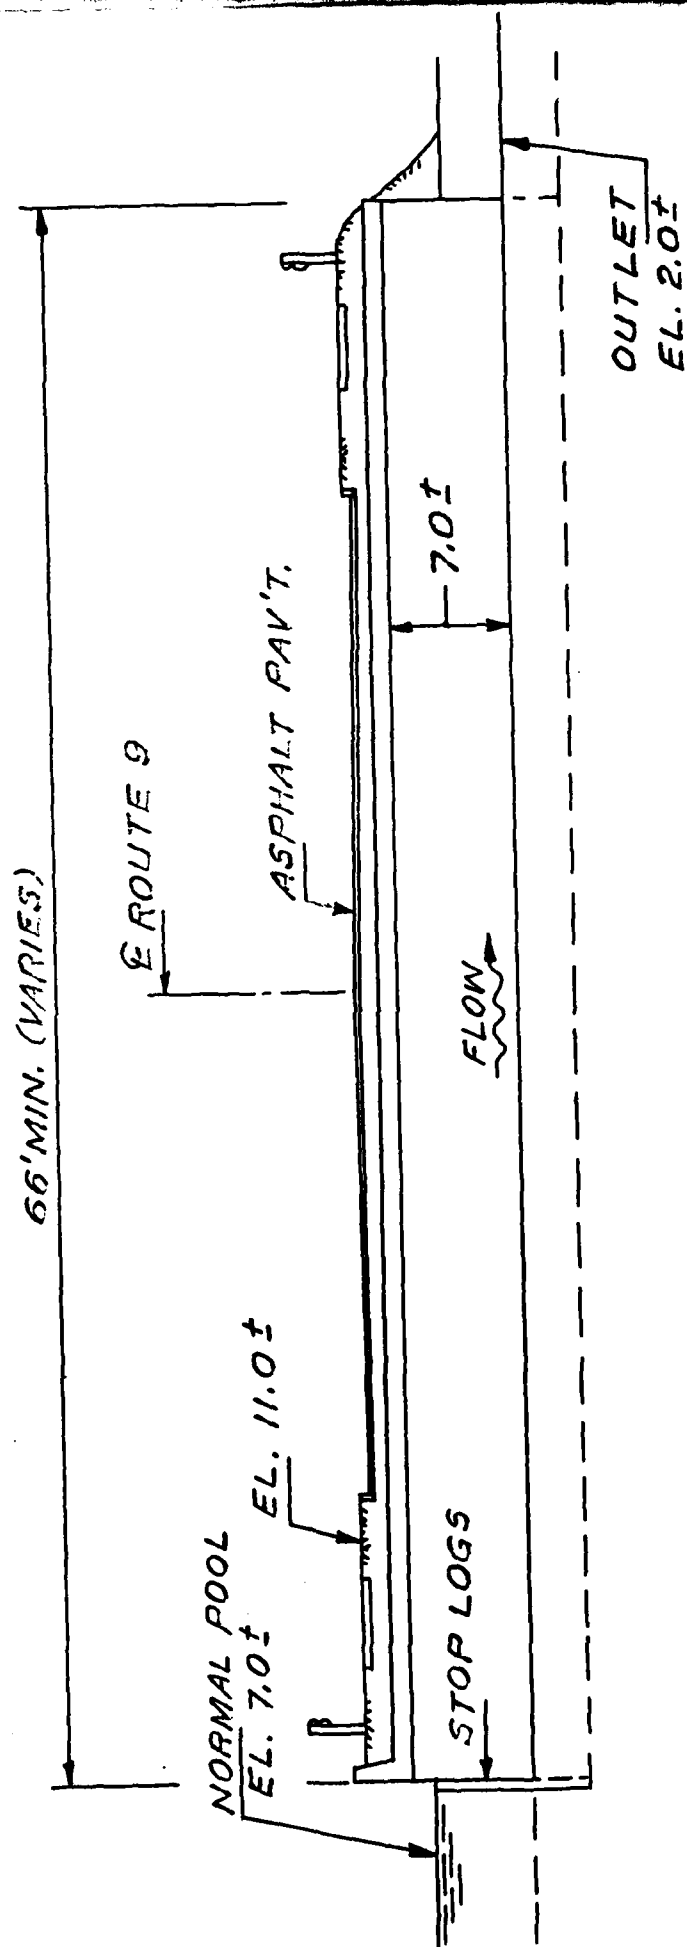
FIGURE 4

SECTION THRU PRINCIPAL SPILLWAY  
NOT TO SCALE
