NAVY EXPERIMENTAL DIVING UNIT

NAVY EXPERIMENTAL DIVING UNIT REPORT

MK 12 SSDS HELMET ADJUSTABLE EXHAUST VALVE ASSEMBLY EVALUATION

24 MARCH 1980

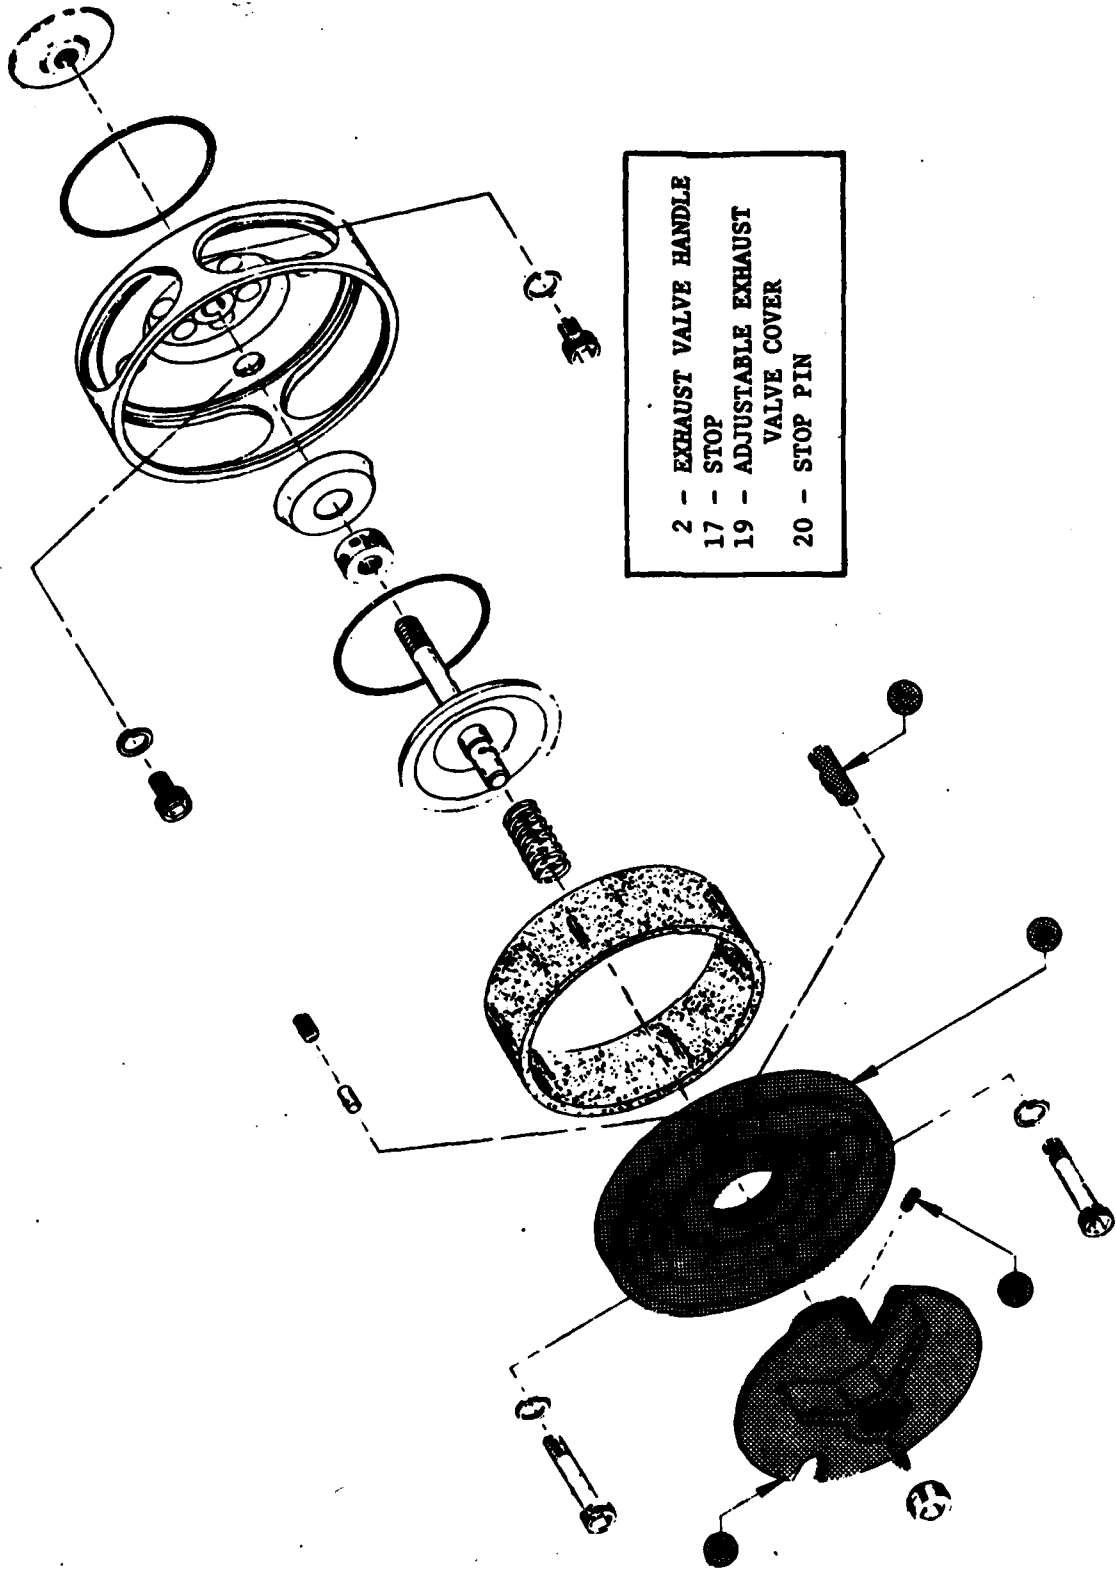
FIGURE 1. MK 12 SSS HELMET ADJUSTABLE EXHAUST VALVE ASSEMBLY RETROFIT AND DESIGN CHANGE PARTS LOCATION

A summary of the findings outlined in the memorandum indicated that many of the existing stop pins had been plastically deformed during valve handle assembly. This condition is the result of inserting the tempered stop pin into a .004" to .006" undersized hole in the valve handle barrel. (See Figures 1 and 2).

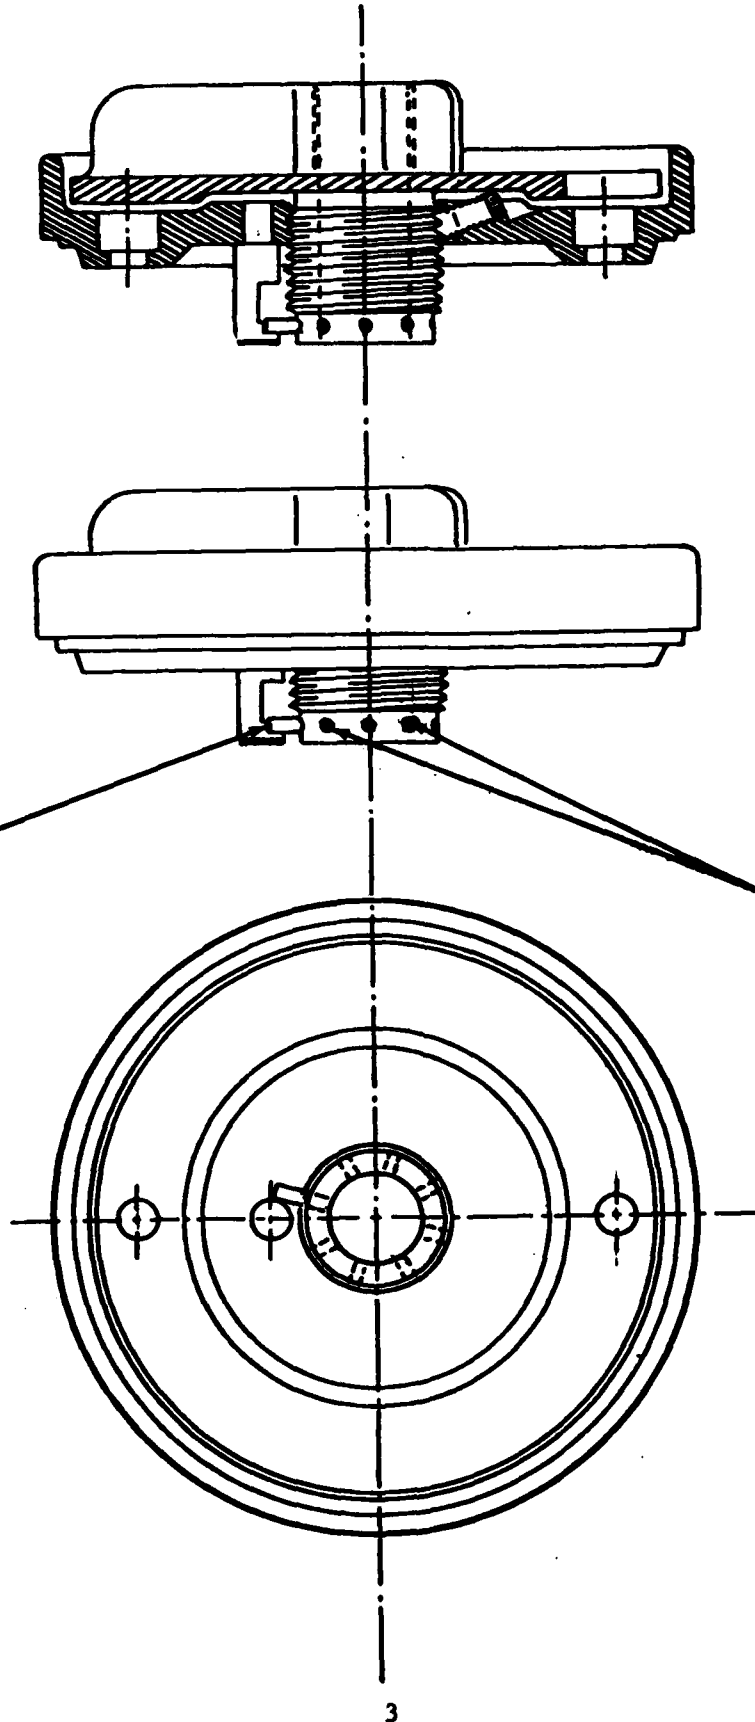
FIGURE 2. PRIMARY FAILURE SITES ON MK 12 SSDS HELMET ADJUSTABLE EXHAUST VALVE ASSEMBLY

UNDERSIZED HOLES
.086 IN. DIAMETER
(SPECIFIED .090 IN./-.092 IN. ON DRAWING 592-475855)

d. The valves that failed were manufactured by Morse Diving Company. Inspection of these parts shows that the diameter of the pin holes was $.086''$ as opposed to the specified $.090''/.092''$ on the drawing. This undersized hole puts an excessive stress concentration on a pin of this temper. It has been noted that several of the valves, as received from the manufacturer, had these pins split at assembly. It is apparent that if the pin is split at assembly, the ability of the pin to remain in its hole as well as resist bending or breaking is considerably reduced.
