**ENGINEERING TEST REPORT**

**ENVIRONMENTAL AND COLD TESTS ON  
 MODEL 04045B03 GENERATOR SET SERIAL NUMBER  
 0000003 WITH IGT 404-4 ENGINE SERIAL NUMBER 1000003,  
 TEST UNIT**

Engine - IGT404-4  
 MODEL Generator Set 04045B03 DATE November 13, 1979

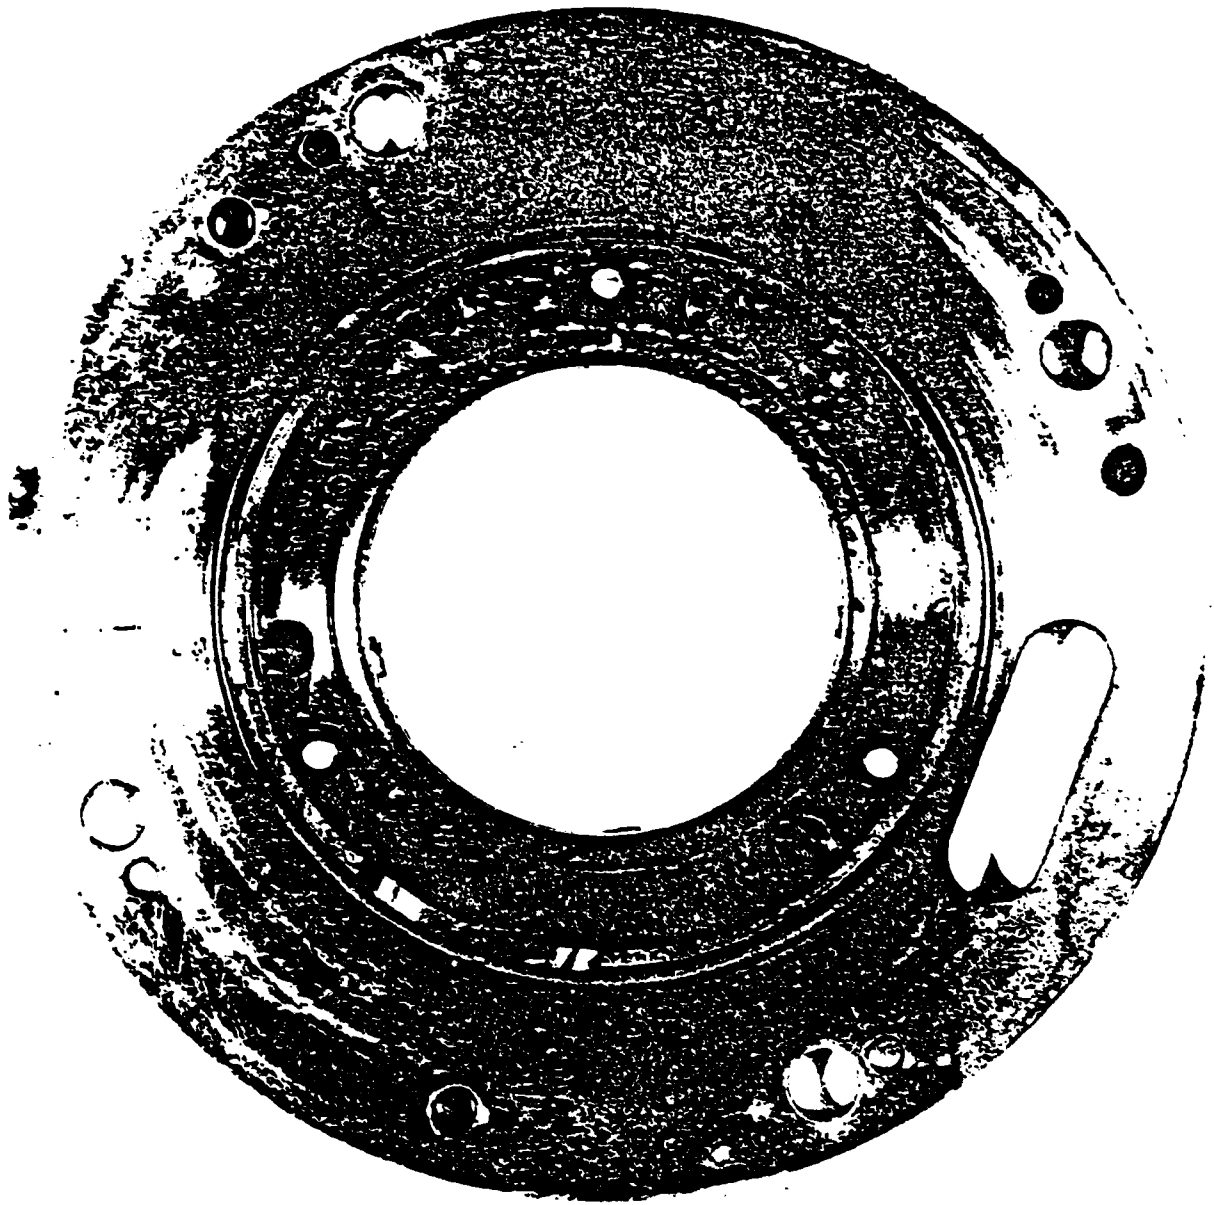
The generator set and engine were disassembled to assess the failure damage. The failure and secondary damage are shown on Photos 351421 through 351439 and 351525.

-50°F COLD TEST BRG. FAILURE, GEN. SET #3, ENG. T3, B.U. 7.

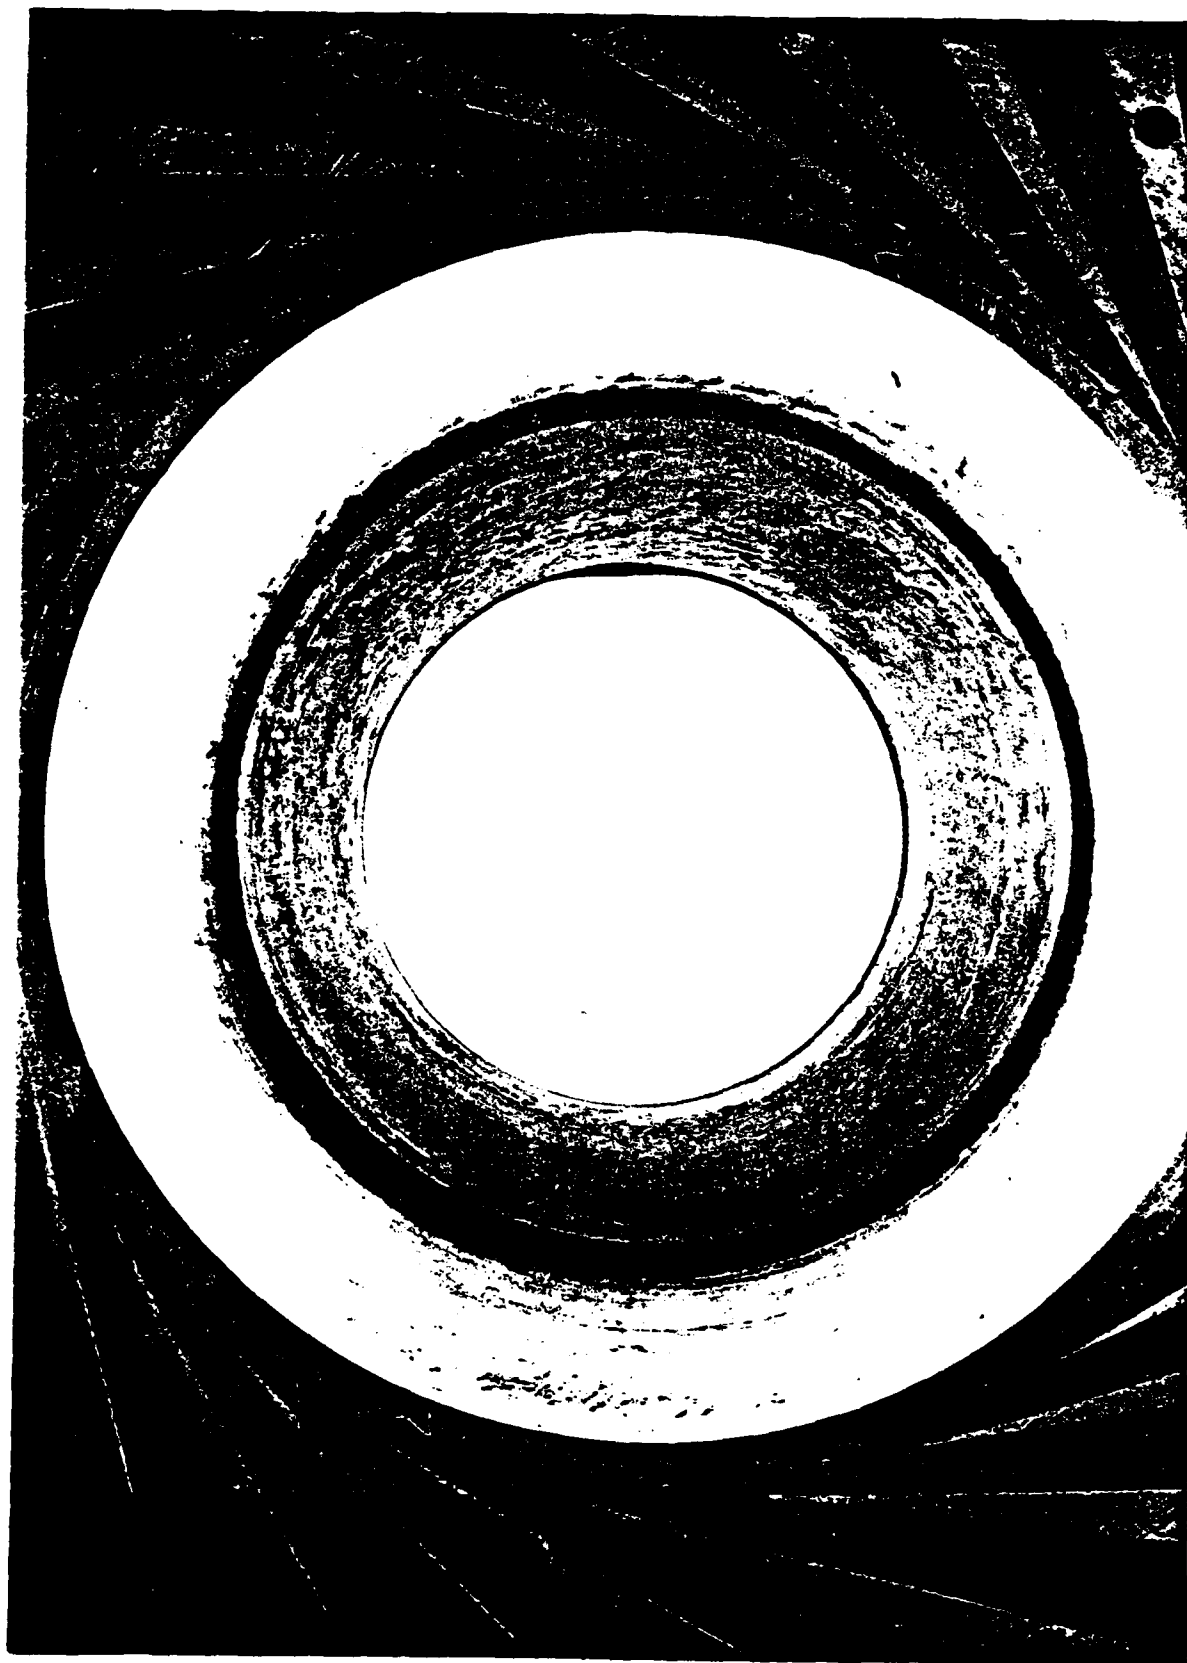
-50°F COLD TEST BRG. FAILURE, GEN. SET #3, ENG. T3, B.U. 7. 351422

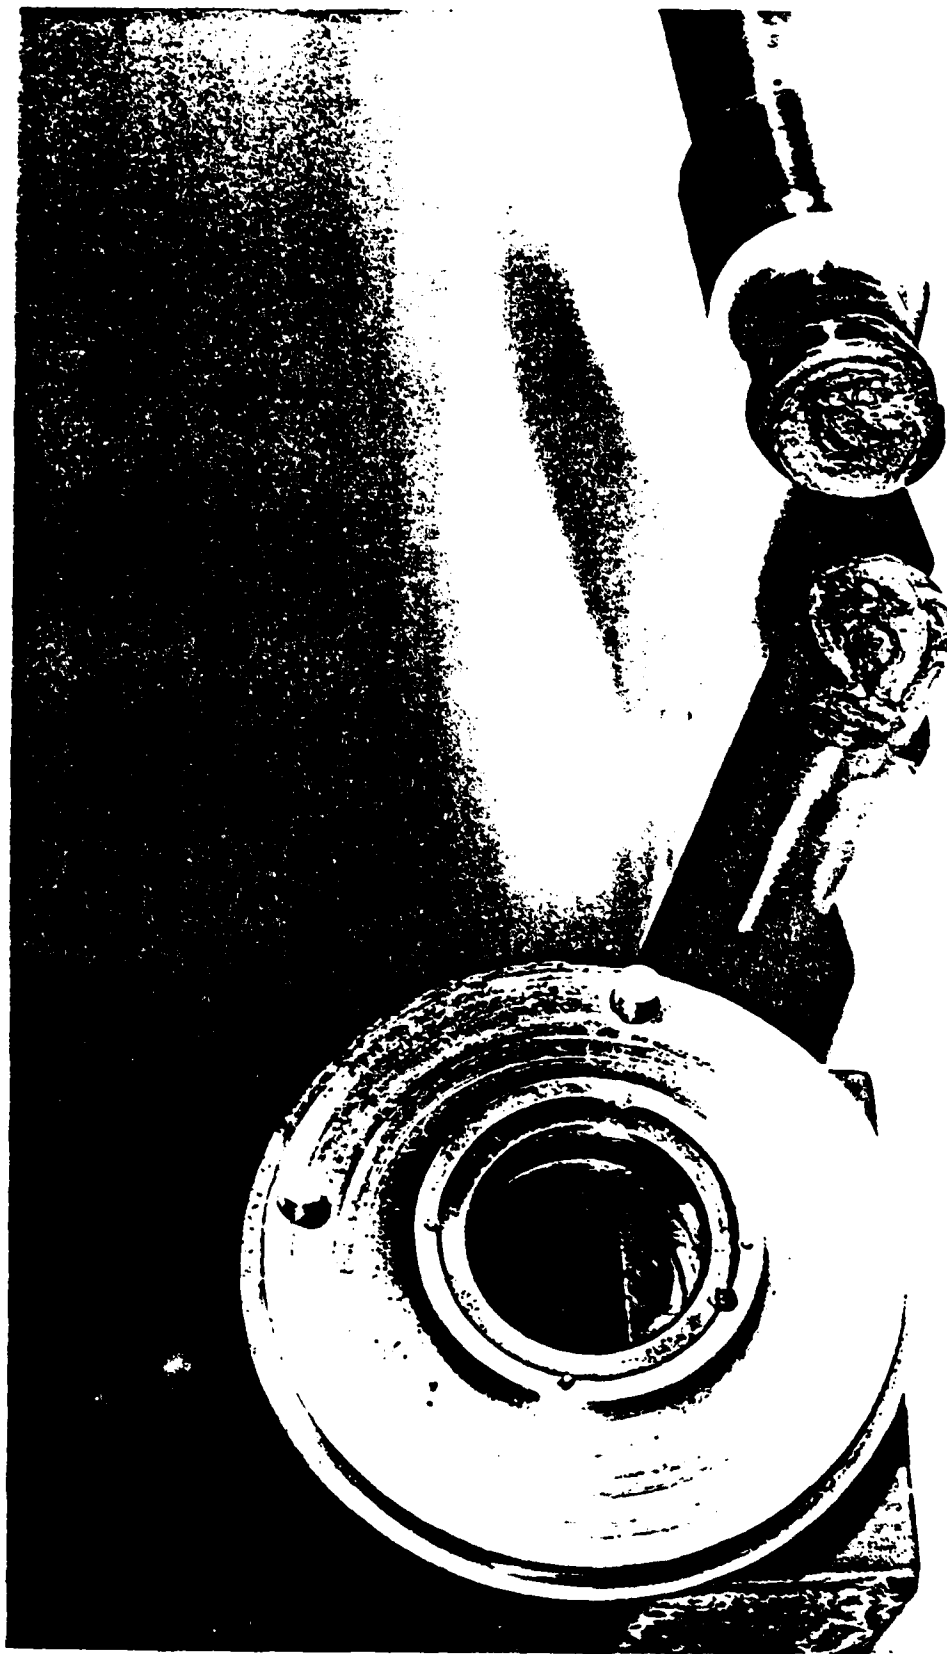
-50°F COLD TEST BRG. FAILURE, GEN. SET #3, ENG. T3, B.U. 7 351424

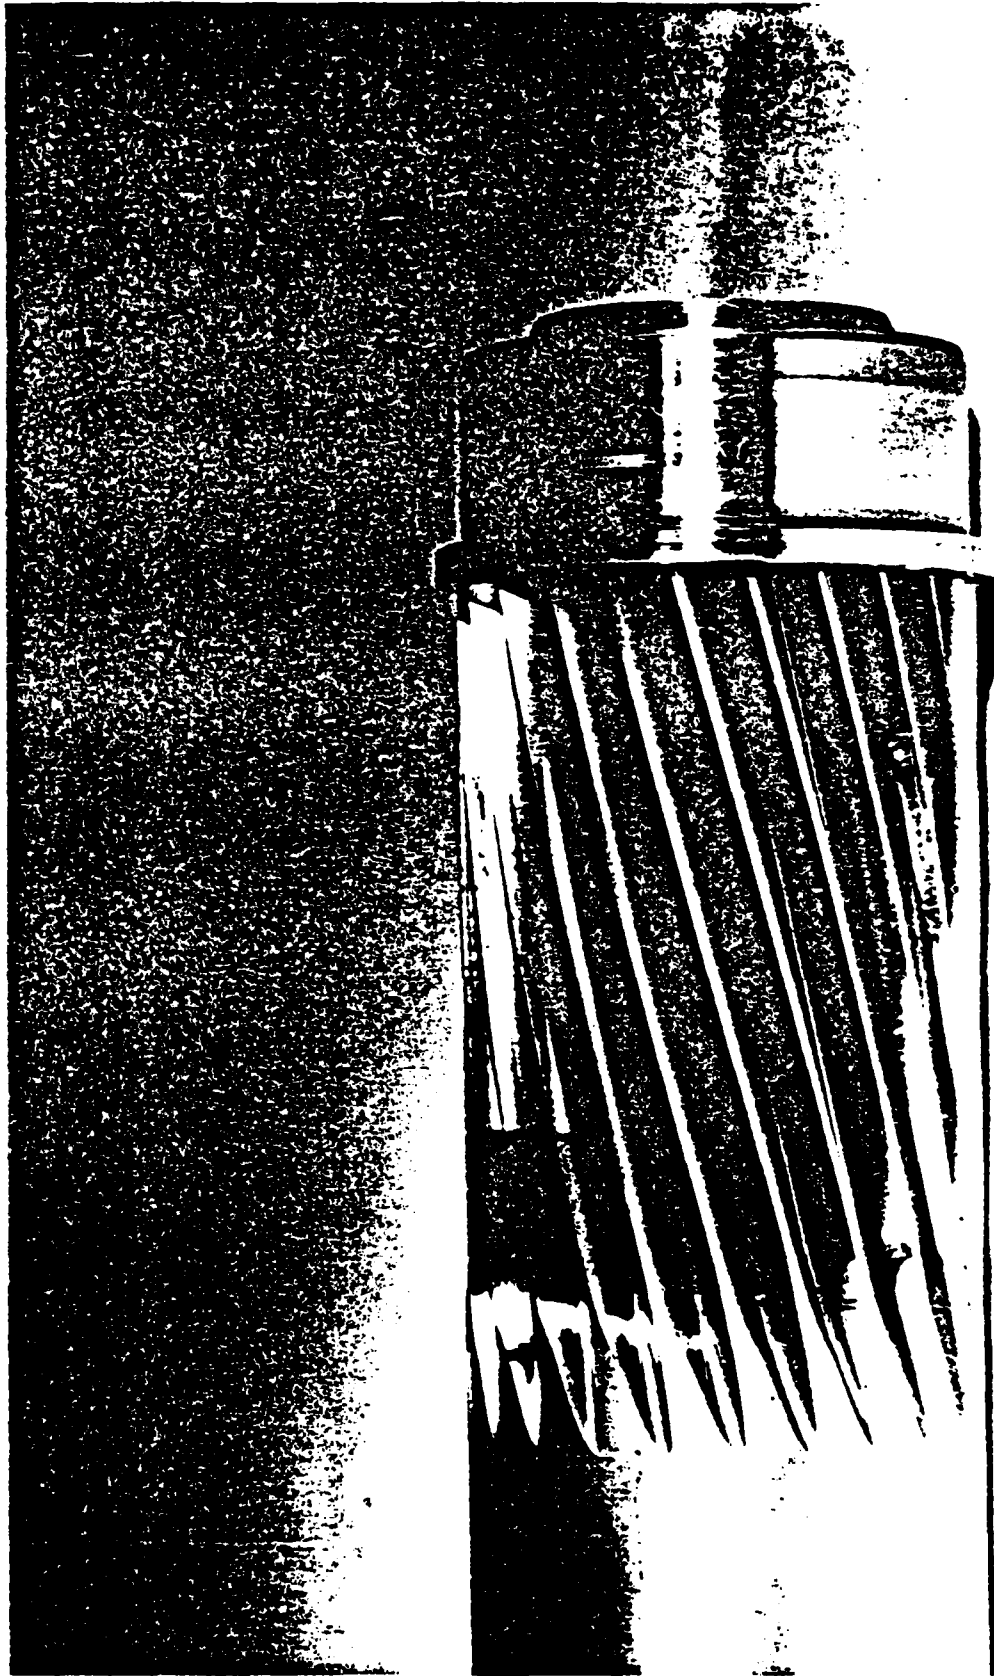
-50°F COLD TEST BRG. FAILURE, GEN. SET #3, ENG. T3, B.U. 7. 351425

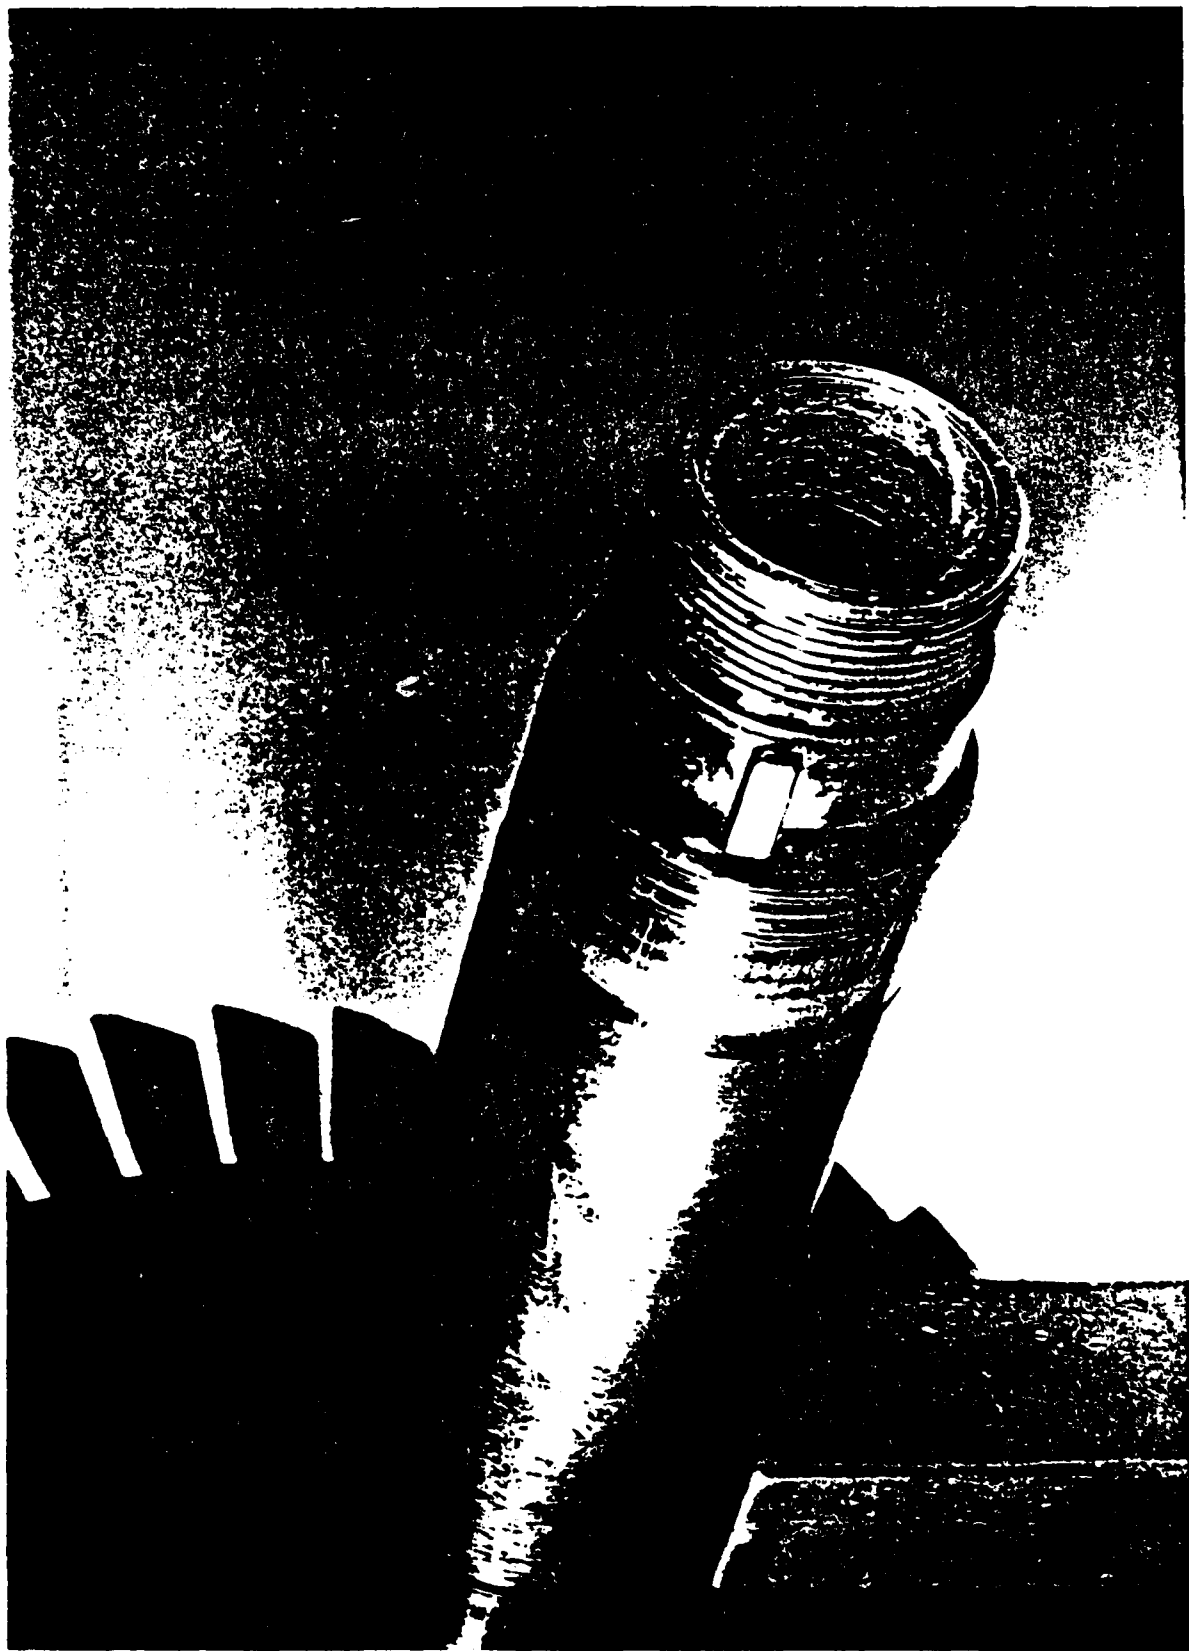
Photographs 351430 and 351432 picture the failed power turbine roller bearing which was apparently the primary failure due to lack of lubrication. The other photographs depict secondary damage but special interest should be taken in the gasifier front (Photo 351429) and rear (Photo 351427) ball bearings which had extreme distress on one side due to the heavy activity at the quill shaft which finally failed at the seal (Photo 351424) which runs in the bushing located in the aft end of the power turbine (Photo 351426).

-50°F COLD TEST BRG. FAILURE, GEN. SET #3, ENG. T3, B.U. 7. 351426

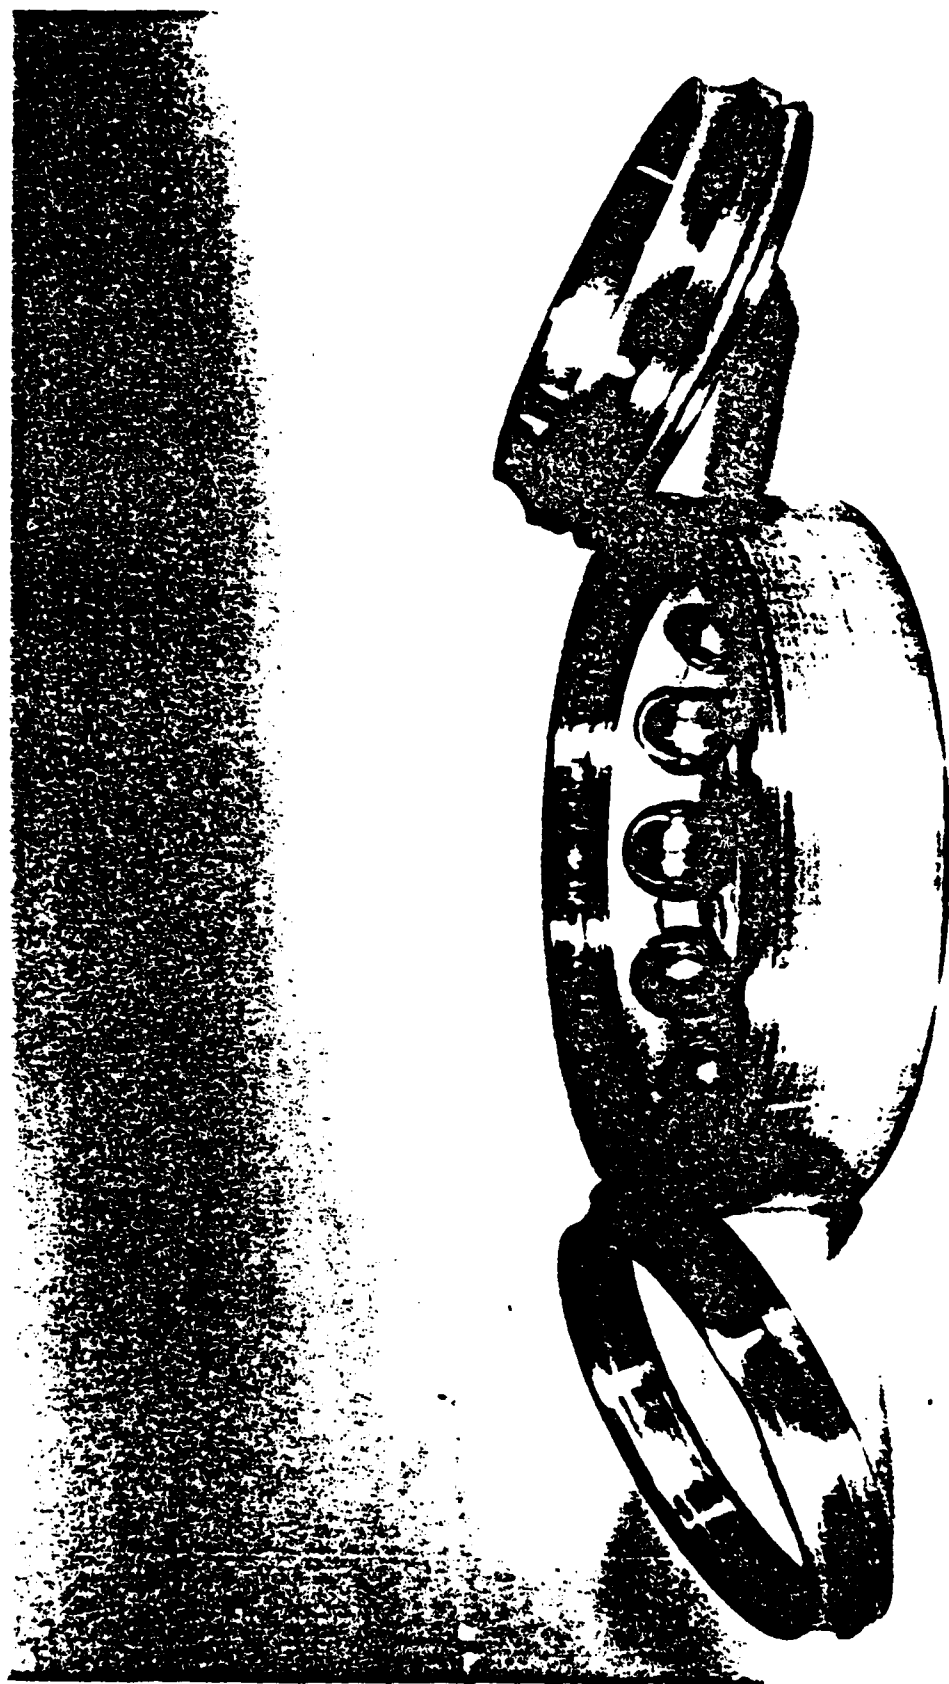
-50°F COLD TEST BRG. FAILURE, GEN. SET #3, ENG. T3, B. U. 7. 351429

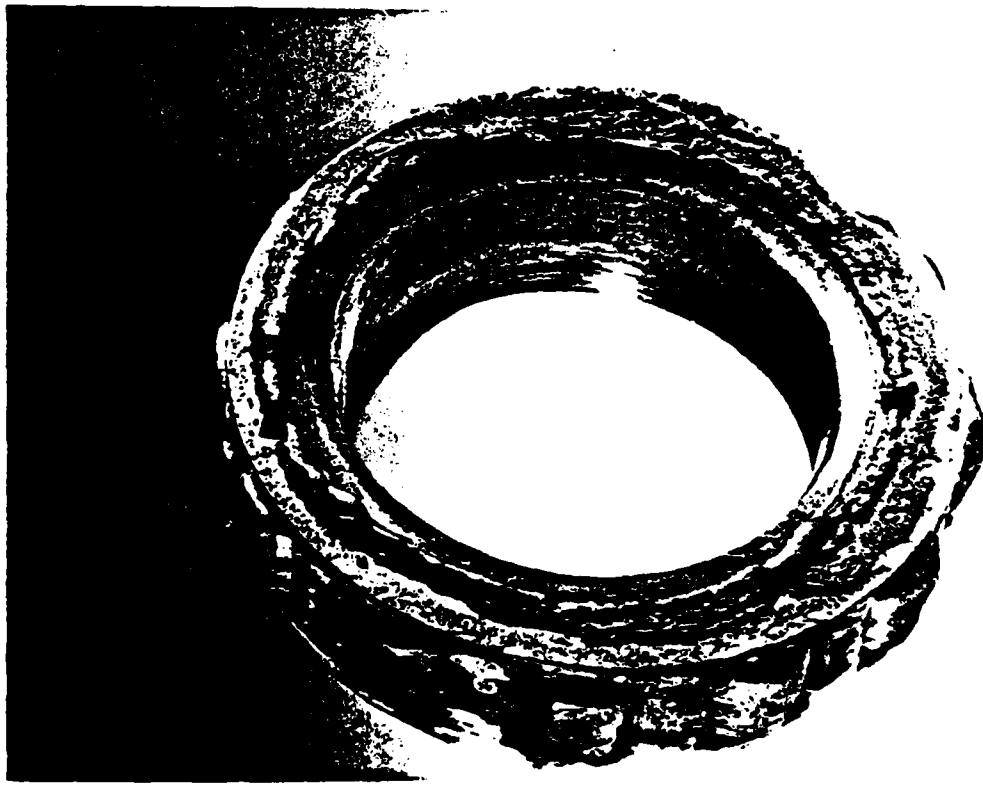
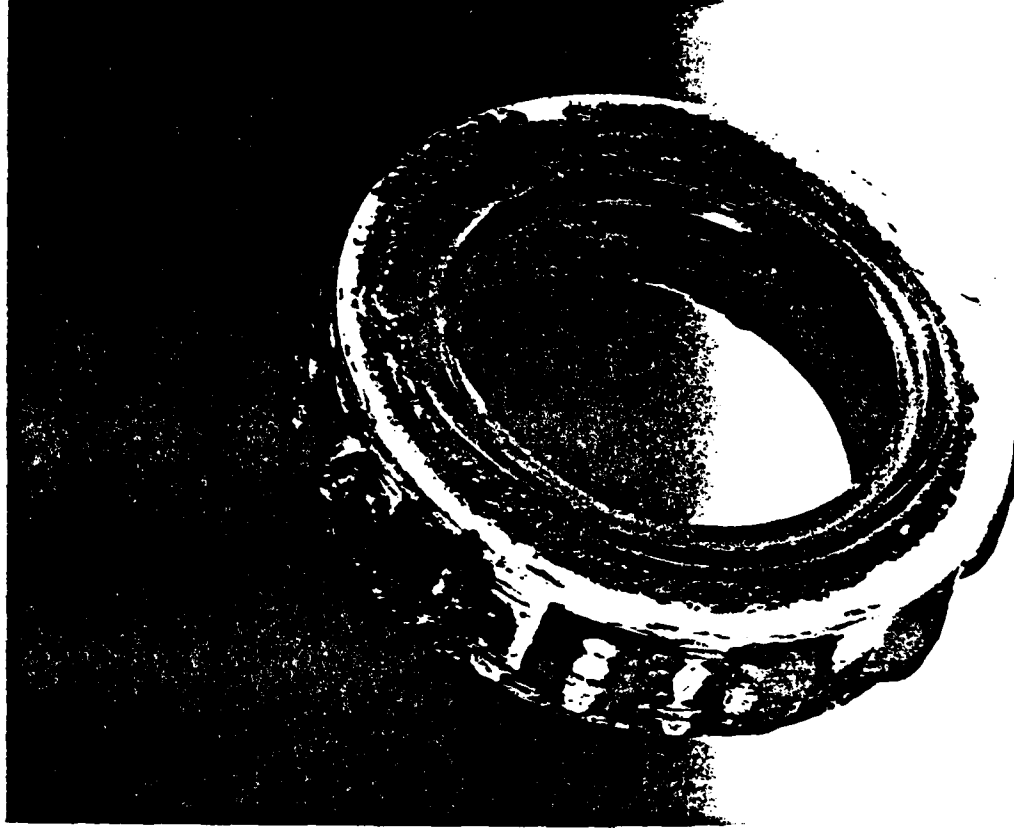
After the normal preparations, the -50°F testing was initiated with a successful start and loading within one minute. However, soon after the loading occurred, the unit emitted two howls and a loud "pop." The pop was apparently due to the quill shaft failing as secondary damage when the power turbine roller bearing failed (lack of lubrication - cooling).

-50°F COLD TEST BRG. FAILURE, GEN. SET #3, ENG. T3, B. U. 7. 351430

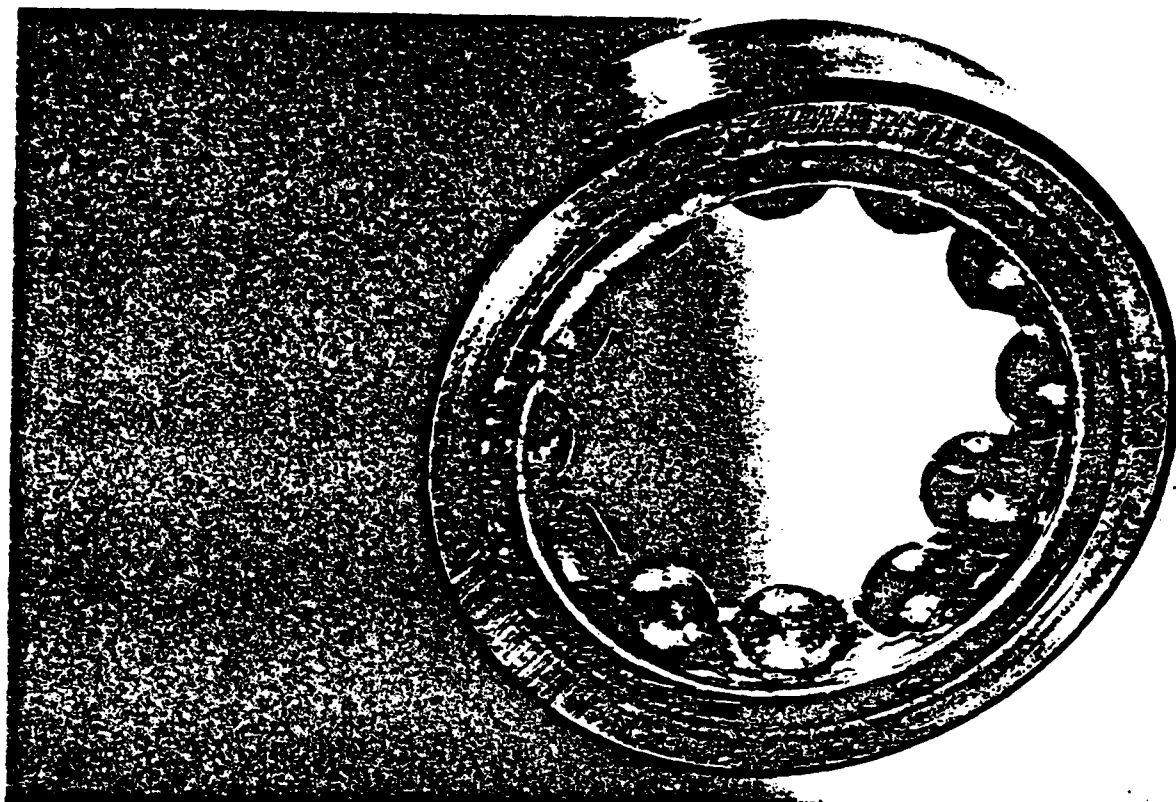
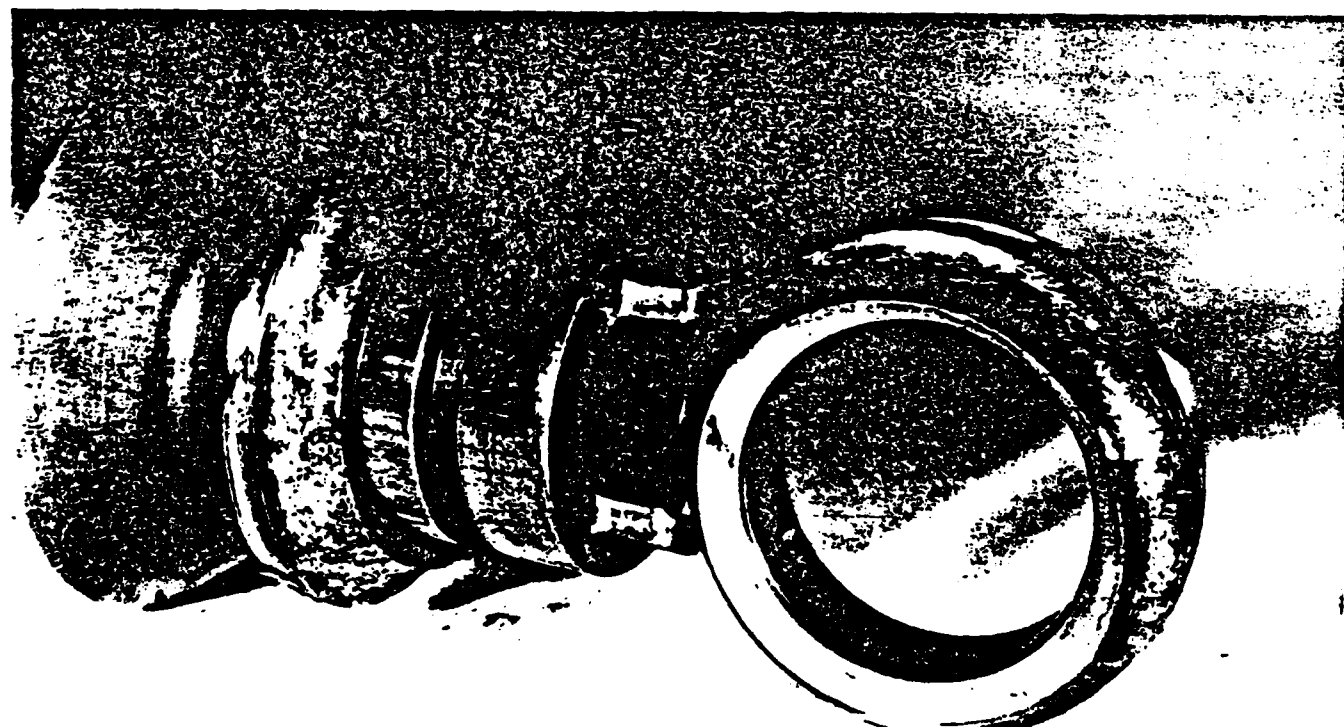
351431

-50°F COLD TEST BRG. FAILURE. GEN. SET #3, ENG. T3, B.U. 7.

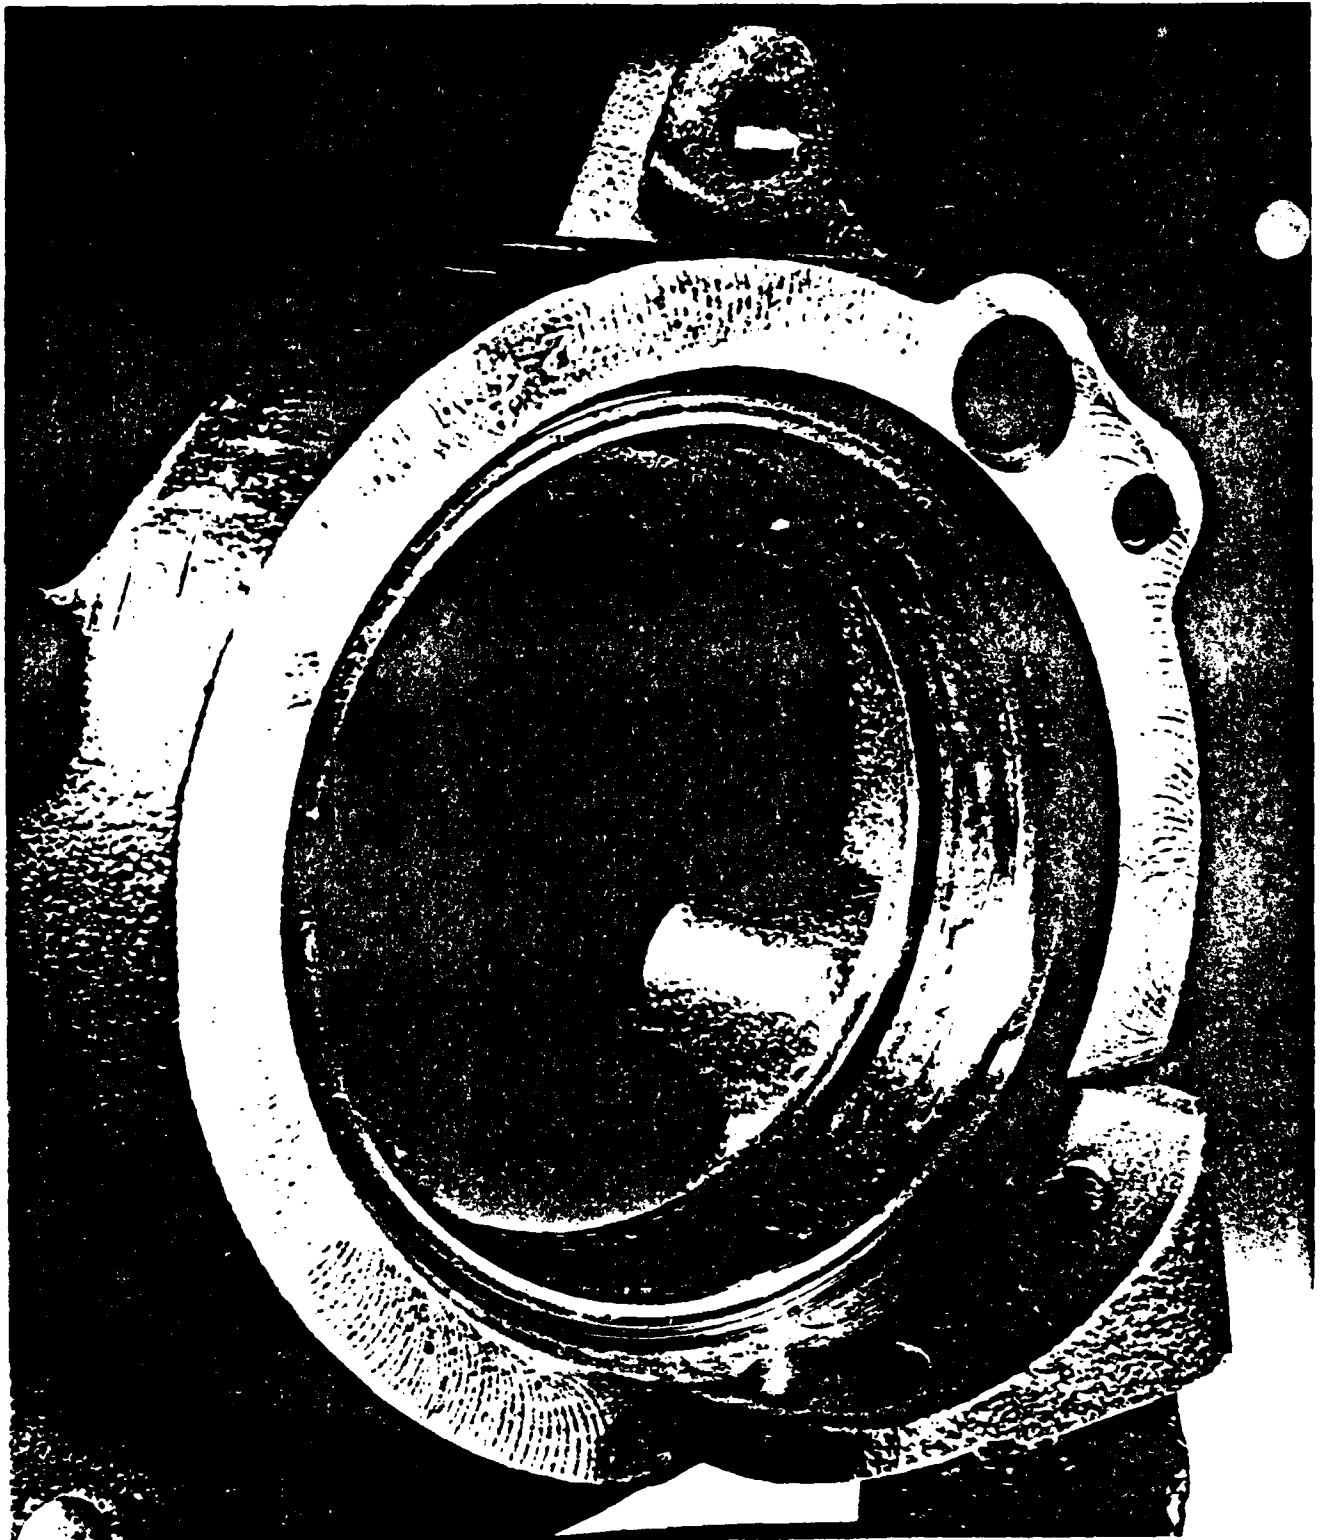
351432

-50°F COLD TEST BRG. FAILURE, GEN. SET #3, ENG. T3, B.U. 7.

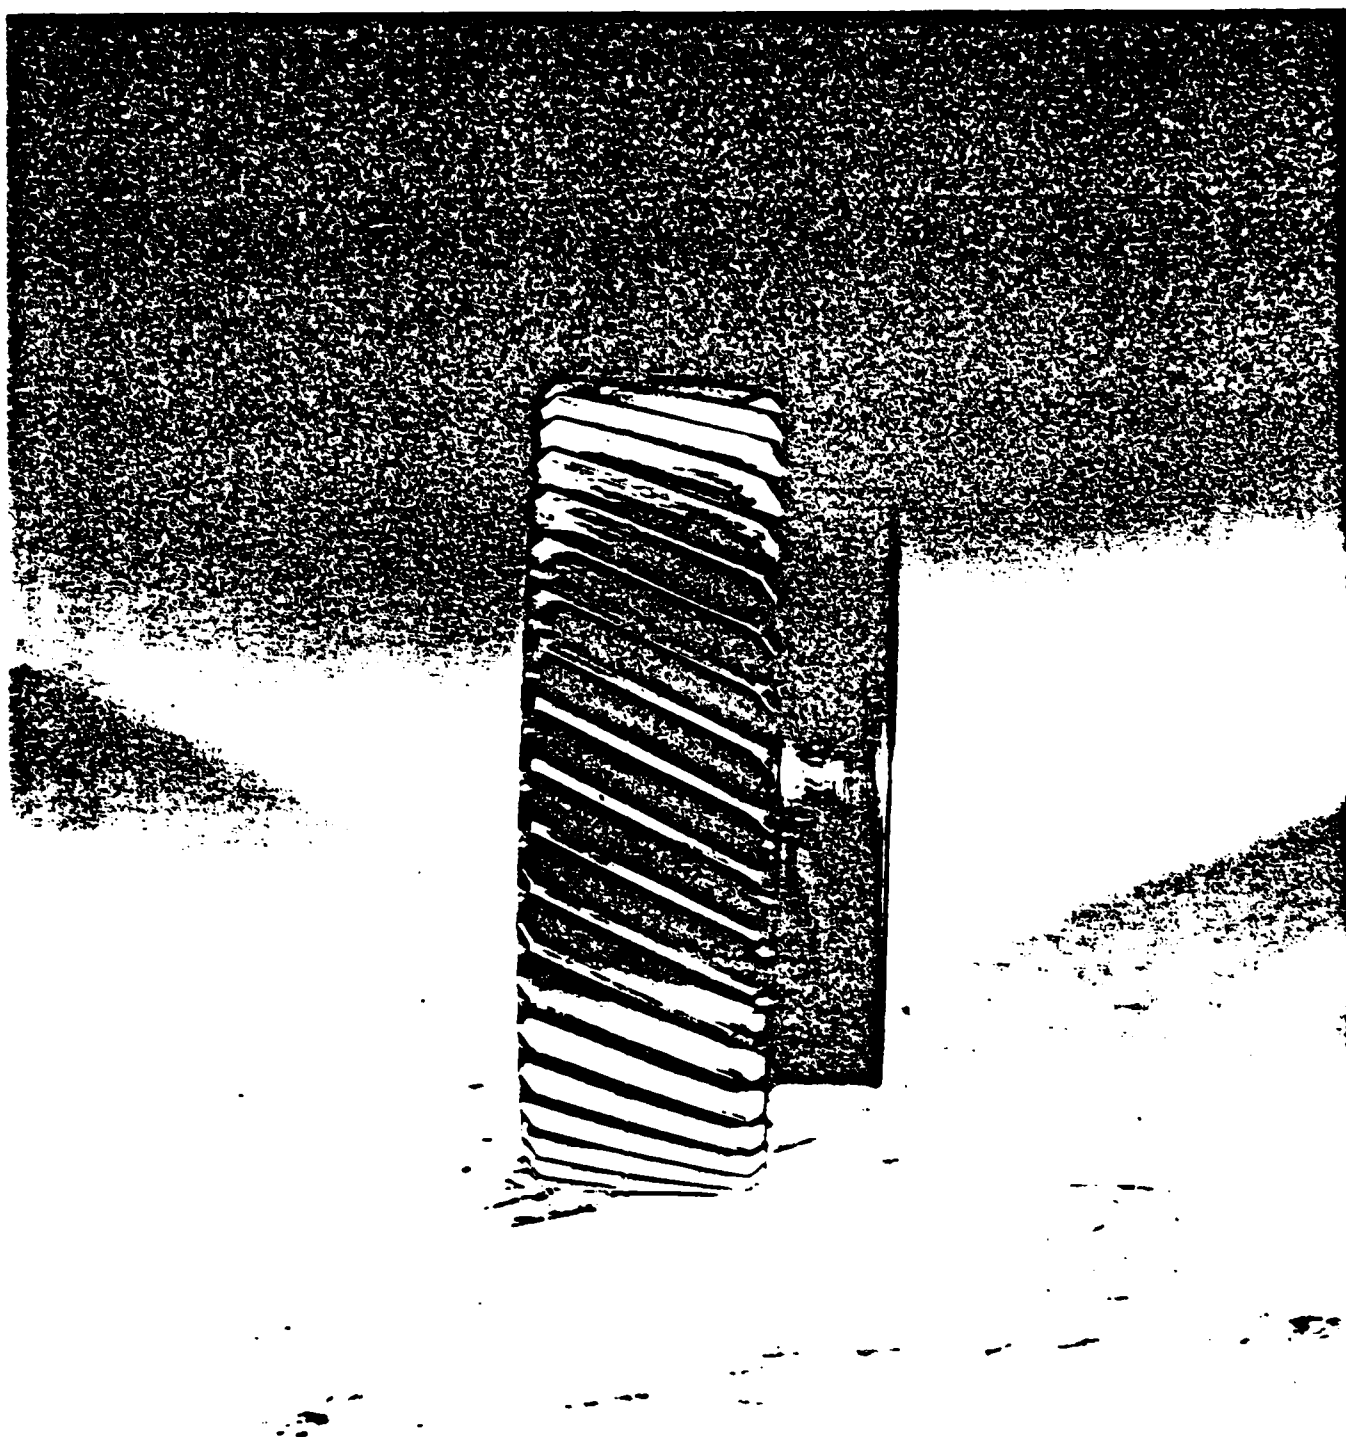
351433

-50°F COLD TEST BRG. FAILURE, GEN. SET #3, ENG. T3, B.U. 7.

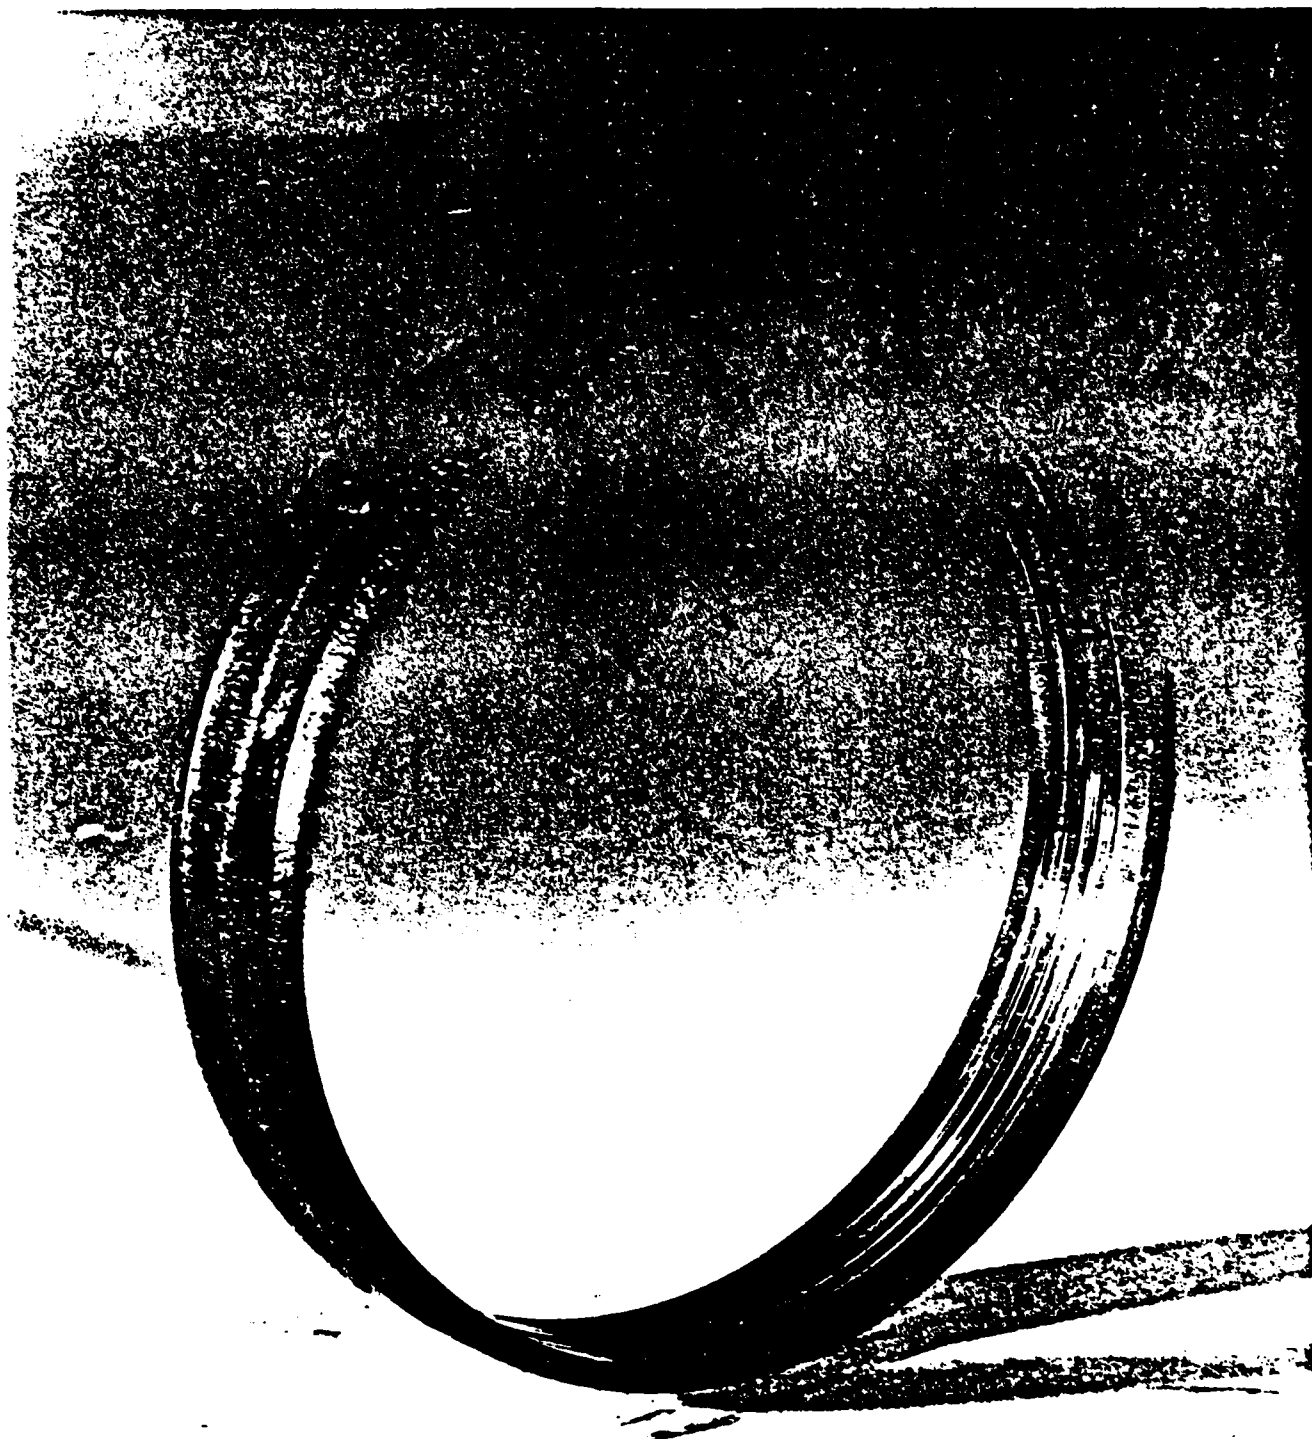
351434

-50°F COLD TEST BRG. FAILURE, GEN. SET #3, ENG. T3, B.U. 7.

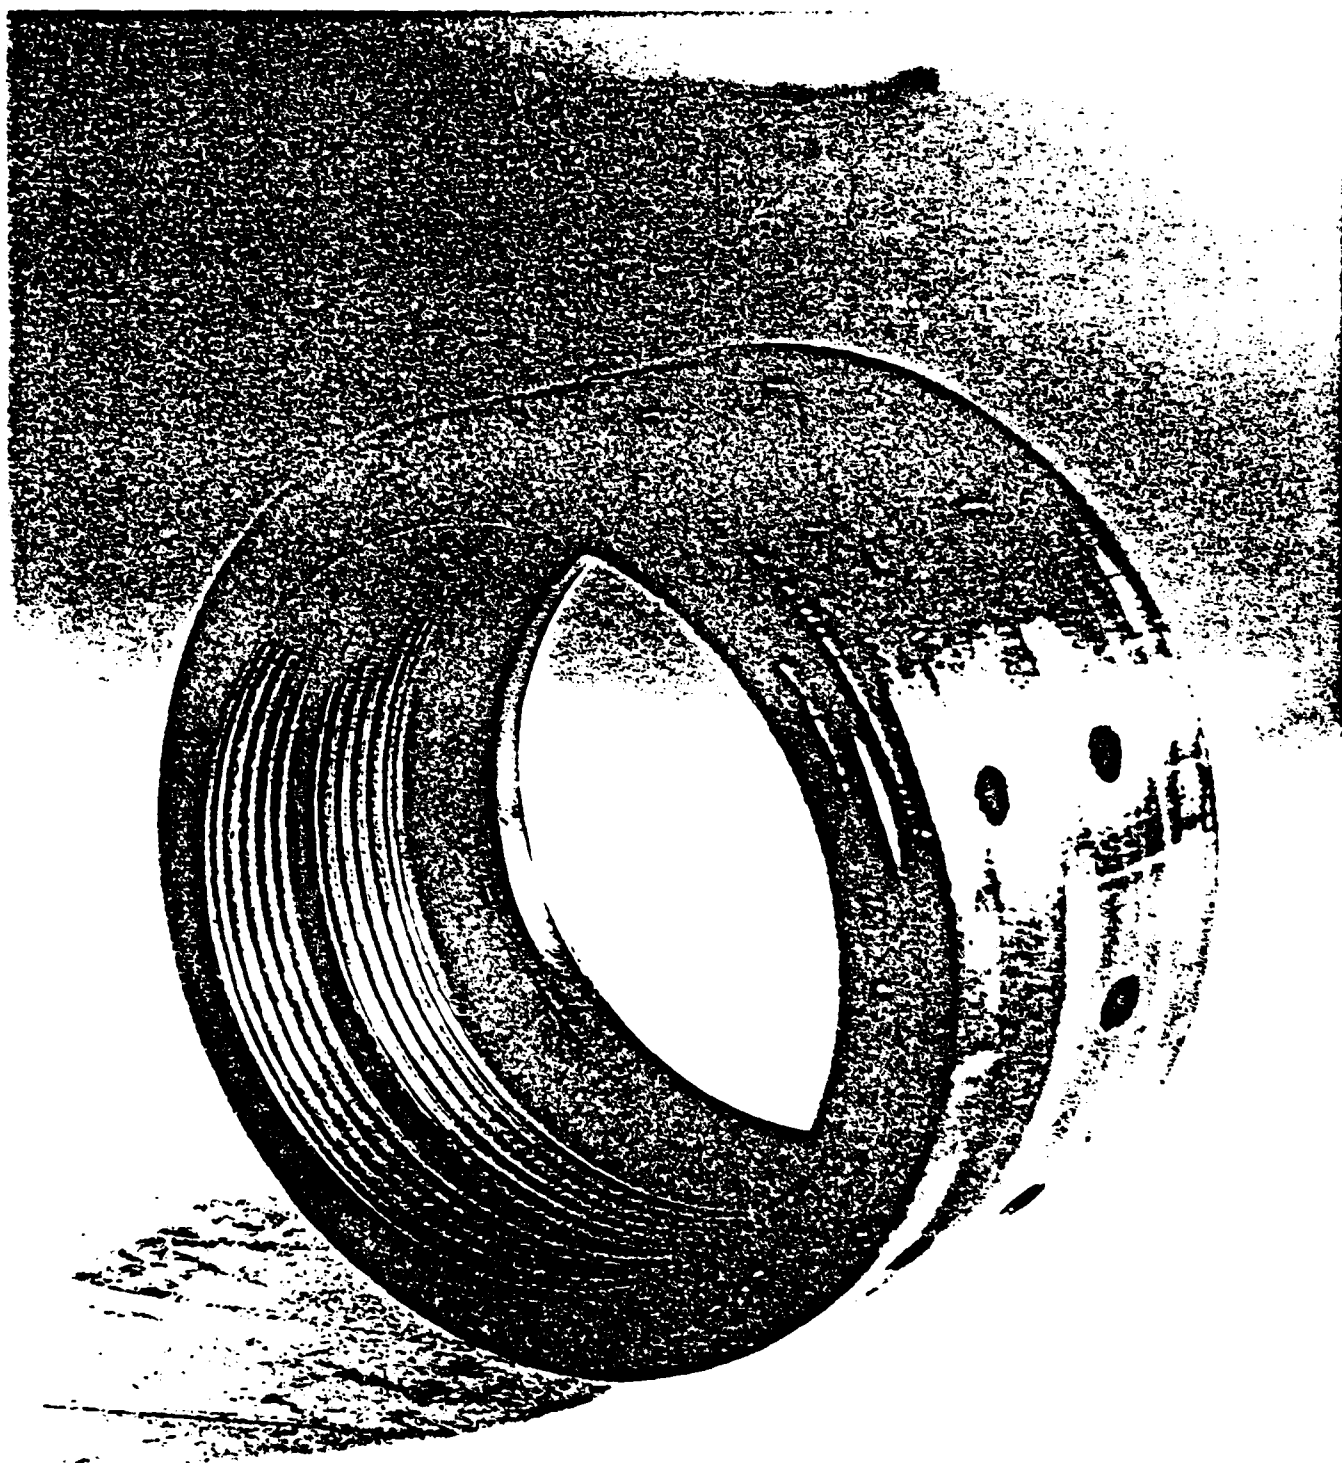
351435

-50°F COLD TEST BRG. FAILURE, GEN. SET #3, ENG. T3, B.U. 7.
