**ENGINEERING TEST REPORT**

**ENVIRONMENTAL AND COLD TESTS ON  
 MODEL 04045B03 GENERATOR SET SERIAL NUMBER  
 0000003 WITH IGT 404-4 ENGINE SERIAL NUMBER 1000003,  
 TEST UNIT**

Engine - IGT404-4  
 MODEL Generator Set 04045B03 DATE November 13, 1979

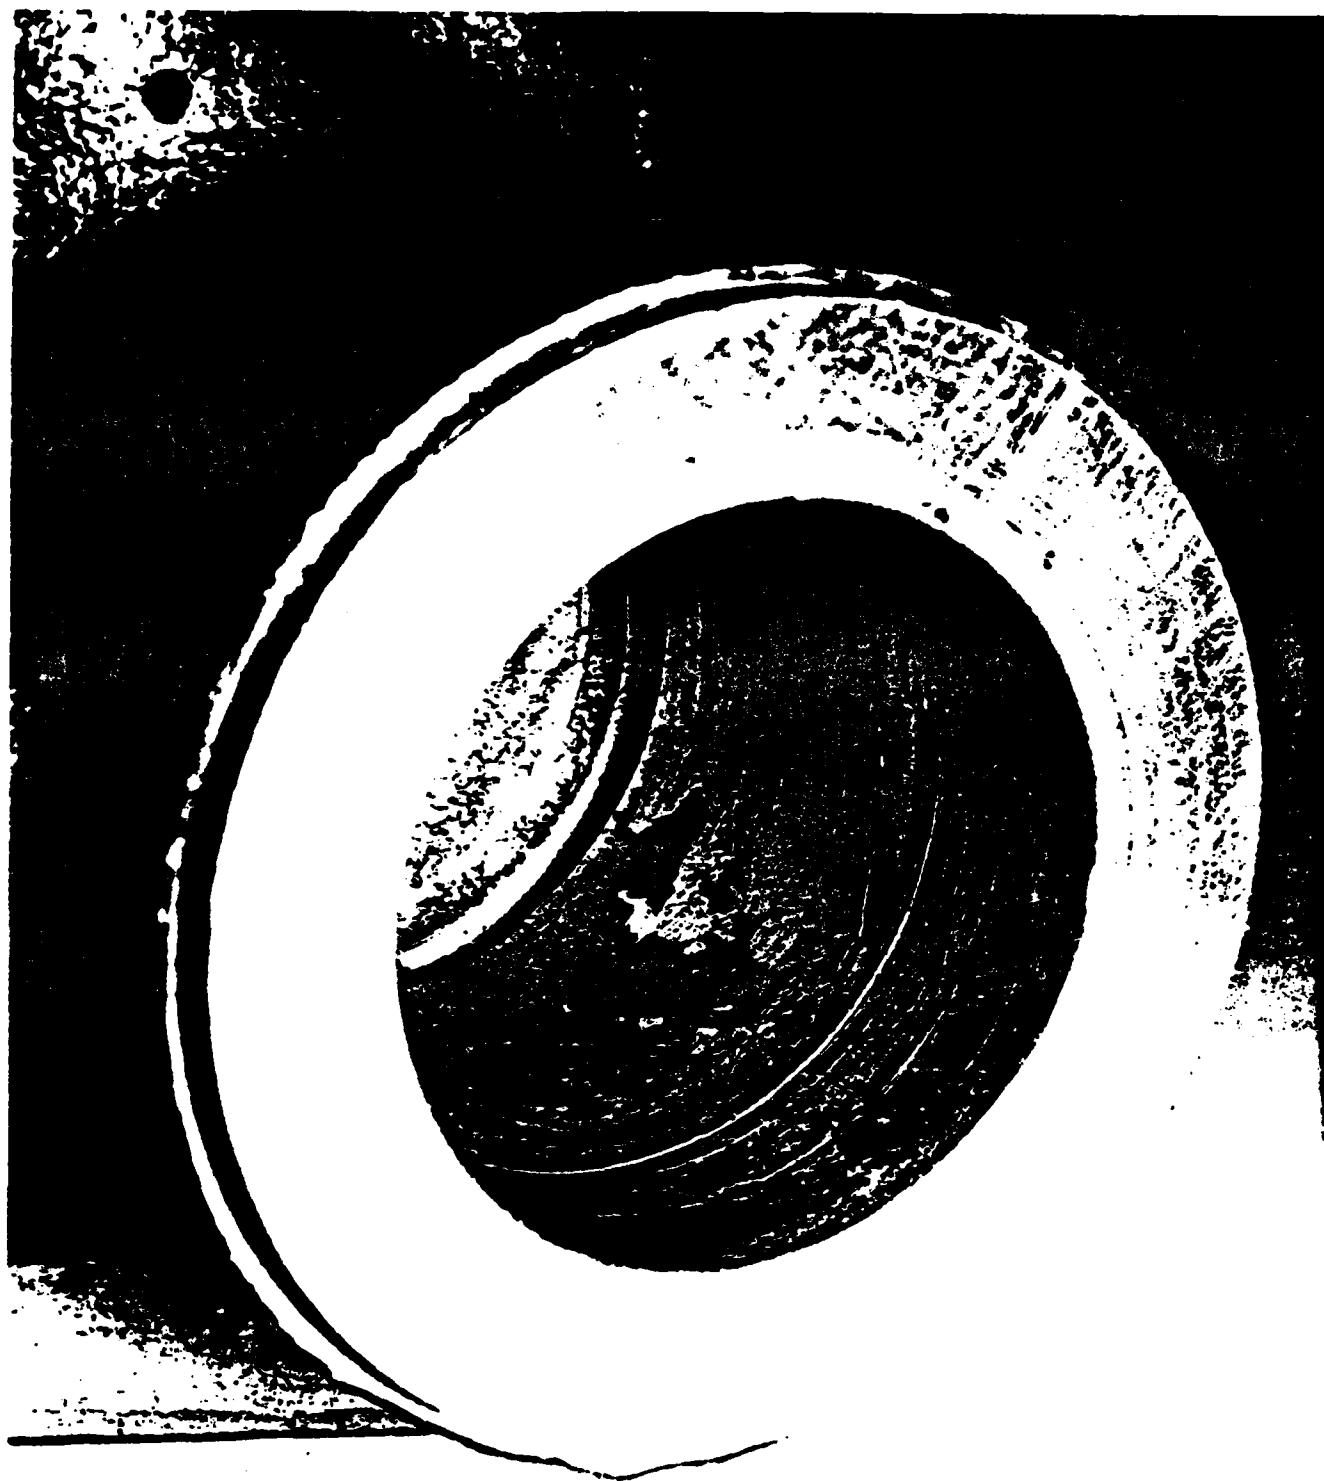
351436

-50°F COLD TEST BRG. FAILURE, GEN. SET #3, ENG. T3, B.U. 7.

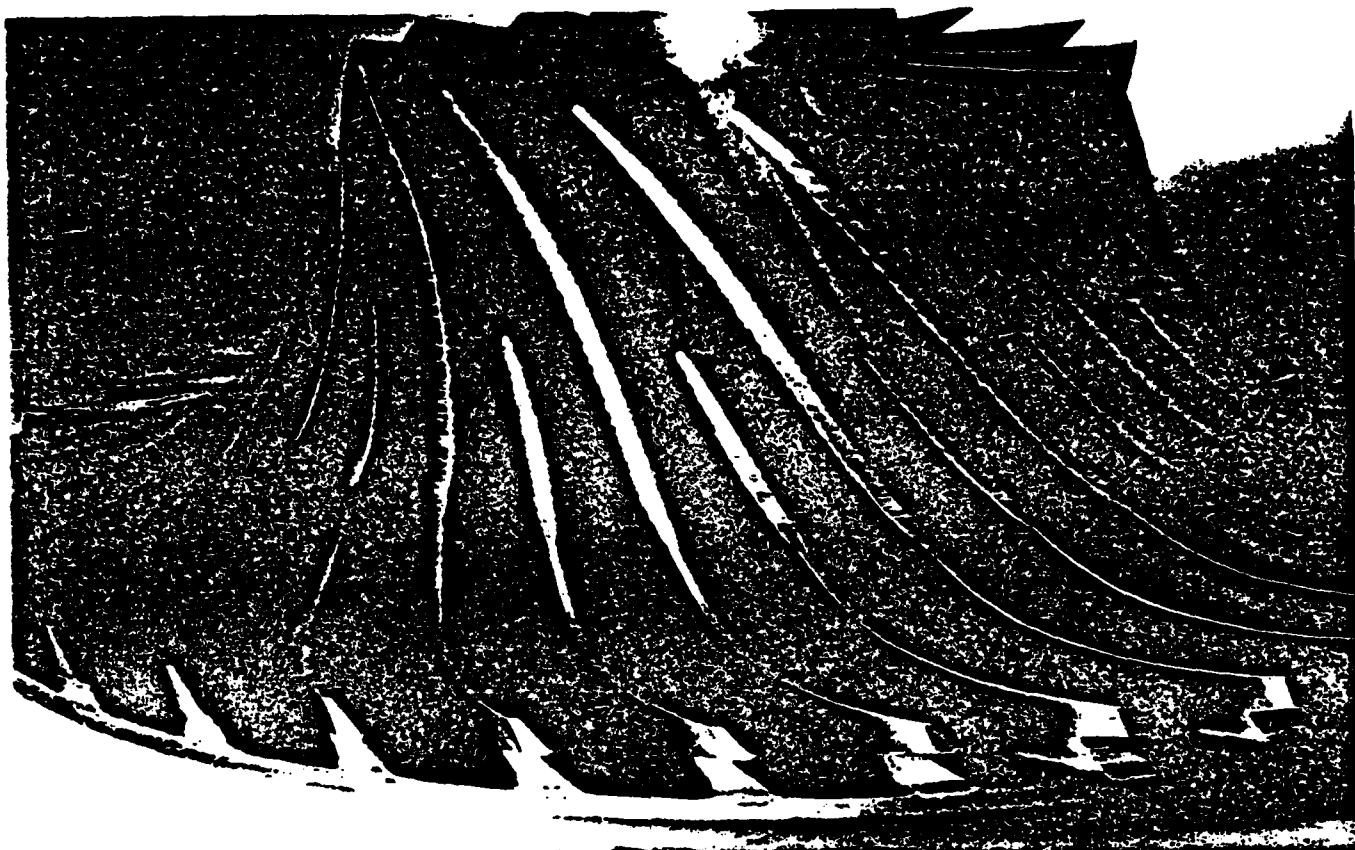
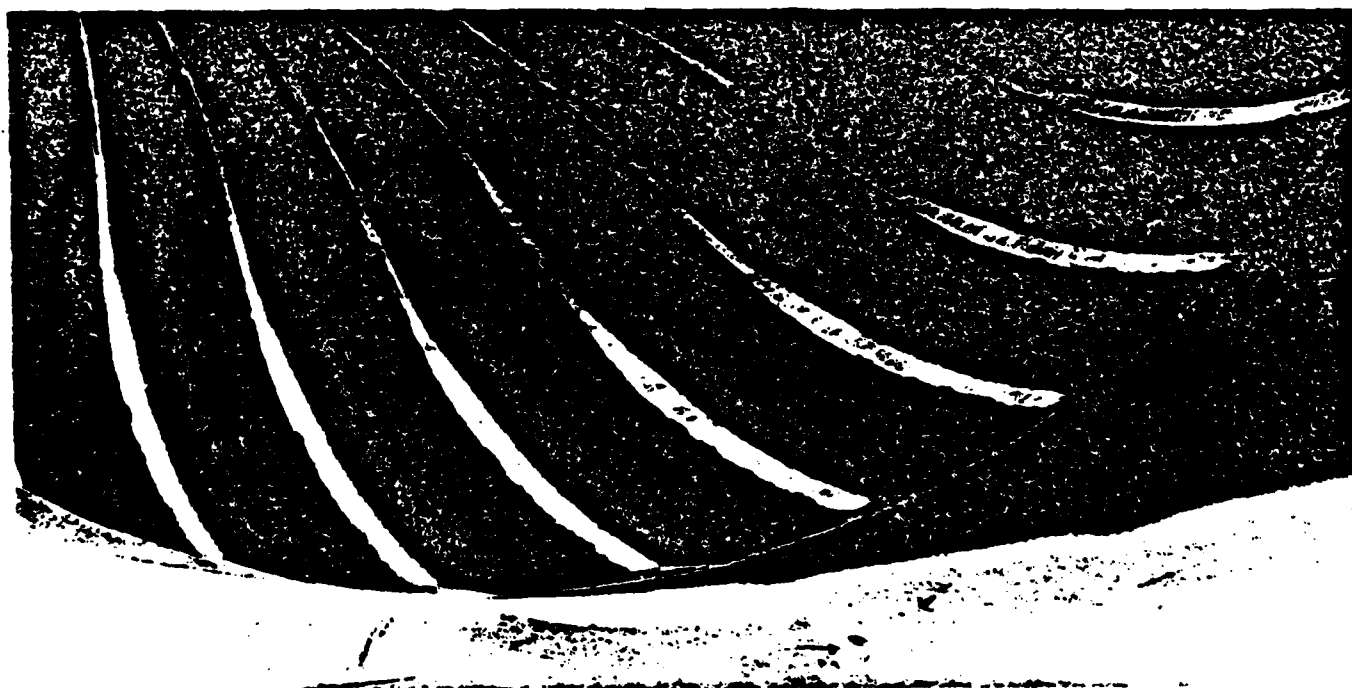
351437

-50°F COLD TEST BRG. FAILURE, GEN. SET #3, ENG. T3, B.U. 7.

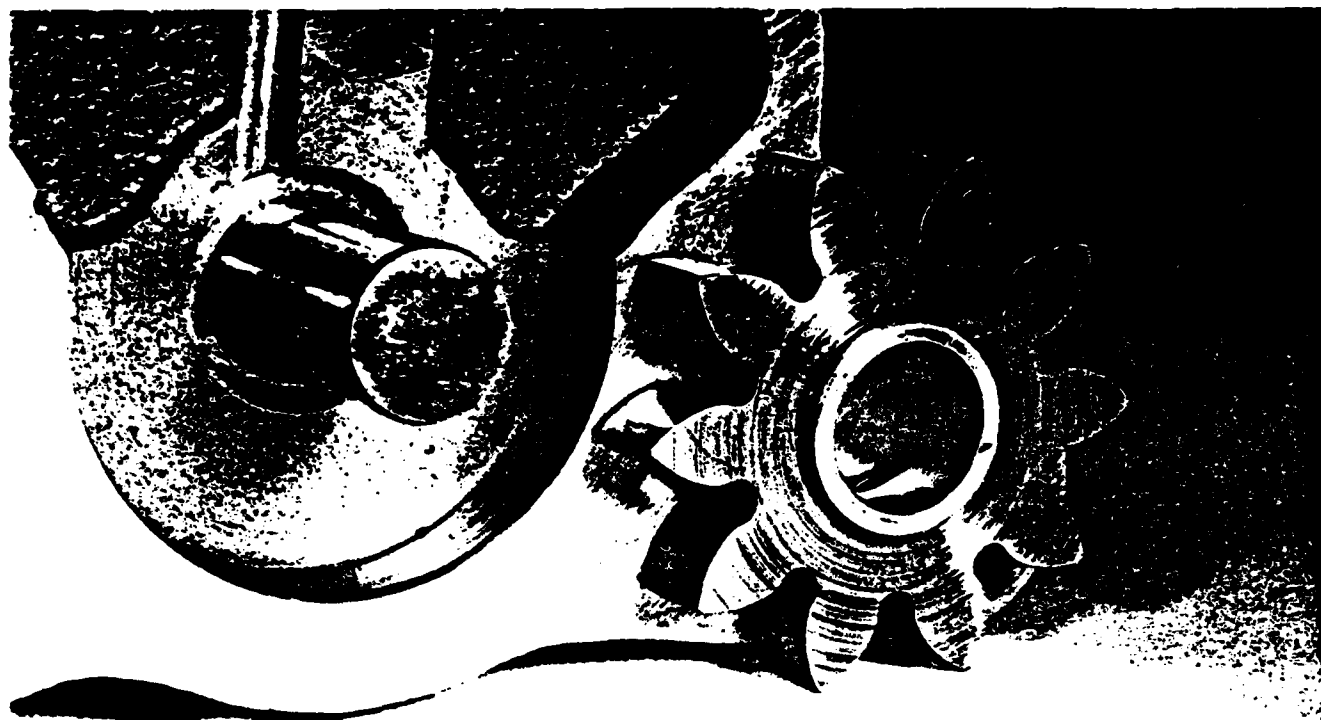
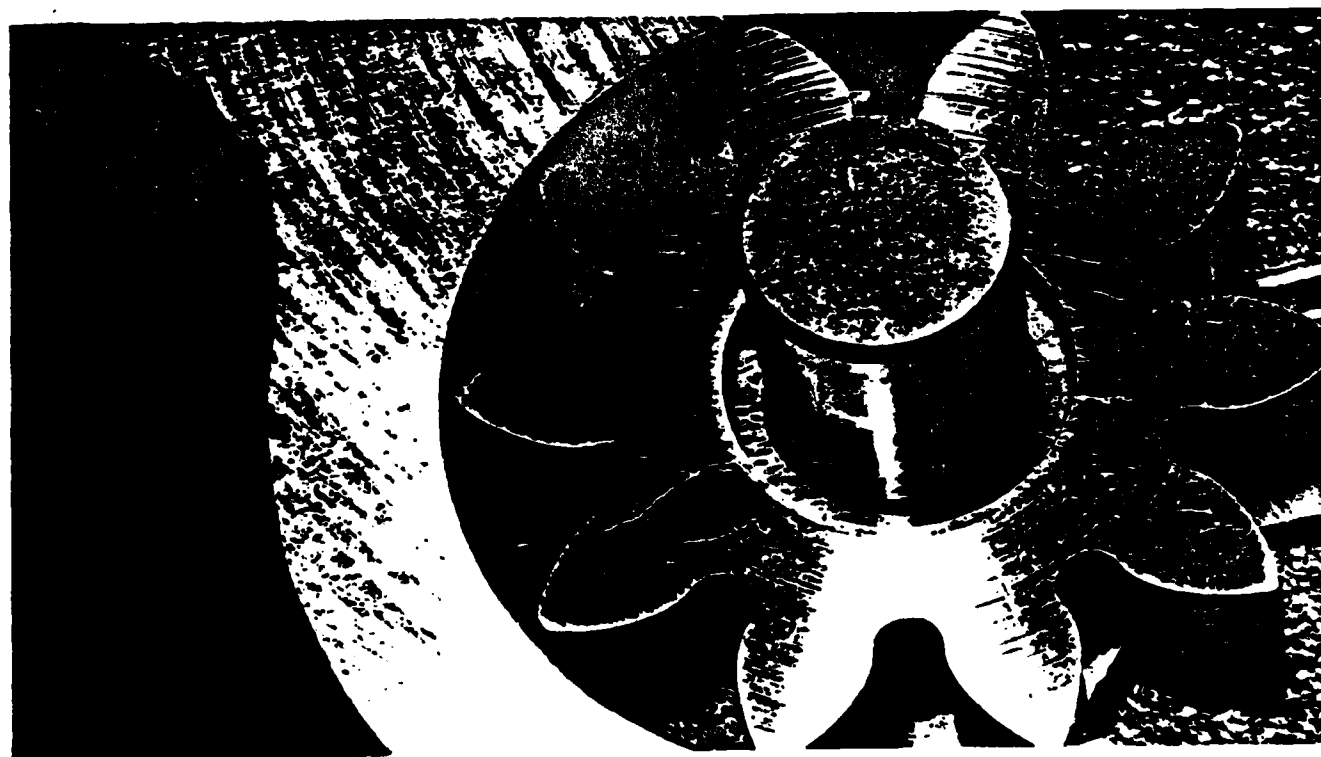
351438

-50°F COLD TEST BRG. FAILURE, GEN. SET #3, ENG. T3, B.U. 7.

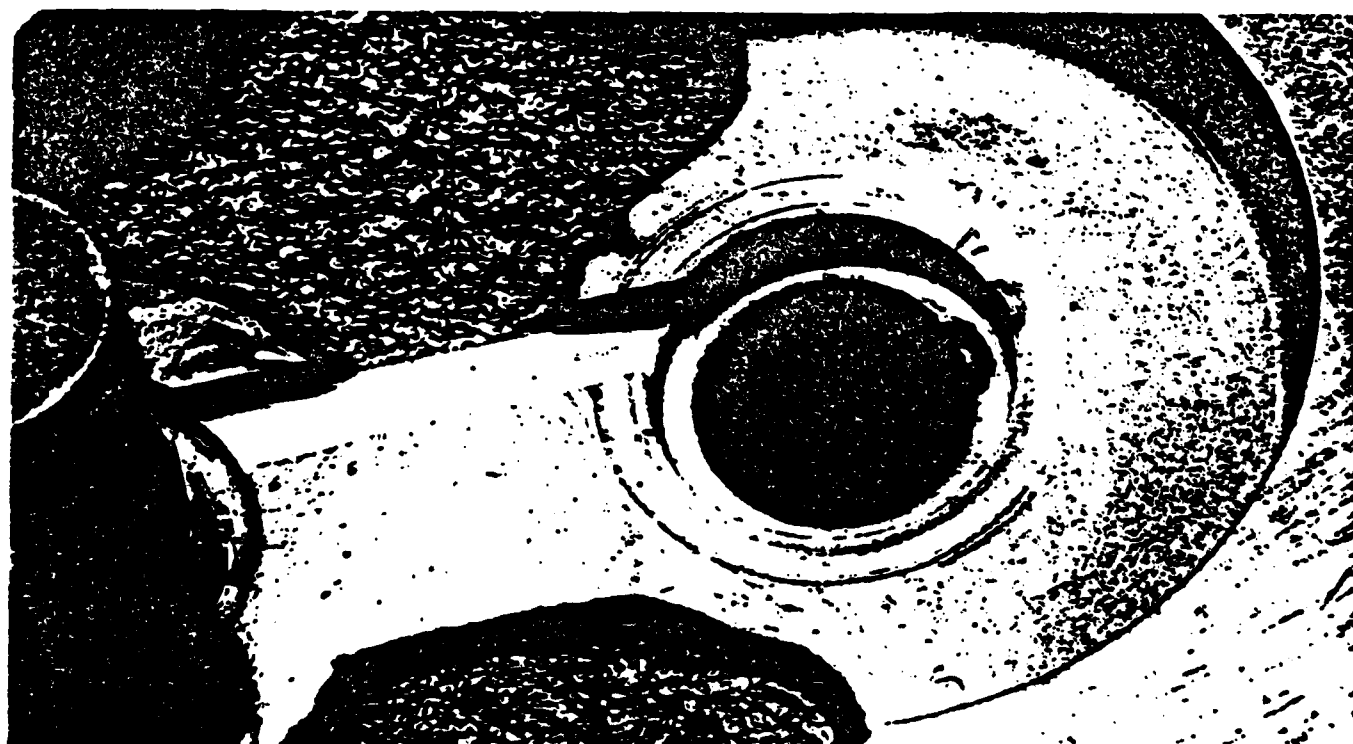
351439

-50°F COLD TEST BRG. FAILURE, GEN. SET #3, ENG. T3, B.U. 7.

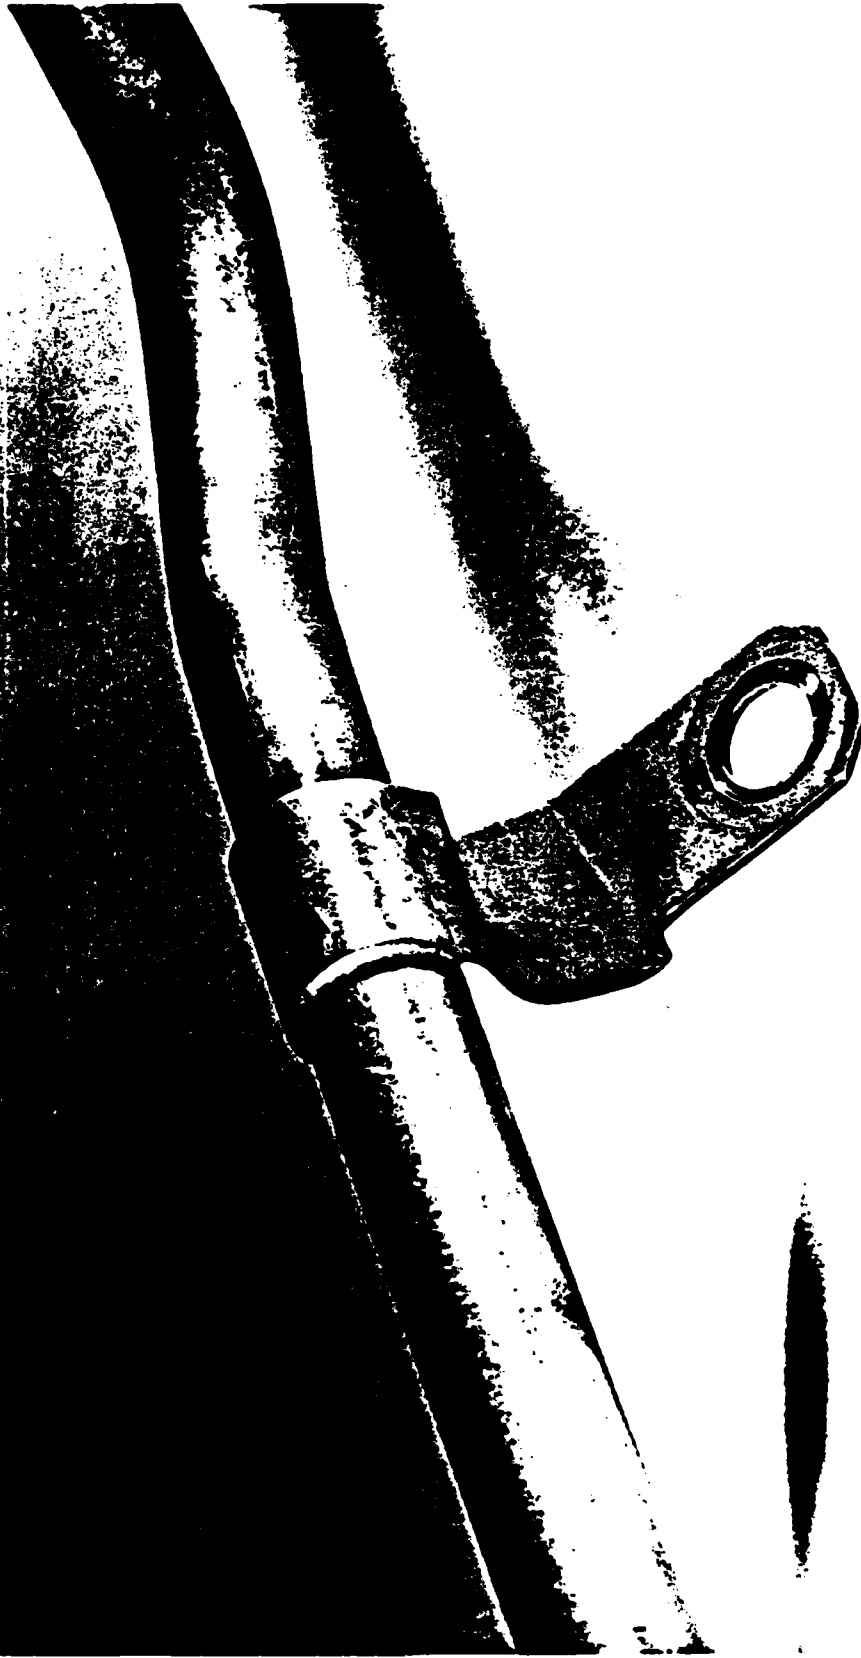
351525

The generator set and engine were disassembled to assess the failure damage. The failure and secondary damage are shown on Photos 351421 through 351439 and 351525.

-50°F COLD TEST BRG FAILURE, GEN SET #3, ENG T3, BU 7
