NEW YORK STATE DEPT OF ENVIRONMENTAL CONSERVATION ALBANY F/8 13/13  
NATIONAL DAM SAFETY PROGRAM. REXMERE DAM (INVENTORY NUMBER NY 5--ETC(1))  
FEB 80 6 KOCH

| REPORT DOCUMENTATION PAGE | | READ INSTRUCTIONS<br>BEFORE COMPLETING FORM |
|---|---|---|
| 4. TITLE (and Subtitle)<br>Phase I Inspection Report<br>Rexmere Dam<br>Delaware River Basin, Delaware County, NY<br>Inventory No. NY 524 | | 5. TYPE OF REPORT & PERIOD COVERED<br>Phase I Inspection Report<br>National Dam Safety Program |

OVERVIEW  
Rexmere Dam  
I.D. No. NY 524

PHASE I INSPECTION REPORT  
NATIONAL DAM SAFETY PROGRAM  
REXMERE DAM  
I.D. No. NY 524  
#160A-3493  
DELAWARE RIVER BASIN  
DELAWARE COUNTY, NEW YORK

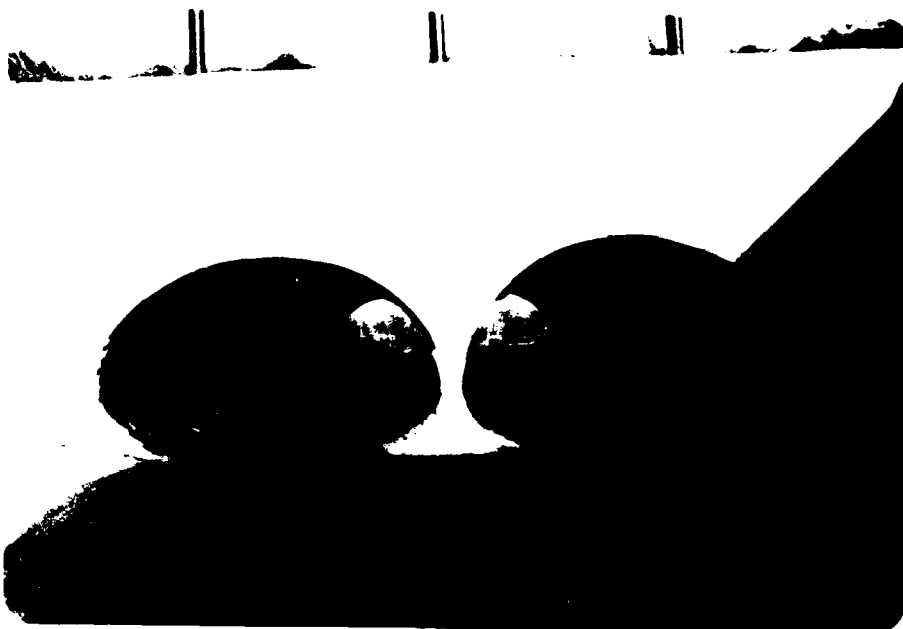
Other deficiencies observed were on the downstream portion of the spillway. The downstream headwall was cracked above and to the right (looking upstream) of the eastern pipe arch. Finally, there were three areas where the concrete and riprap at the end of the channel had been undermined, resulting in subsidence of the riprap. Water was entering these areas from the spillway channel and was flowing beneath these depressed sections.

Headwall at Outlet of Pipe-Arches - Note Cracks in Wall above Right Pipe-Arch

- 2 PIPE-ARCHES. CONCRETE & CONCRETED RIPRAP DISCHARGE CHANNEL.
- a. General SATISFACTORY - DOWNSTREAM HEADWALL AT EASTERN PIPE ARCH HAS 1 VERTICAL & 1 DIAGONAL CRACK ALONG ENTIRE FACE.
- b. Condition of Service Spillway BOTH PIPES BITUMINOUS COATED  
BOTH HAVE SOME COATING MISSING & DISCOLORATION & CORROSION IN THOSE SPOTS. BOTH PIPES HAVE AN INWARD BULGE NEAR THE CENTER. WESTERN PIPE ARCH HAS A JOINT SEPARATION (1" x 12") AT THE CROWN IN THE UPSTREAM 1/3 OF PIPE. EASTERN PIPE ARCH HAS SEVERAL JOINT SEPARATIONS ALONG INVERT WHICH HAVE BEEN PLUGGED WITH JOINT SEALER.

- e. A monitoring program should be established to periodically inspect the cracks on the spillway outlet headwall as well as the bulges on the pipe-arches and determine whether these conditions are worsening.
- f. Surface irregularities on the crest should be repaired and measures should be taken to prevent unnecessary traffic from crossing the crest.
- g. Minor deficiencies with the spillway pipe-arches such as the joint separations and the spots where the bituminous coating has worn off should be monitored and repaired if the conditions become more serious.
- h. The reservoir drain should be made operable. The valve box for the reservoir drain should be repaired. The major defects which must be addressed are the deterioration of the concrete on the box and the fact that the box is full of water.
- i. An emergency action plan for the dam should be developed.
