**STILWELL LAKE DAM  
ORANGE COUNTY, NEW YORK  
INVENTORY NO. 770**

**PHASE I INSPECTION REPORT  
NATIONAL DAM SAFETY PROGRAM**

**NEW YORK DISTRICT CORPS OF ENGINEERS**

**DECEMBER 1978**

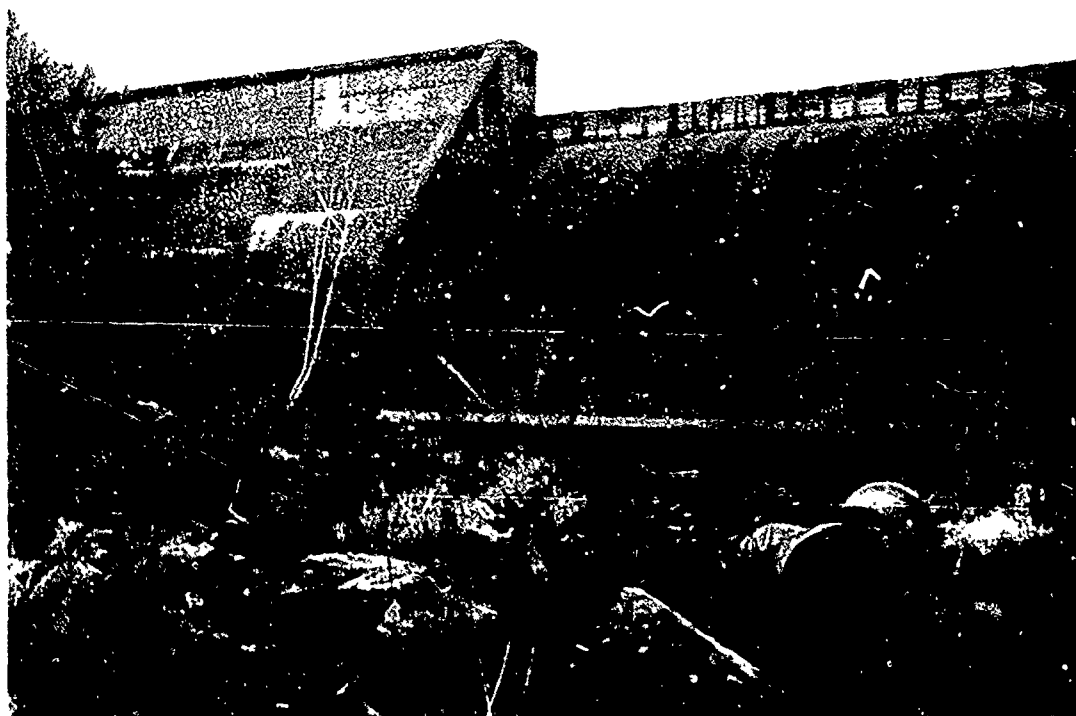
2. DOWNSTREAM FACE OF SPILLWAY AND RIGHT  
NON-OVERFLOW MONOLITH

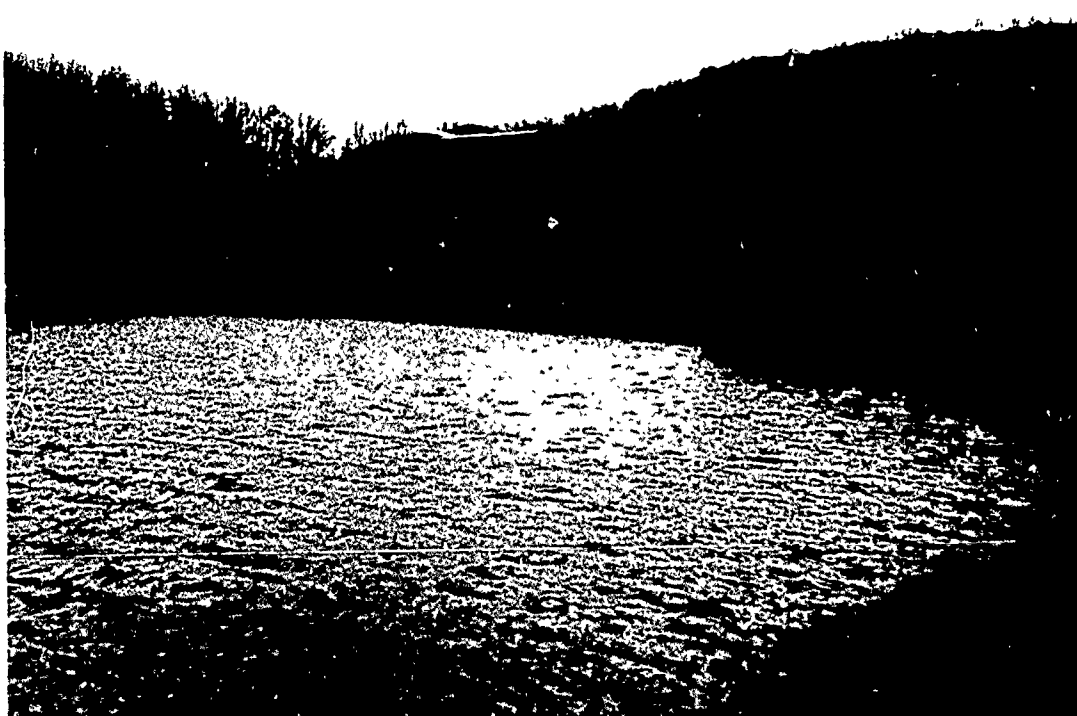
4. UPSTREAM VIEW OF DAM

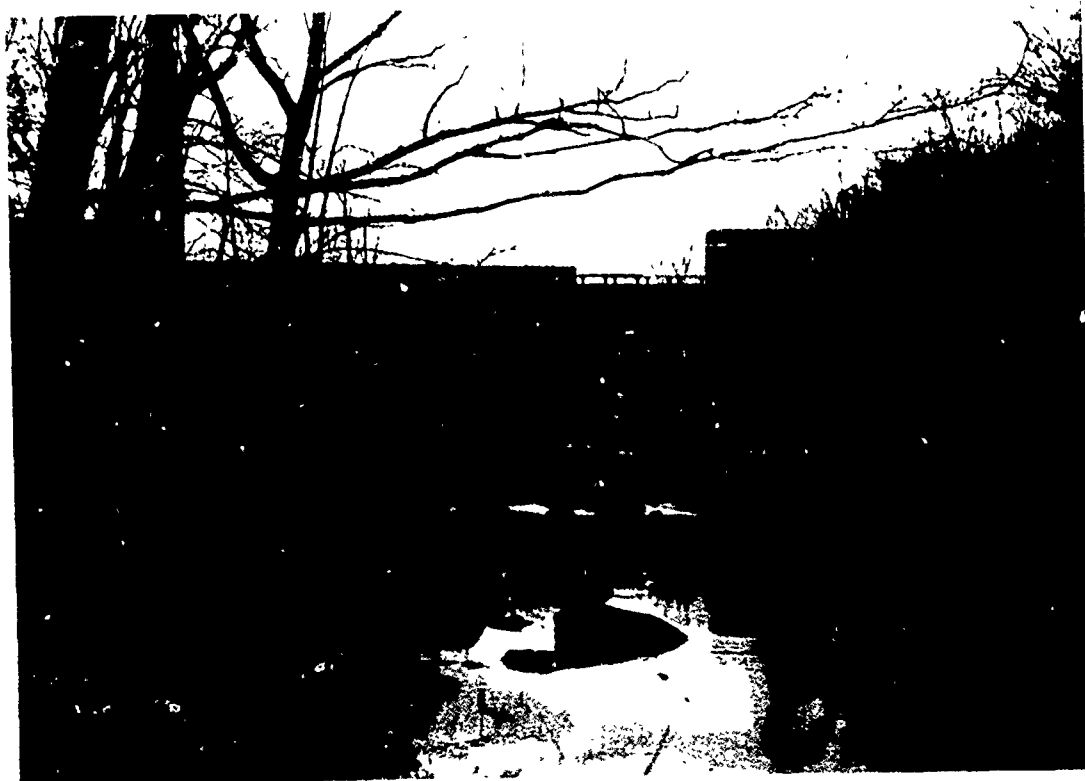
9. OVERALL VIEW OF DOWNSTREAM CHANNEL
