ALPINA DAM (Inventory Number **778**)
St. Lawrence River Basin **NY**
LEWIS COUNTY,
NEW YORK.

PHASE I INSPECTION REPORT,
NATIONAL DAM SAFETY PROGRAM

Name of Dam Alpina Dam NY778

State Located New York
County Located St. Lawrence
Stream Bonaparte Creek
Date of Inspection May 2, 1979

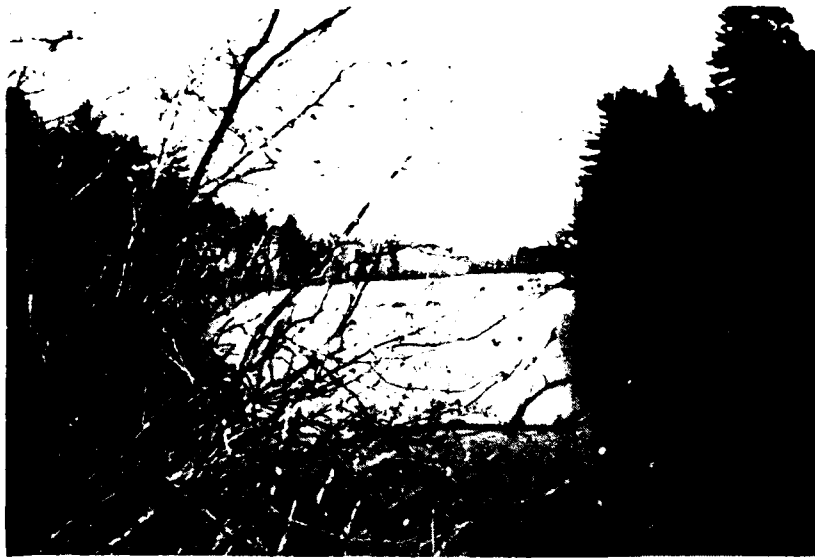
3. View of reservoir above dam.
