MINE LAKE DAM  
(Inventory Number NY 767)  
ORANGE COUNTY,  
NEW YORK.

PHASE I INSPECTION REPORT,  
NATIONAL DAM SAFETY PROGRAM

NEW YORK DISTRICT CORPS OF ENGINEERS

JULY 1979

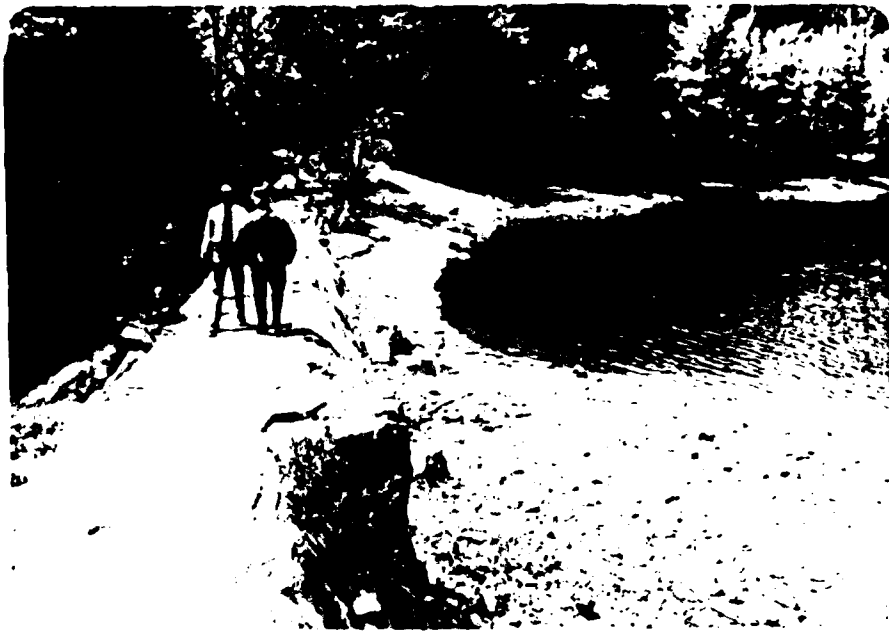
1. Close-up view across spillway section with reservoir in drawn down condition.
